Tesla, Inc. Service Bulletin	Rework Electrical Harness Due To Water Ingress	
SB-20-17-002 February 29, 2020		R1		
Classification		Section/Group		Mobile Service
Campaign Bulletin		17 - Electrical		Can Perform (where permitted)
Model Year	Model	Country/Region		Version
2019	Model 3	Europe, Middle East, Africa, Asia Pacific		RHD
The model(s) and model year(s) listed are a general approximation of the affected VIN list. Refer to the VIN/Bulletin Tracker or Customer/Vehicle profile to determine applicability of this bulletin for a particular vehicle.

On certain RHD Model 3 vehicles, the front main harness upper CAN connectors to the steering rack might not have been properly weatherproofed. Consequently, water might have entered the connectors, and possibly corroded the terminals.

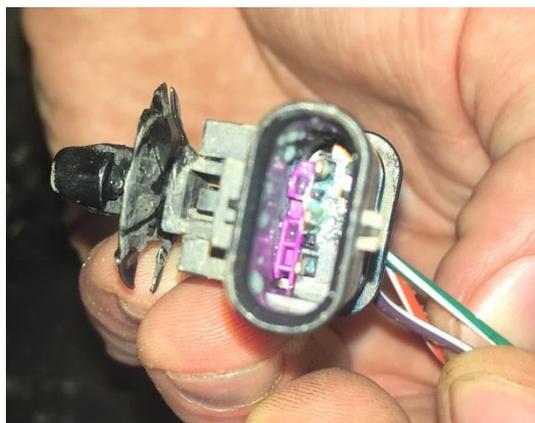
- If any of the terminals appear to have corrosion (Figures 4 and 5), both connectors must be replaced. Skip to section "Replace Connector X193".

✘ Figure 4 – Corrosion on male connector

Inspect the vehicle for symptoms related to the condition. If symptoms are present, apply silicone dielectric paste to the connectors. If the connector terminals are corroded, replace the connectors altogether.

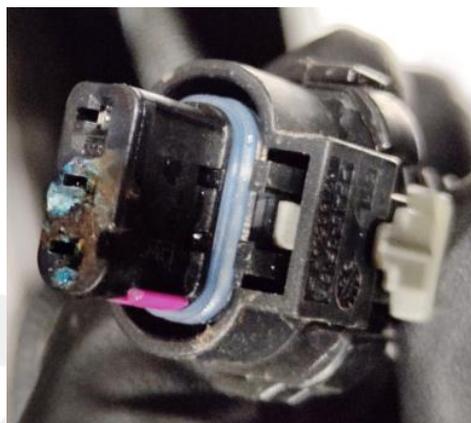
✘ Figure 5 – Corrosion on female connector

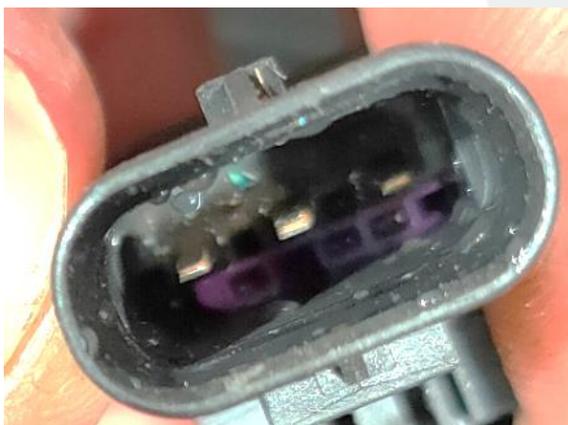
- If the terminals appear clean and without corrosion (Figures 6 and 7), regardless if there is water present, continue to the next step.

✔ Figure 6 – Wet, but no corrosion on male connector

6. If water is present, wrap each side of connector X193 with an air gun in a shop towel, and then blow out the water from the connector.

7. Apply a liberal amount of silicone dielectric paste to both male and female sides of connector X193, and then reconnect the male and female sides (Figure 8).

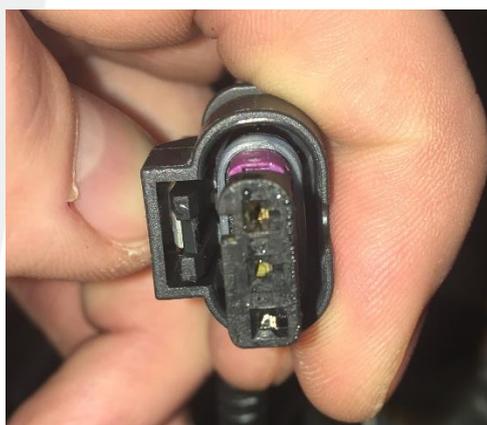
✔ Figure 7 – Wet, but no corrosion on female connector
