Tesla, Inc. Service Bulletin			Replace Front Drive Unit Halfshafts	
SB-21-3 January 1		R3		
Classification			Section/Group	Mobile Service
Repair Bulletin			39 - Front Drive Unit	Cannot Perform
Model Year	Model		Country/Region	Version
2014 - 2020	Model S, M	odel X	All	All
The model(s) and mo			I approximation of the affected VIN list. Refer to the VIN/B	ulletin Tracker or Customer/Vehicle profile to determine

Condition

Some versions of Model S and X front drive unit halfshafts might cause excessive vibrations during hard acceleration at higher ride height settings. This is exclusively an NVH issue and does not otherwise affect steering functionality, braking, or acceleration.

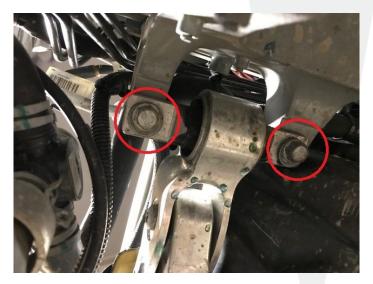
Figure 1

- 1. Raise and support the vehicle (refer to Service Manual procedure 10000205; Model S, Model X).
- 2. Shine a light into the front aero shield LH front caster adjustment opening (Figure 1) and inspect the flanges of the front drive unit clevis that attach to the side rail.
 - If the clevis flanges are squared and fastened with hex bolts (Figure 2), clevis and halfshaft replacement are necessary; skip to step 3.
 - If the clevis flanges are rounded and fastened with External Torx bolts with large washers that obscure the flange (Figure 3), clevis replacement is not necessary; however, the halfshafts must be replaced. Skip to step 4.
