Tesla, Inc.
Service Bulletin

Inspect Front Door Panel Brackets

SB-24-10-004

February 7, 2024

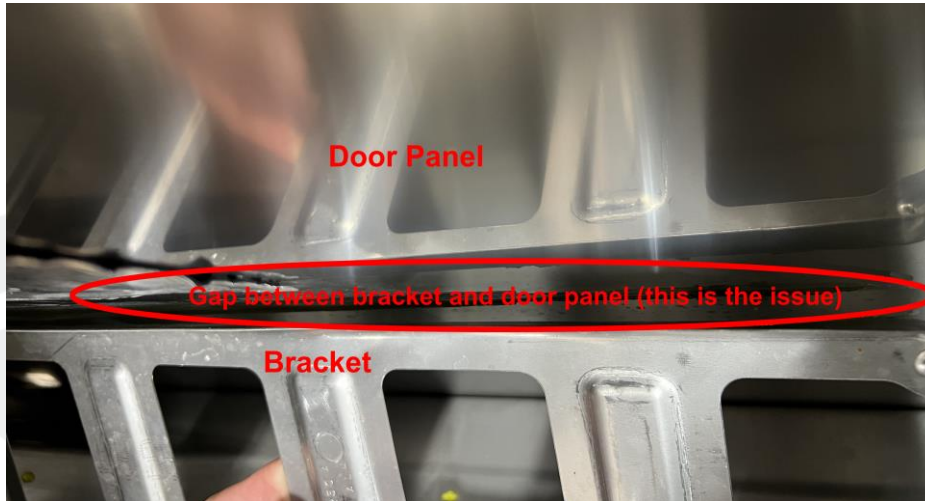
Figure 1

On some Cybertruck vehicles, a bracket inside the front door panels might not meet Tesla quality standards, which might result in a clanging noise when closing the door or driving over bumps.

3. Inspect the bracket near the bottom of the door panel (Figure 1), checking for a gap between the bracket and the door panel.

- If a gap between the door bracket and door panel is observed, this bulletin applies to this door. Continue to step 4.
 - If a gap between the door bracket and door panel is *not* observed, this bulletin does not apply to this door. Skip to step 7.
4. Use IPA wipes to clean the surfaces of the door bracket and door panel that face each other (Figure 1).
NOTE: The surfaces should be thoroughly cleaned, as butyl tape will be installed between the door bracket and door panel in the following steps.
NOTE: Allow the surfaces to dry for at least one minute before performing step 6.
 5. Cut a 44.5 cm long strip of butyl tape; and then cut the strip in half lengthwise, resulting in a 44.5 cm x 2.5 cm strip of tape.
 6. Position the strip of butyl tape between the front door panel and bracket, with the protective backing facing the door panel. (Figure 2).

Upon customer complaint, inspect the vehicle for symptoms related to the condition. If symptoms are present, install butyl tape between the front door panel(s) and door panel bracket(s).
