Tesla, Inc.
Service Bulletin

Replace Door Check Strap Joint Bolts

SB-24-11-001
March 7, 2024

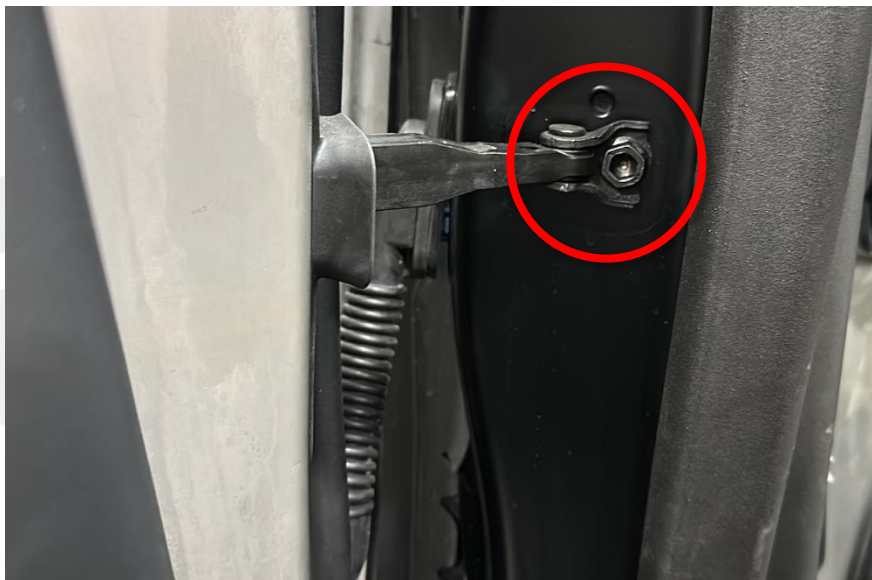
✓ Figure 1

1. Open all the doors and lower all the windows.
2. Inspect the door check strap joint bolt head at each door.
 - If the bolt heads are 13 mm hex (1623708-00-A) (Figure 1), no further action is necessary. Raise all the windows and close all the doors. Use correction code S022411001.
 - If the bolt heads are T40 Torx (1902621-00-A) (Figure 2), continue to the next step.

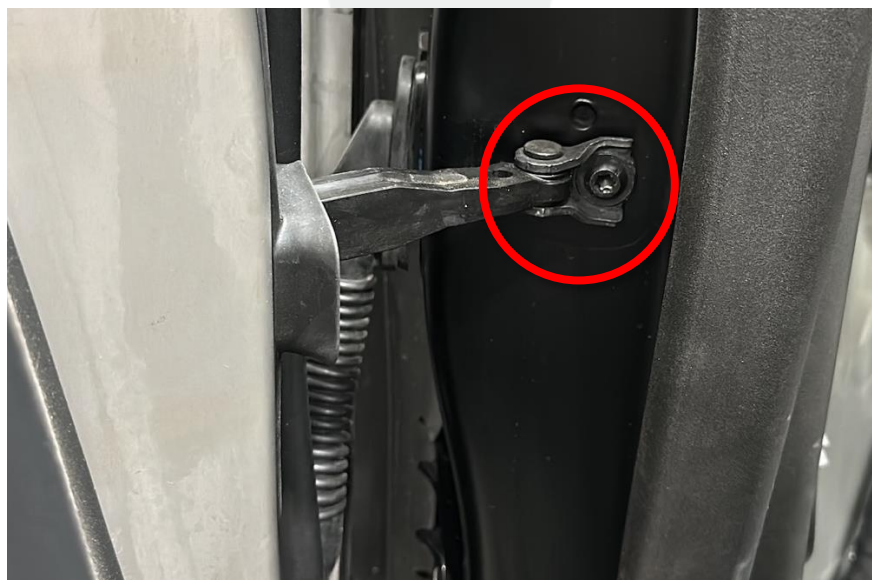
✗ Figure 2

On some Cybertruck vehicles, the door check strap joint bolts on all four (4) doors may become loose which may result in a clicking noise when opening or closing a door.

3. Remove and discard the T40 Torx check strap joint bolts, replace them with 13 mm hex bolts (1623708-00-A) at all doors, and then tighten the new hex bolts to the updated specification (torque 35 Nm).

⚠ CAUTION: This fastener uses an updated torque specification. Do not use the old torque specification that was previously used with the T40 Torx fastener.
