Tesla, Inc. Service Bulletin		<h2 style="margin: 0;">Remove Side Apron Seals And Install Clips</h2>	
SB-24-12-004 May 29, 2024			
Classification Repair Bulletin		Section/Group 12 - Exterior Fittings	Mobile Service Can Perform (where permitted)
		Configuration All	
Model Cybertruck	Model Year 2024	Country/Region North America	Build Location Giga Texas
<small>The model(s) and model year(s) listed are a general approximation of the affected VIN list. Refer to the VIN/Bulletin Tracker or Customer/Vehicle profile to determine applicability of this bulletin for a particular vehicle.</small>

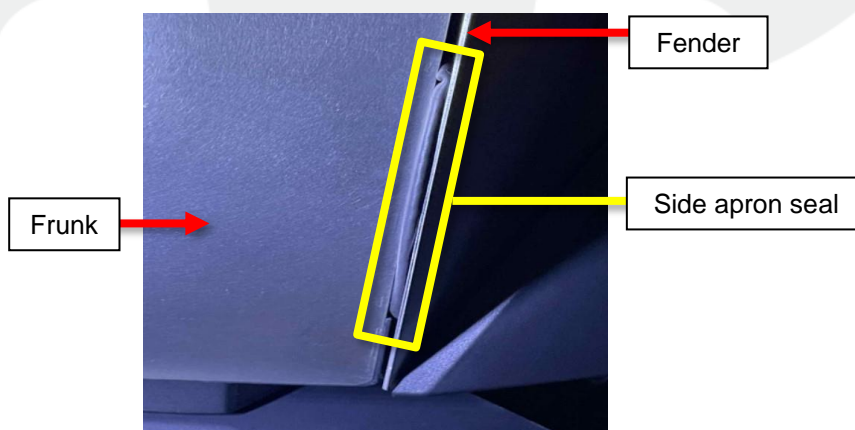
Figure 1

On certain Cybertruck vehicles, the LH and/or RH side apron seal may be visible through the frunk-to-fender gap (Figure 1).

Upon customer complaint, remove and discard the LH and RH side apron seals, and then plug the holes in the LH and RH side apron assemblies with clips.
