Tesla, Inc. Service Bulletin		<h1>Replace HW4 Camera Hood</h1>	
SB-24-15-003 October 17, 2025		R2	
Classification Repair Bulletin		Section/Group 15 - Interior Trim	Mobile Service Can Perform (where permitted)
		Configuration HW4	
Model Model Y	Model Year 2024–2025	Country/Region Europe, Middle East, Africa	Build Location Giga Berlin
<small>The model(s) and model year(s) listed are a general approximation of the affected VIN list. Refer to the VIN/Bulletin Tracker or Customer/Vehicle profile to determine applicability of this bulletin for a particular vehicle.</small>

On certain Model Y vehicles, the camera hood may not hold the GNSS antenna firmly in place, causing a rattling sound that can be heard from the rear view mirror area.

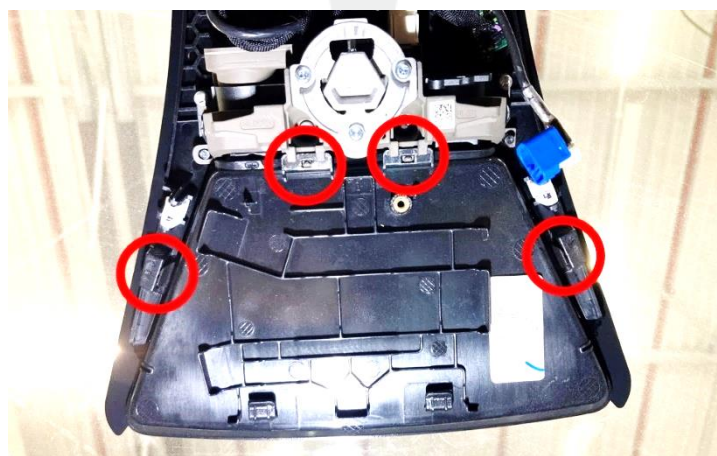
Figure 5 – Push side tabs (x2)

4. Push the tabs (x2) at the side of the camera hood, and then lower the camera hood from the tabs (x2) on the windshield bracket (Figure 5).

5. Attach the tabs (x2) at the top of the new camera hood to the camera assembly, and then engage the tabs (x2) at the side of the camera hood to install the camera hood to the windshield bracket (Figure 5).
6. Attach the GNSS antenna to the tabs (x2) of the camera hood, and then fasten the bolt (T10, torque 0.8 Nm) that attaches the GNSS antenna to the camera hood (Figure 4).
7. Connect the GNSS antenna connector to the GNSS antenna (Figure 3).
8. Install the upper camera cover, but do not install the rear view mirror and lower camera cover yet (refer to Service Manual procedure [15051802](#)).
