Tesla, Inc.
Service Bulletin

Install Flat Flex Cable Harness Guide

SB-24-17-004

September 10, 2024

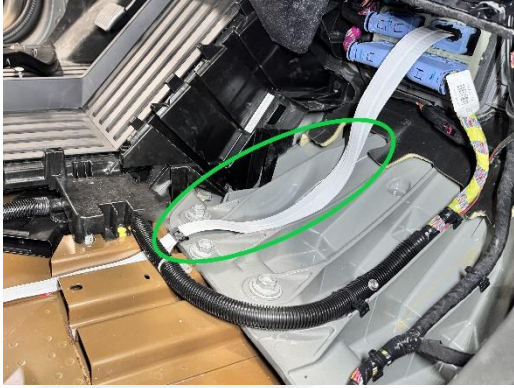
9. Inspect the front passenger (Figure 3) and rear passenger (Figure 4) sections of the FFC for abrasions and damage.

Figure 3 – Front passenger section; seat and trim removed for clarity

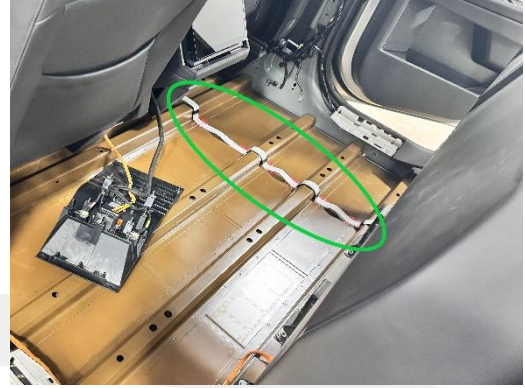
Figure 4 – Rear passenger section

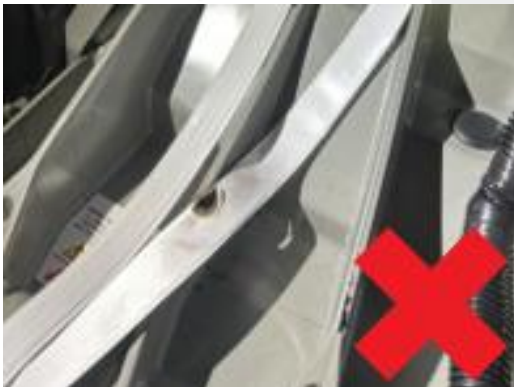
Figure 5 – Example damage at the front passenger section of the FFC

- If damage to the FFC such as exposed inner wires is found (Figures 5 and 6), replace the Mid Voltage (MV) backbone harness (refer to Service Manual procedure [1710013032](#)) and discontinue this procedure. Use Correction Code S022417004.

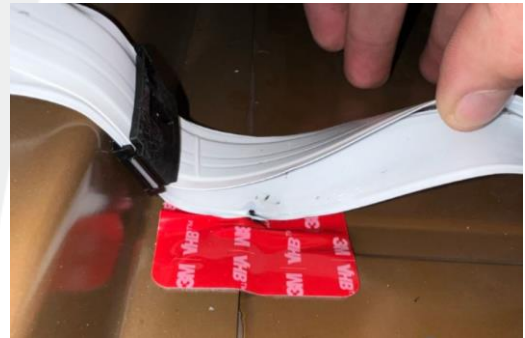
Figure 6 – Example damage at the rear passenger section of the FFC

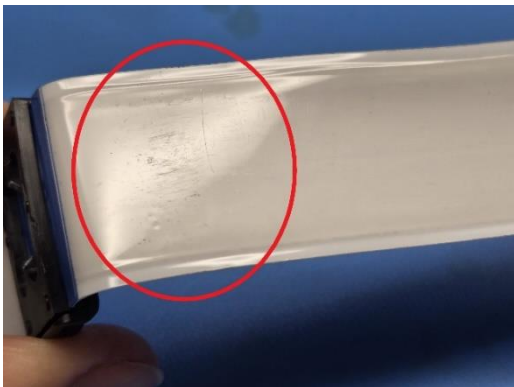
Figure 7 – Example Abrasion 1

- If only abrasions to the outer cover are found (Figures 7 and 8), the FFC does not need to be replaced. Continue to step 10.

10. Apply 3M VHB Foam (PN: 1879451-00-B) to the FFC over the abrasions (Figures 9 and 10).

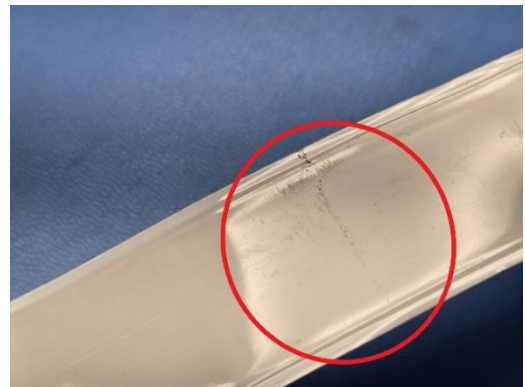
Figure 8 – Example Abrasion 2

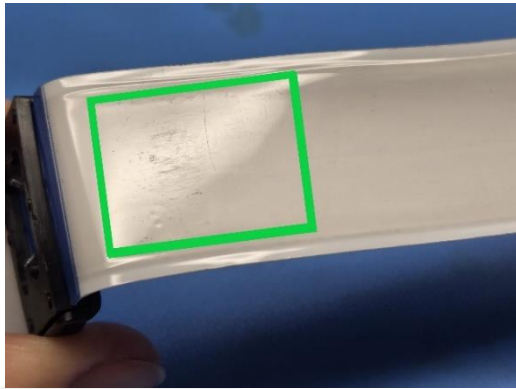
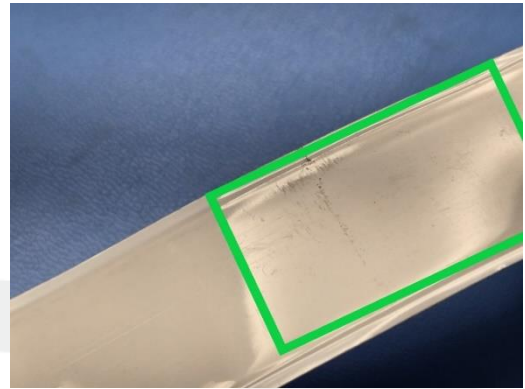
Figure 9 – The green box shows the correct application area of the 3M VHB Foam

Figure 10 – The green box shows the correct application area of the 3M VHB Foam

⚠ CAUTION: Do not wrap the cable in the 3M VHB foam. Only apply the foam to the flat side of the cable. Wrapping the cable may cause damage to the cable due to excessive heat.

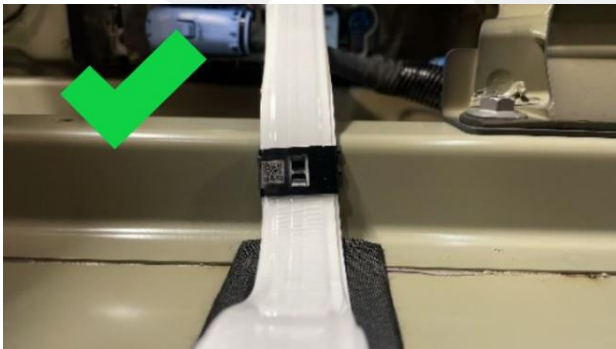
Figure 11 – Correct

11. At the rear passenger section of the FFC, position the cable so that it lays flat (Figure 11).

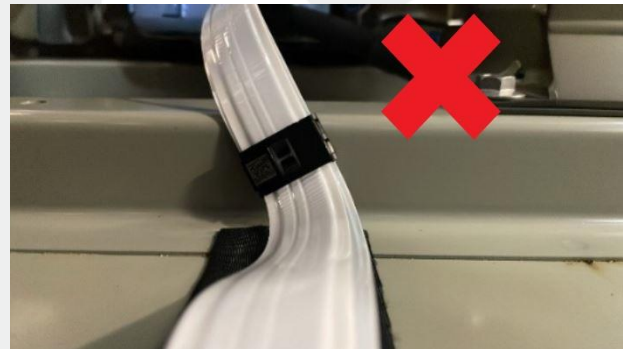
Figure 12 – Incorrect

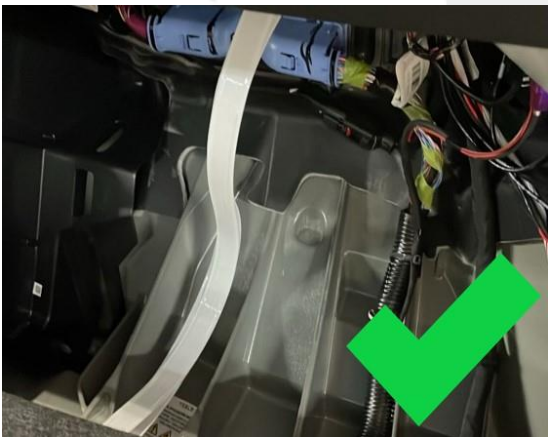
Figure 17 – Correctly routed through LH channel

20. Route the FFC through the LH channel of the cast ribbing (Figure 17).

! CAUTION: Make sure the cable is flat against the casting and is not twisted.

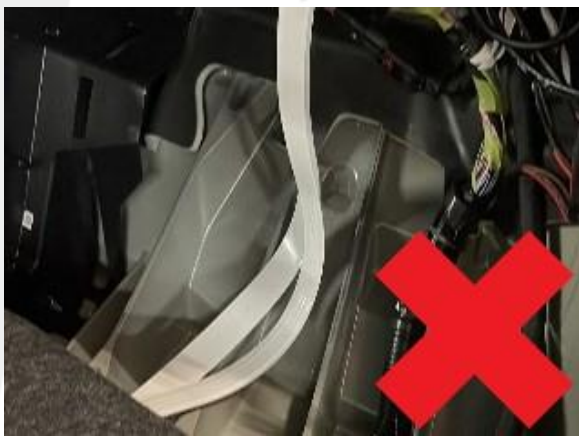
Figure 18 – Incorrectly routed through RH channel
