| Tesla, Inc. Service Bulletin | | <h2>Rear Touchscreen Bluetooth Audio Retrofit</h2> | |
| SB-24-21-001 April 30, 2024 | | | |
| 2021 | Model S, Model X | All | Fremont |

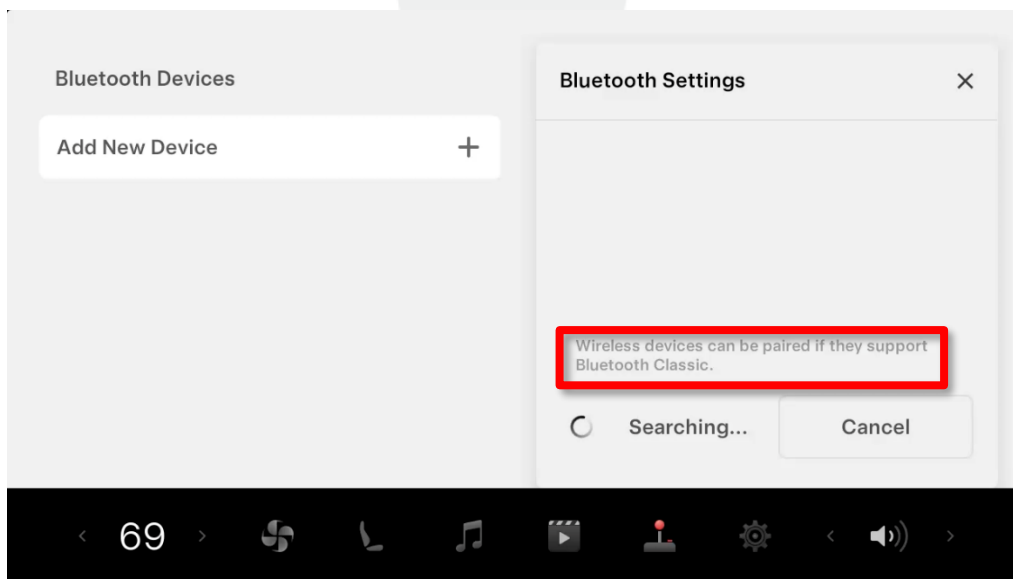
Figure 1

- If the message “Wireless devices can be paired if they support Bluetooth Classic” appears (Figure 1), then the front USB hub assembly has the necessary Bluetooth hardware. Discontinue this procedure and use correction code S022421001.
- If the message “Some vehicles may require additional hardware to be compatible with headphone pairing” appears (Figure 2), then the front USB hub assembly is incompatible. Skip to “[Front USB Hub Assembly Replacement Procedure](#)” in this document.

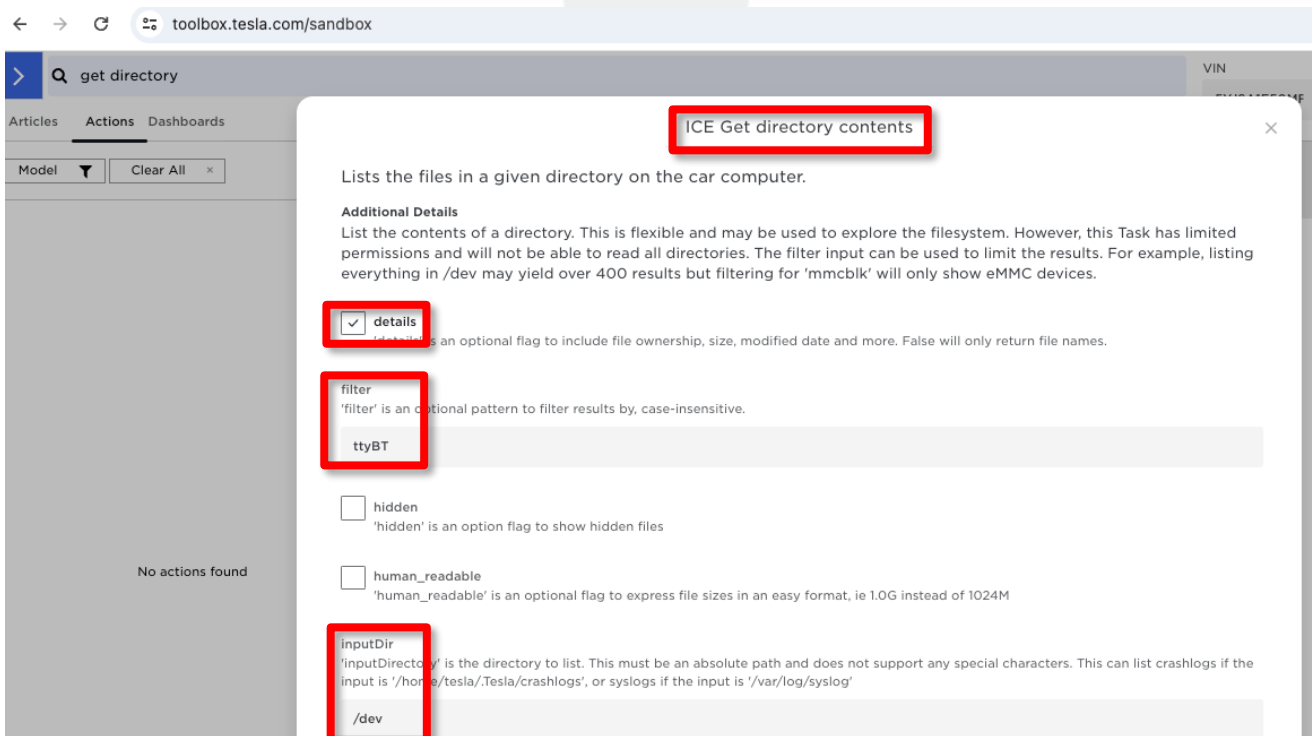
Figure 3

1. Connect to the vehicle remotely using Toolbox.
2. Click the **Actions** tab, and then click **ICE Get directory contents**.
3. Under the “ICE Get directory contents” screen (Figure 3), perform the following:
 - a. Select the "details" checkbox.
 - b. Type **ttyBT** in the “filter” field.
 - c. Type **/dev** in the “inputDir” field.
