<b>Tesla, Inc.</b> Service Bulletin		<h2 style="margin: 0;">Inspect Front Knuckles And Front Upper Control Arms</h2>	
<b>SB-24-31-001</b> January 4, 2024			
<b>Classification</b>		<b>Section/Group</b>	<b>Mobile Service</b>
Campaign Bulletin		31 - Suspension	Cannot Perform
			Configuration
			All
<b>Model Year</b>	<b>Model</b>	<b>Country/Region</b>	<b>Build Location</b>
2023	Cybertruck	United States	Giga Austin
<small>The model(s) and model year(s) listed are a general approximation of the affected VIN list. Refer to the VIN/Bulletin Tracker or Customer/Vehicle profile to determine applicability of this bulletin for a particular vehicle.</small>

On some Cybertruck vehicles, the Front Upper Control Arms (FUCA) and/or knuckles may require replacement to address possible front suspension noise or separation of the front knuckle from the FUCA.

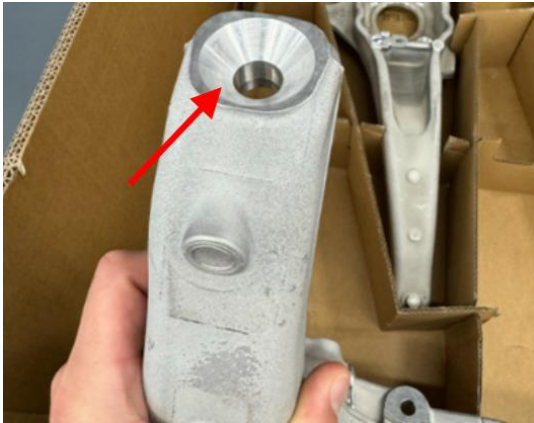
Figure 3

- If the top of the knuckle has a cone-shaped recess (Figure 3) and the FUCA ball joint stud has an alignment cone (Figure 4), replacement is unnecessary. Position the parts for reinstallation and install a new nut that attaches the LH FUCA to the LH front knuckle (torque 85 Nm) (Figure 2).

- If either the knuckle or the FUCA have the cone-shaped feature (Figures 3 or 4) while the other part does *not* have the cone-shaped feature (Figures 5 or 6), the front knuckle and the FUCA require replacement. Take note and continue to the next step.

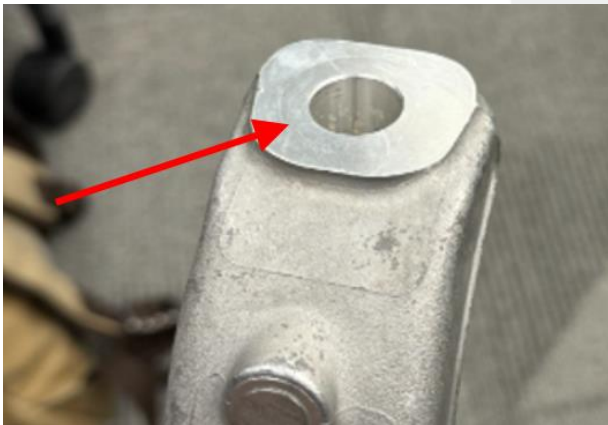
Figure 5

- If the top of the knuckle is flat (Figure 5), and the FUCA ball joint stud does NOT have an alignment cone (Figure 6), replacement is unnecessary. Position the parts for reinstallation and install a new nut that attaches the LH FUCA to the LH front knuckle (torque 85 Nm) (Figure 2).
