Tesla, Inc. Service Bulletin		<h2>Replace Steering Yoke Due To Peeling Issue</h2>	
SB-24-32-005 March 5, 2024			
Classification		Section/Group	Mobile Service
Repair Bulletin		32 - Steering	Can Perform (where permitted)
Model Year	Model	Country/Region	Build Location
2021 - 2024	Model S, Model X	All	Fremont
<small>The model(s) and model year(s) listed are a general approximation of the affected VIN list. Refer to the VIN/Bulletin Tracker or Customer/Vehicle profile to determine applicability of this bulletin for a particular vehicle.</small>

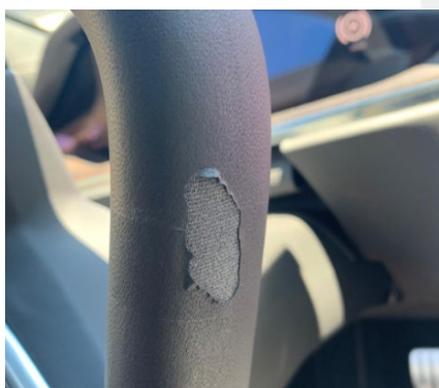
Figure 1

On certain Model S and Model X vehicles built from February 2021 to January 3, 2024, the material of the steering yoke cover might be susceptible to peeling (Figures 1 and 2).

NOTE: This condition is strictly cosmetic, and does not impact the functionality or safety of the steering yoke.

Upon customer complaint that the steering yoke cover is peeling, replace the air bag and steering yoke.

WARNING: The existing air bag is not compatible with the replacement yoke, it **cannot be reused** and **must be replaced**.
