**Tesla, Inc.**  
**Service Bulletin**

# Adjust Charge Port

**SB-24-44-001**  
March 20, 2024

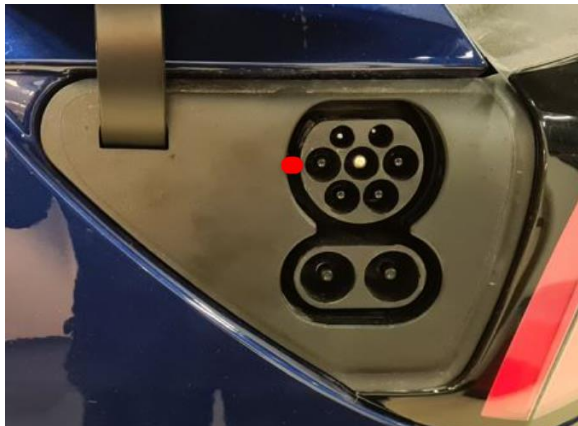
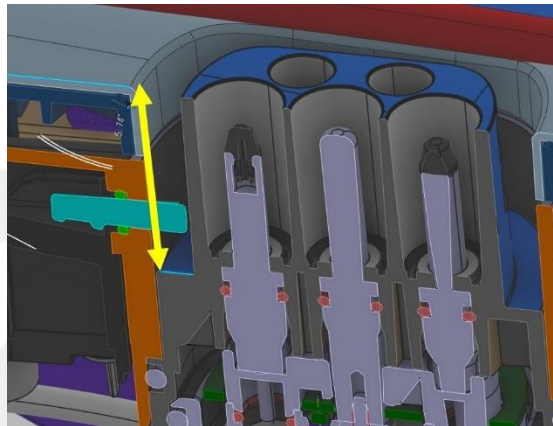
1. Open the charge port door.
2. Insert a digital caliper next to the LH side of the Type 2 charging inlet near the location of the latch pin, which is horizontally aligned with the top three AC connectors of the charge port (Figures 1 and 2).

Figure 1 – Measurement location in red

Figure 2 – Distance to be measured

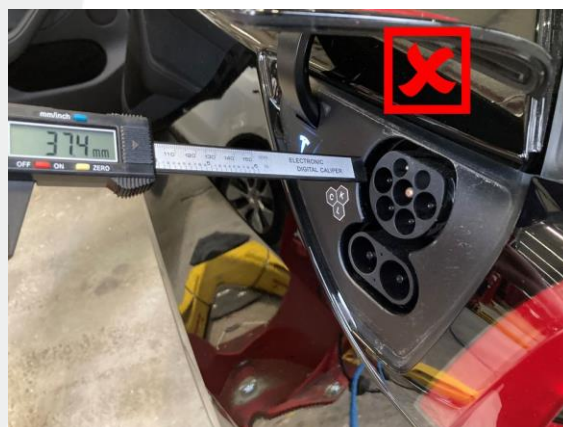
Figure 3

3. Measure the distance between the charge port faceplate and the bottom of the charge port inlet (Figures 3 and 4).

- If the distance is more than 35.80 mm, subtract 35.80 mm from the measured distance and note the required adjustment, and then proceed with the section [Adjust Charge Port](#).
- If the distance is less than 35.80 mm, no rework is needed. Discontinue this procedure and use correction code S022444001.

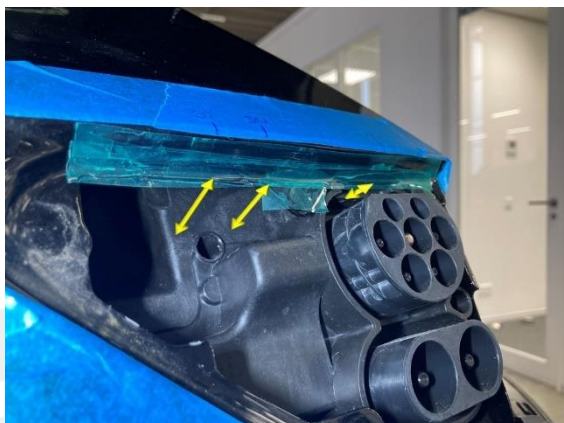
**Figure 8**

4. Measure the distance between the metal edge of the quarter panel and the charge port assembly at three locations, and then note the measured values (Figure 8).

5. Calculate the required distance adjustment for the three measurement points: for every 1 mm of charge port door adjustment that was determined during the inspection, the distance between the metal edge and the charge port assembly needs to be reduced by 1.25 mm (Table 1).

- Measure the distance between the metal edge of the quarter panel and the charge port assembly at the three locations that were marked in step 4 (Figure 8).

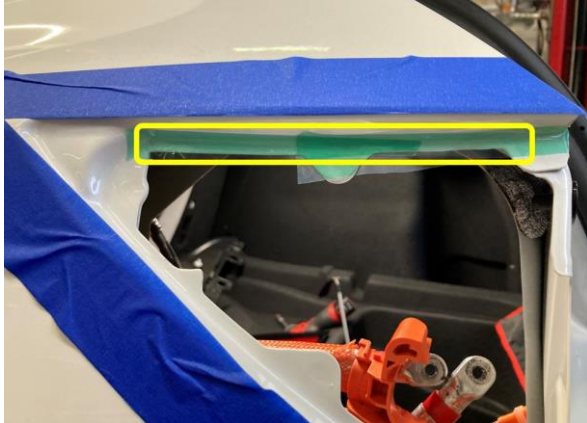
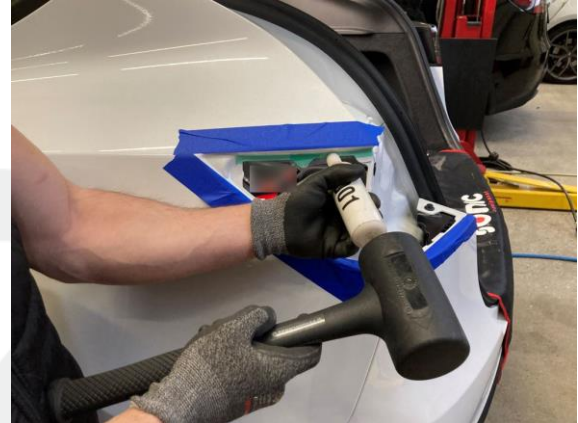
**Figure 10**

**Figure 9 – Adjust full width of upper edge**

- Using the charge port door over flush tool, carefully adjust the full width of the upper edge of the LH rear quarter inwards (Figures 9 and 10).

**📖 NOTE:** Use a dead blow hammer and an HV battery handle if the charge port door over flush tool is unavailable.
