<b>Tesla, Inc.</b> <b>Service Bulletin</b>		<h1>Adjust Charge Port</h1>	
<b>SB-24-44-001</b> April 17, 2024	<b>R1</b>		
<b>Classification</b>		<b>Section/Group</b>	<b>Mobile Service</b>
Campaign Bulletin		44 - High Voltage System	Can Perform (where permitted)
<b>Configuration</b>			
All			
<b>Model</b>	<b>Model Year</b>	<b>Country/Region</b>	<b>Build Location</b>
Model Y	2023 - 2024	Europe, Middle East, Africa	Giga Berlin
<small>The model(s) and model year(s) listed are a general approximation of the affected VIN list. Refer to the VIN/Bulletin Tracker or Customer/Vehicle profile to determine applicability of this bulletin for a particular vehicle.</small>

On certain Model Y vehicles built at Giga Berlin, an incorrect alignment offset between the charge port door trim and the charge port inlet may prevent latching of certain charge handles, which can reduce or inhibit charging.

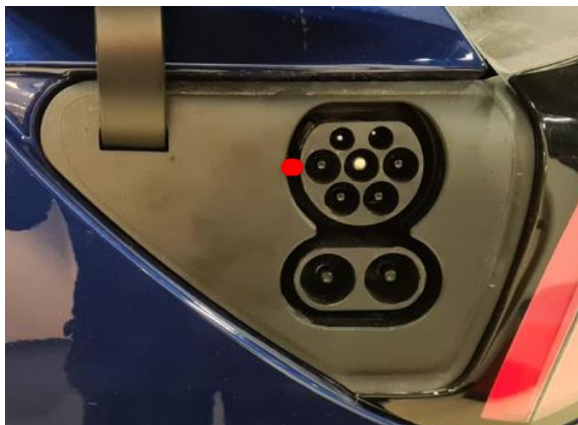
1. Open the charge port door.
2. Insert a digital caliper next to the LH side of the Type 2 charging inlet near the location of the latch pin, which is horizontally aligned with the top three AC connectors of the charge port (Figures 1 and 2).

Figure 1 – Measurement location in red

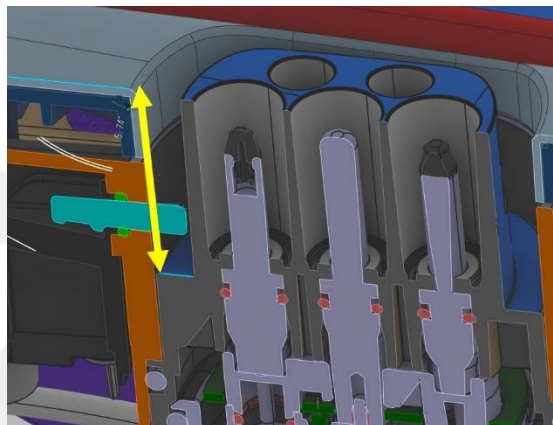
Figure 2 – Distance to be measured

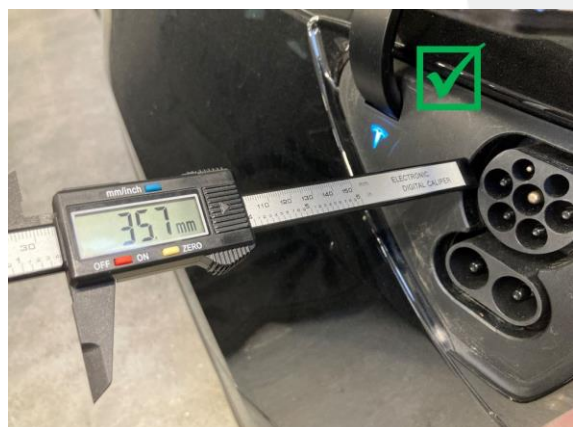
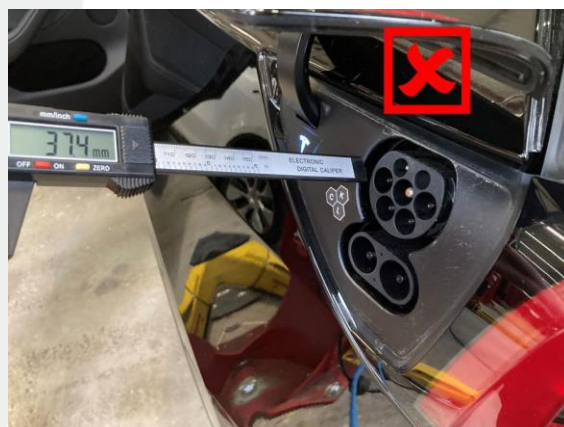
3. Measure the distance between the charge port faceplate and the bottom of the charge port inlet (Figures 3 and 4).

- If the distance is more than 35.80 mm, subtract 35.80 mm from the measured distance and note the required adjustment, and then proceed with the section [Adjust Charge Port](#).
- If the distance is less than 35.80 mm, no rework is needed. Discontinue this procedure and use correction code S022444001.

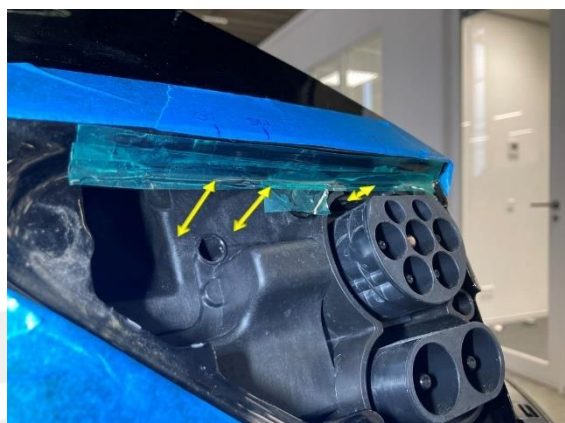
**Figure 8**

4. Measure the distance between the metal edge of the quarter panel and the charge port assembly at three locations, and then note the measured values (Figure 8).

5. Calculate the required distance adjustment for the three measurement points: for every 1 mm of charge port door adjustment that was determined during the inspection, the distance between the metal edge and the charge port assembly needs to be reduced by 1.25 mm (Table 1).
