Tesla, Inc. Service Bulletin		<i>Inspect Tonneau Cover for Exposed Water Management Channel</i>			
SB-25-11-001 February 25, 2025							
Classification				Section/Group		Mobile Service	Configuration
Repair Bulletin				11 - Closures		Cannot Perform	All
Model		Model Year		Country/Region		Build Location	
Cybertruck		All		United States		Giga Texas	
The model(s) and model year(s) listed are a general approximation of the affected VIN list. Refer to the VIN/Bulletin Tracker or Customer/Vehicle profile to determine applicability of this bulletin for a particular vehicle.

Condition

On some Cybertruck vehicles, when the tonneau cover is closed, the tonneau slat water management channel is exposed, which under certain environmental conditions, may cause excessive water to enter the cargo bed.

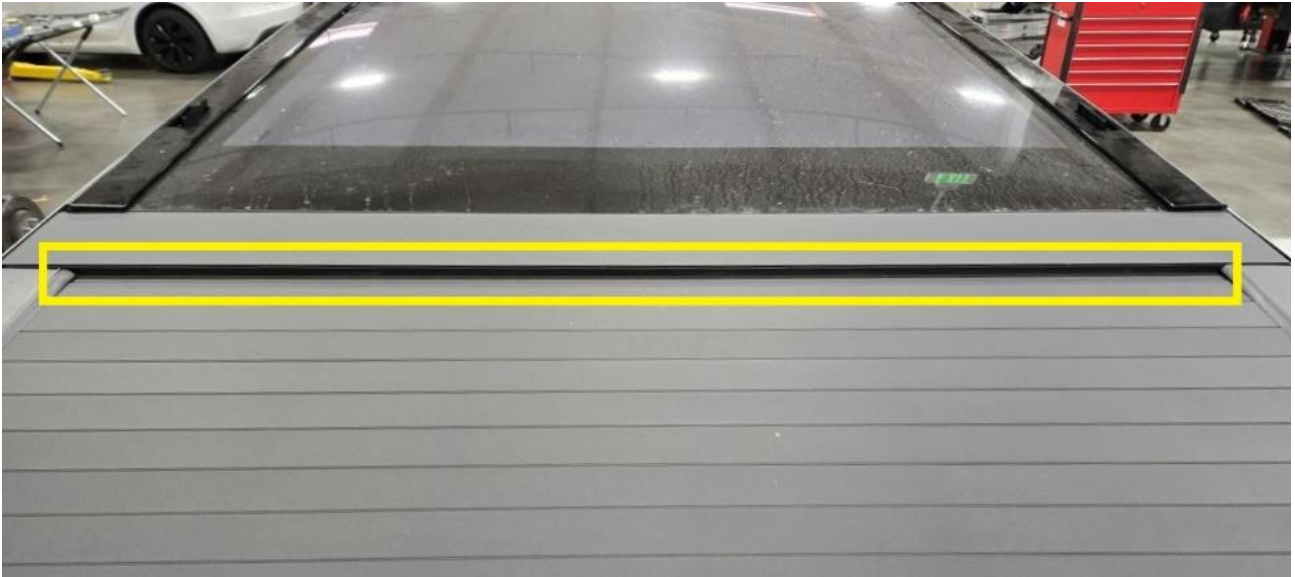
Figure 1

Inspect the tonneau cover for a horizontal gap between the water management slat and the tonneau applique that exposes the tonneau slat water management channel (Figures 1–3).

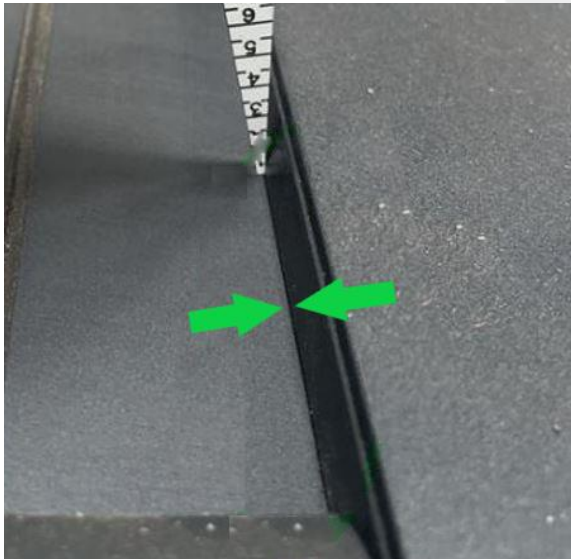
**NOTE:** There should be no gap horizontally between the water management slat and the tonneau applique (Figure 2).

Figure 2 – No Gap Between Water Management Slat and Tonneau Applique; Water Management Channel Not Exposed

- If the water management channel is not exposed (Figure 2), discontinue this procedure and use correction code S022511001. Continue diagnosis if excessive water into the cargo bed needs to be investigated.
- If the water management channel is exposed (Figure 3), install an additional slat into the tonneau cover (refer to Service Manual procedure [1120122007](#)). Use correction code S032511001.

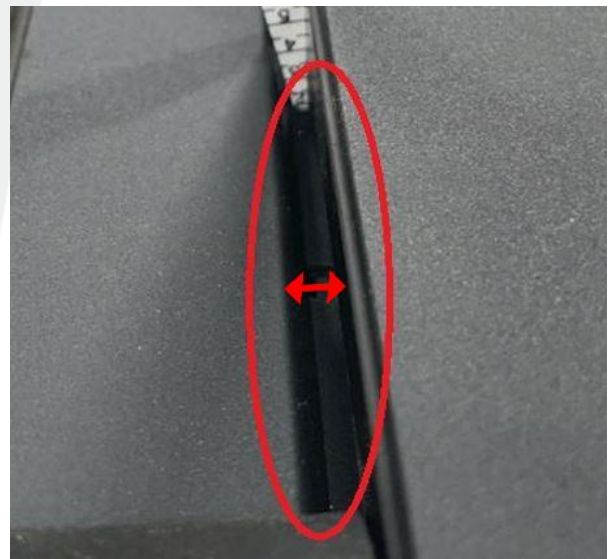
Figure 3 – Gap Between Water Management Slat and Tonneau Applique (Red Arrow); Water Management Channel Exposed

Upon customer complaint of an exposed water management channel or excessive water entering the cargo bed, inspect the vehicle for symptoms related to the condition. If symptoms are present, install an additional slat into the tonneau cover.
