| | | <b>Tesla, Inc.</b><br>Service Bulletin | | <b><i>Replace And Rework Body Side Liftgate Ball Studs</i></b> |
| <b>SB-25-11-002</b><br>April 10, 2025 | | | | |
| Model Y | 2024 | Asia Pacific, Europe, Middle East | Giga Berlin, Giga Shanghai | |

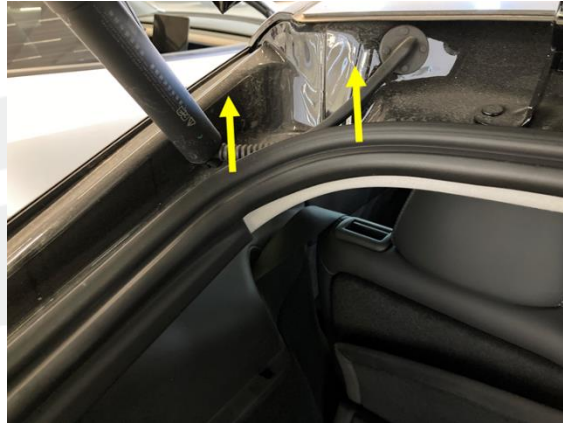
**Figure 1 – Strut might not be connected to the body as shown**

1. Support the liftgate and remove the body side ball stud that is not broken (refer to Service Manual procedure [11335052](#)).
2. On the side of the broken liftgate ball stud, lift the upper corner of the liftgate seal upwards, and then move the seal to the side (Figure 1).
