<b>Tesla, Inc.</b> Service Bulletin		<b><i>Inspect Front Seat Back for Unintended Noise</i></b>	
<b>SB-25-13-002</b> July 11, 2025					
<b>Classification</b>		<b>Section/Group</b>	<b>Mobile Service</b>	<b>Configuration</b>	
Repair Bulletin		13 - Seats	Can Perform (where permitted)	All	
<b>Model</b>	<b>Model Year</b>	<b>Country/Region</b>	<b>Build Location</b>		
Model 3	All	Europe, Middle East, Africa	All		
Model Y	All				
Model S	2021+				
Model X	2021+				
Cybertruck	All				
The model(s) and model year(s) listed are a general approximation of the affected VIN list. Refer to the VIN/Bulletin Tracker or Customer/Vehicle profile to determine applicability of this bulletin for a particular vehicle.

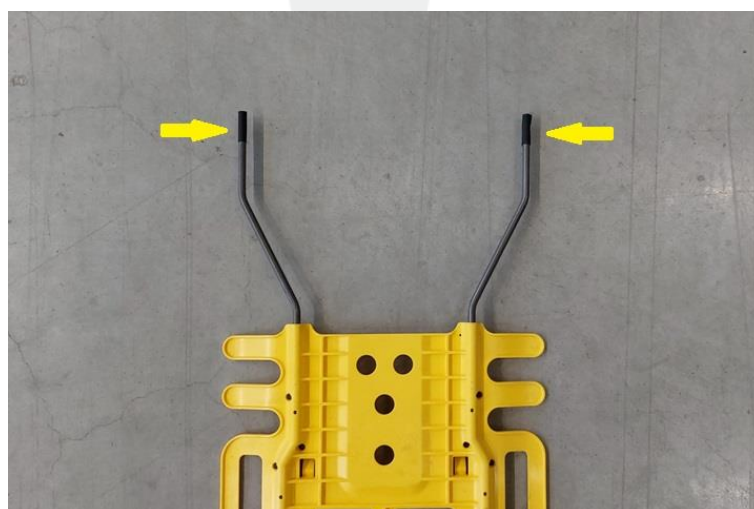
Figure 17

On some Model 3, Model Y, Model S, Model X and Cybertruck vehicles, the front driver and/or passenger seat back may exhibit an unintended noise, originating from the seat back shoulder area when the occupant moves in the seat or when driving over bumpy roads, even when the seat is not occupied. This is caused by interference between the seat back guide rail and its bushing.

15. Cut 2 cm of felt tape (x2) and apply the tape at the top of each guide rail (Figure 17).
