Tesla, Inc. Service Bulletin		<i>Replace Flood Port Plungers</i>	
SB-25-16-002 May 5, 2025					
Classification		Section/Group	Mobile Service	Configuration	
Campaign Bulletin		16 - HV Battery	Cannot Perform	All	
Model	Model Year	Country/Region	Build Location		
Model S	2021–2022	United States, Europe	Fremont		
Model X	2021–2022				
The model(s) and model year(s) listed are a general approximation of the affected VIN list. Refer to the VIN/Bulletin Tracker or Customer/Vehicle profile to determine applicability of this bulletin for a particular vehicle.

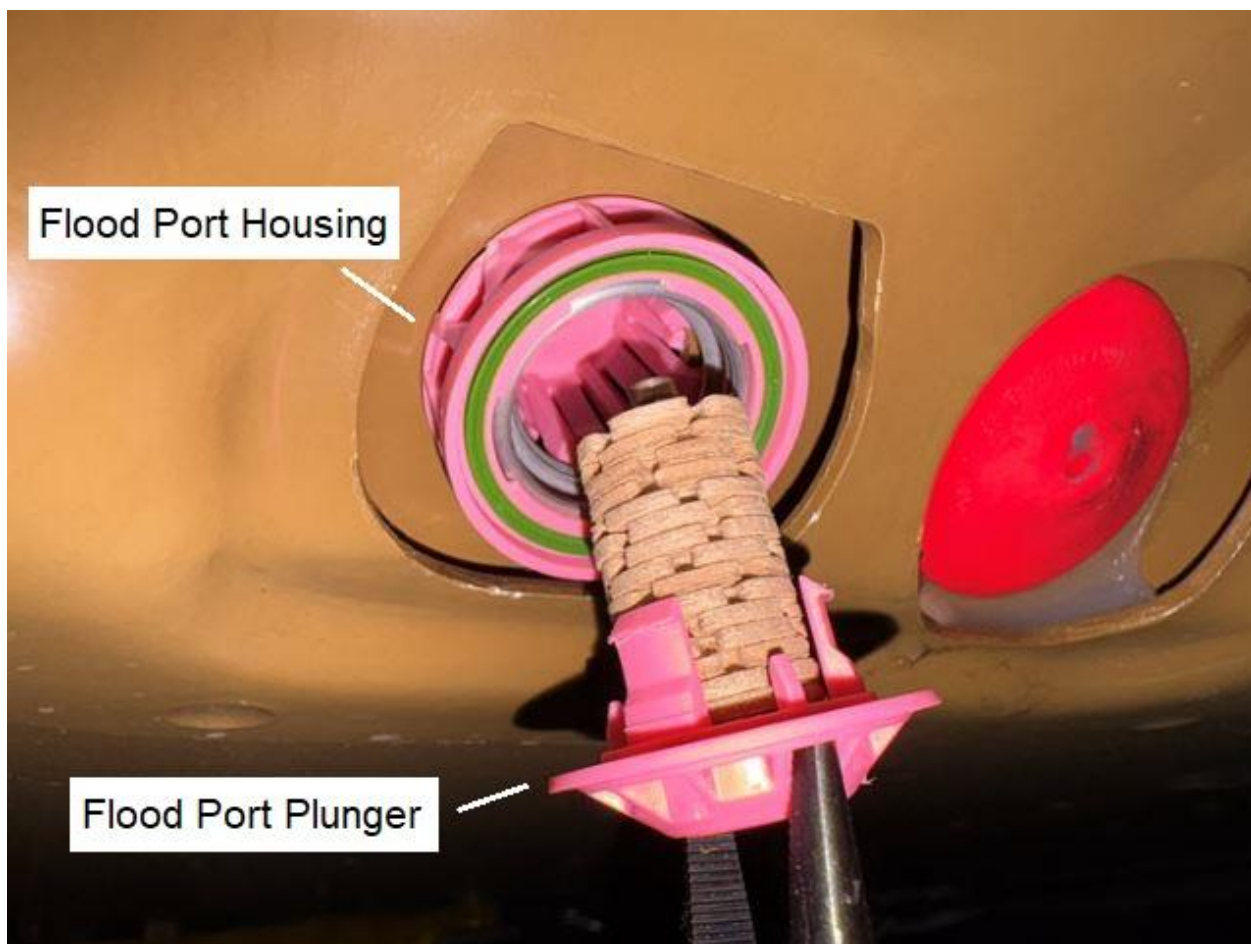
Figure 1

⚠ CAUTION: The Service Manual procedure only replaces the flood port plunger (Figure 1). **Do not** replace the flood port housing.

Replace the flood port plungers (x5) (refer to Service Manual procedure 16102712; [Model S](#), [Model X](#)).
