| | | <b>Tesla, Inc.</b><br>Service Bulletin | | <b><i>Replace Suspension Components</i></b> |
| <b>SB-25-31-005</b><br>June 9, 2026 | | <b>R1</b> | | |
| Model Y | 2025+ | North America | Fremont, Giga Texas | |

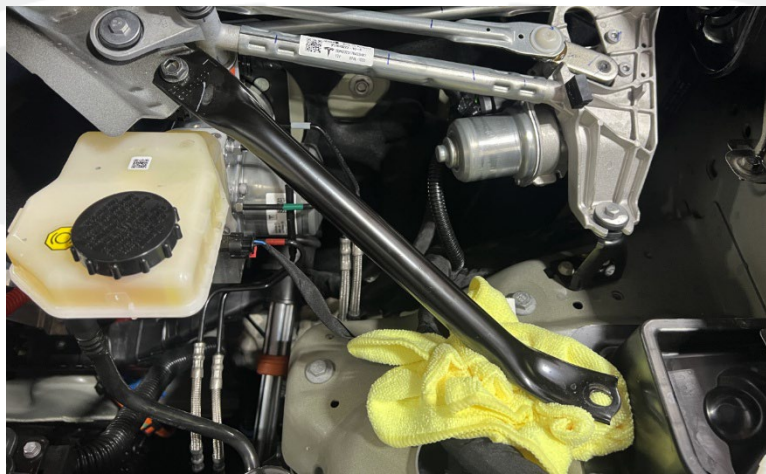
**Figure 1**

- If the rattling or knocking noise is present, continue to the next step.
  - If the rattling or knocking noise is not present or a different noise is heard, discontinue this procedure and use correction code S022531005.
2. Remove the bolts (x2, 13 mm) from the LH and RH wiper bracket pencil brace lower attachment points and swing the arms away from the bolted flanges, then wedge a shop towel between each of the braces and mounts to isolate the lower attachment points (Figure 1).

3. Drive the vehicle over the same bumps or rough road at the same speed as in step 1. Listen for the same rattling or knocking noise that was observed in step 1.
  - If the noise is reduced, continue to the next step.
  - If the rattling or knocking noise persists at the original volume, remove the towels. Reinstall the bolts at the lower attachment points of both wiper bracket pencil braces (torque 27 Nm). Discontinue this procedure and proceed with diagnosis outside of this bulletin, as the NVH issue is caused by a different component. Use correction code S032531005.
4. Replace both front upper control arm mounts with the updated parts. Refer to Service Manual procedure [3115010702](#).
