## Tech Note: Rapid Mate Inspection

Tech Notes are internal announcements that help to communicate and track new information about Tesla Service concerns.

Improper sealing of the HV Rapid Mate (Figures 1 and 2) can allow water ingress. This can result in isolation faults and, in extreme cases, damage to the Rapid Mate connection points. Any time the HV battery pack is removed, follow the care points in this tech note.

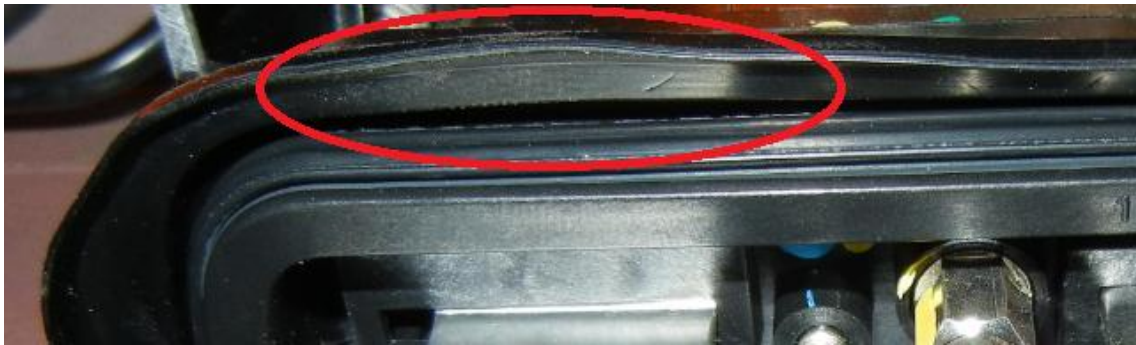
Inspect the skirt seal on the vehicle-side HV Rapid Mate. The seal is pliable, but can become permanently deformed (Figures 4 and 5) during removal and reinstallation of the HV battery pack. In the “After Securing the Battery Pack” section, it is necessary to confirm proper seating with a boroscope. Therefore:

Figure 4 (Seal deformed outwards)

- If the long, straight section of the seal on the front side of the vehicle is deformed, replace the vehicle-side HV Rapid Mate, because this area is not visible with a boroscope once the battery is reattached.
- If the long, straight section of the skirt seal on the rear side of the vehicle is deformed, mold it back into place, if possible. Follow the steps in the “After Securing the Battery Pack” section to ensure proper seating. If the seal is permanently deformed, replace the vehicle-side HV Rapid Mate.

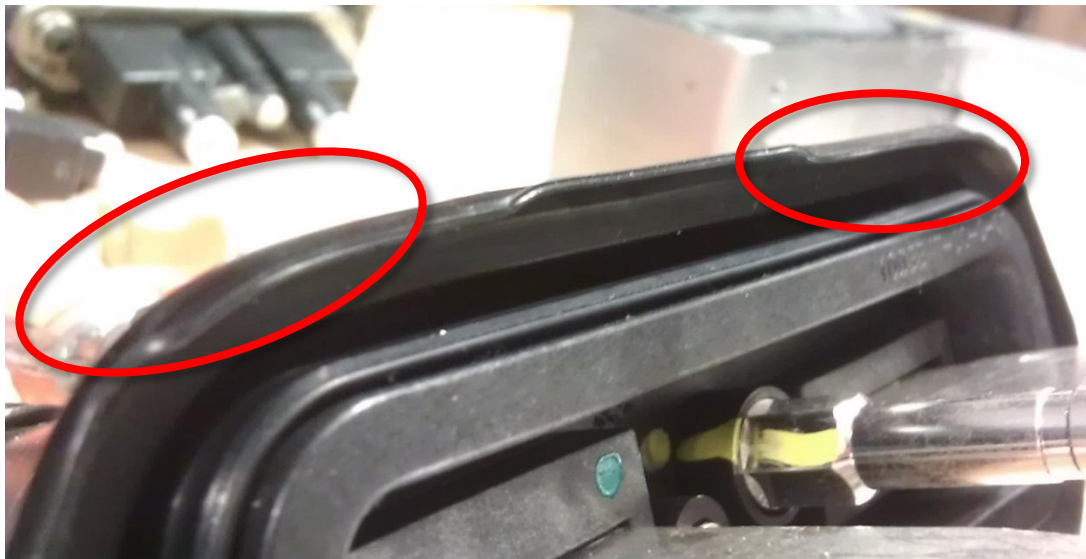
Figure 5 (Seal deformed inwards)

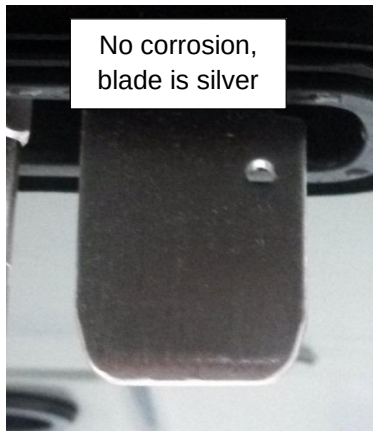
No corrosion,  
blade is silver

✓ Ideal  
Figure 6

1. Clean the vehicle-side HV blades, pins, and plastic insulator plate with isopropyl alcohol and a non-abrasive cloth. Thoroughly dry all parts.
2. Inspect the blades and pins for signs of corrosion (Figures 6-8). A small amount of discoloration is acceptable, but if any silver is flaking off, or is bubbled or cracked, replace the vehicle-side HV Rapid Mate. If there is any doubt whether there is corrosion, take high resolution pictures and attach them to the ATTAC case.

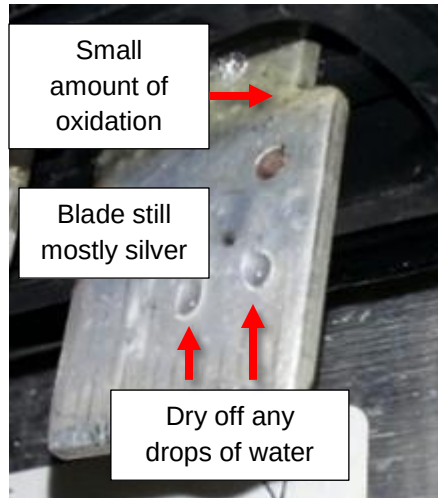
Small  
amount of  
oxidation

Blade still  
mostly silver

✓ Acceptable  
Figure 7

Dry off any  
drops of water

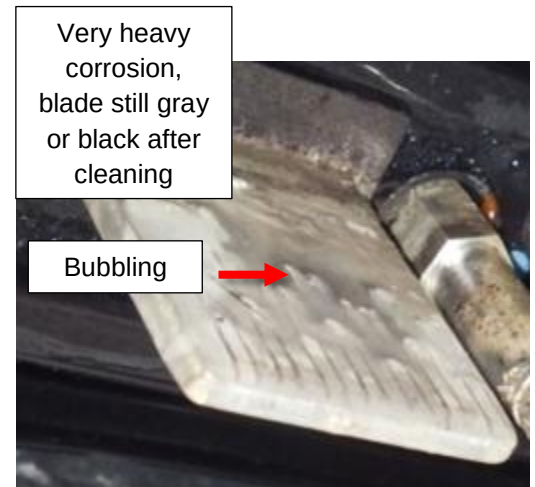
Very heavy  
corrosion,  
blade still gray  
or black after  
cleaning

Bubbling

✗ Unacceptable  
Figure 8

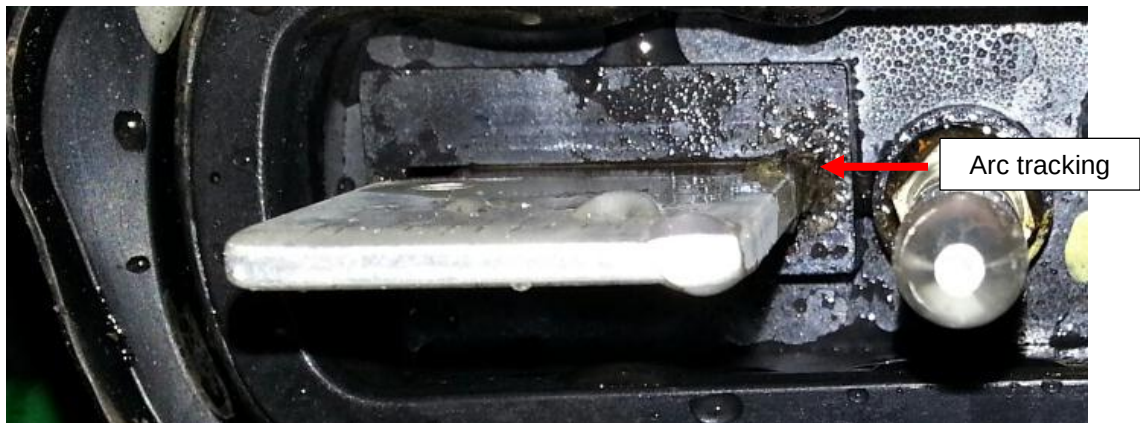
Figure 9

3. Inspect the blades, pins, and plastic insulator plate for signs of arc-tracking (Figures 9 and 10). If the plastic insulator plate is deformed, cracked, or melted, or if the metal on the blades or pins is discolored or deformed, replace the vehicle-side HV Rapid Mate. If there is any doubt whether there is arc-tracking, take high resolution pictures and attach them to the ATTAC case.

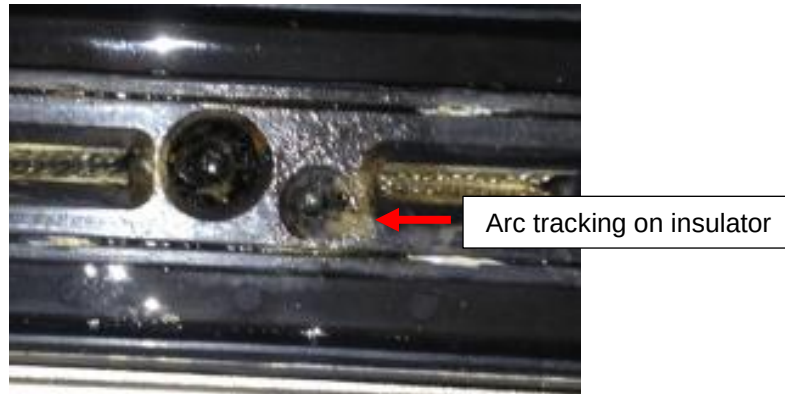
**Figure 11**

1. Clean the plastic insulator with isopropyl alcohol and a non-abrasive cloth.
2. Inspect the battery-side HV Rapid Mate for signs of arc-tracking (Figure 11).

3. Use shop air to clean dirt and other foreign debris out the connectors, even if there is no visible debris. Take high resolution pictures of the connectors and attach them to the ATTAC case.

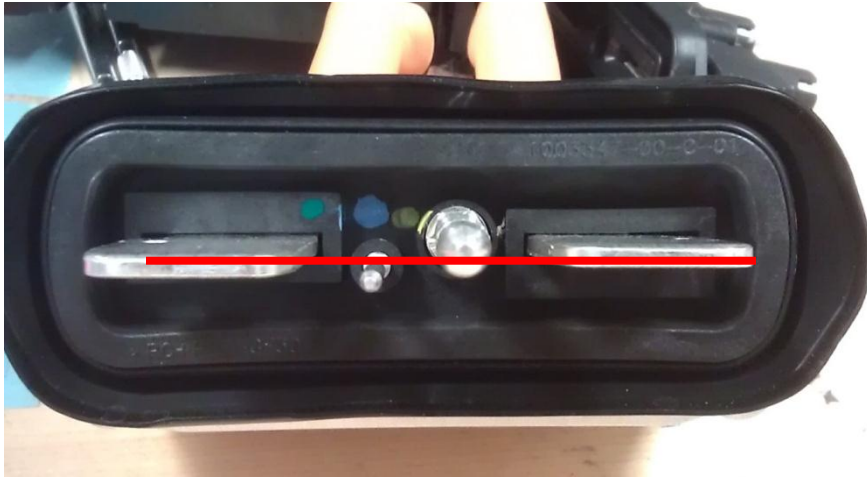
✓ Acceptable  
Figure 12

Examine the blades on the vehicle-side of the HV Rapid Mate (Figures 12 and 13). If the blades are far out of alignment, gently use nylon-tipped pliers to position the blades back into place. If the blades cannot be corrected, replace the vehicle-side HV Rapid Mate.

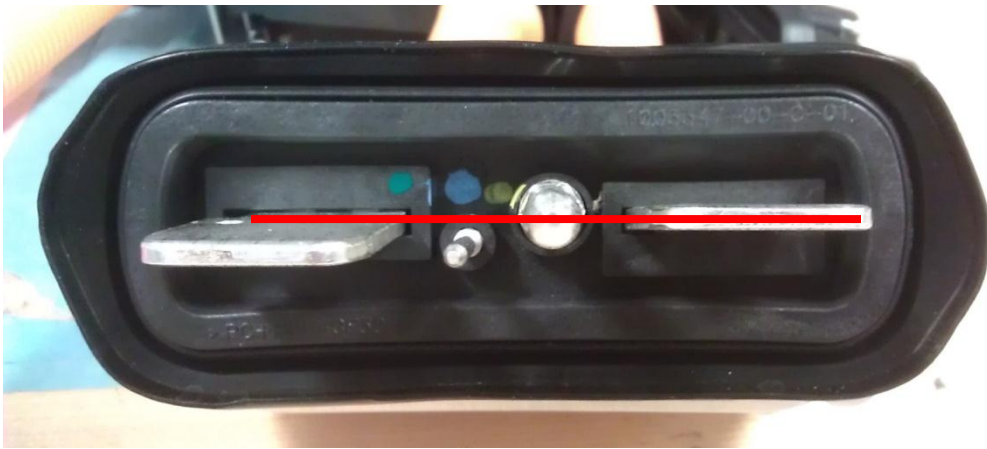
✗ Unacceptable  
Figure 13

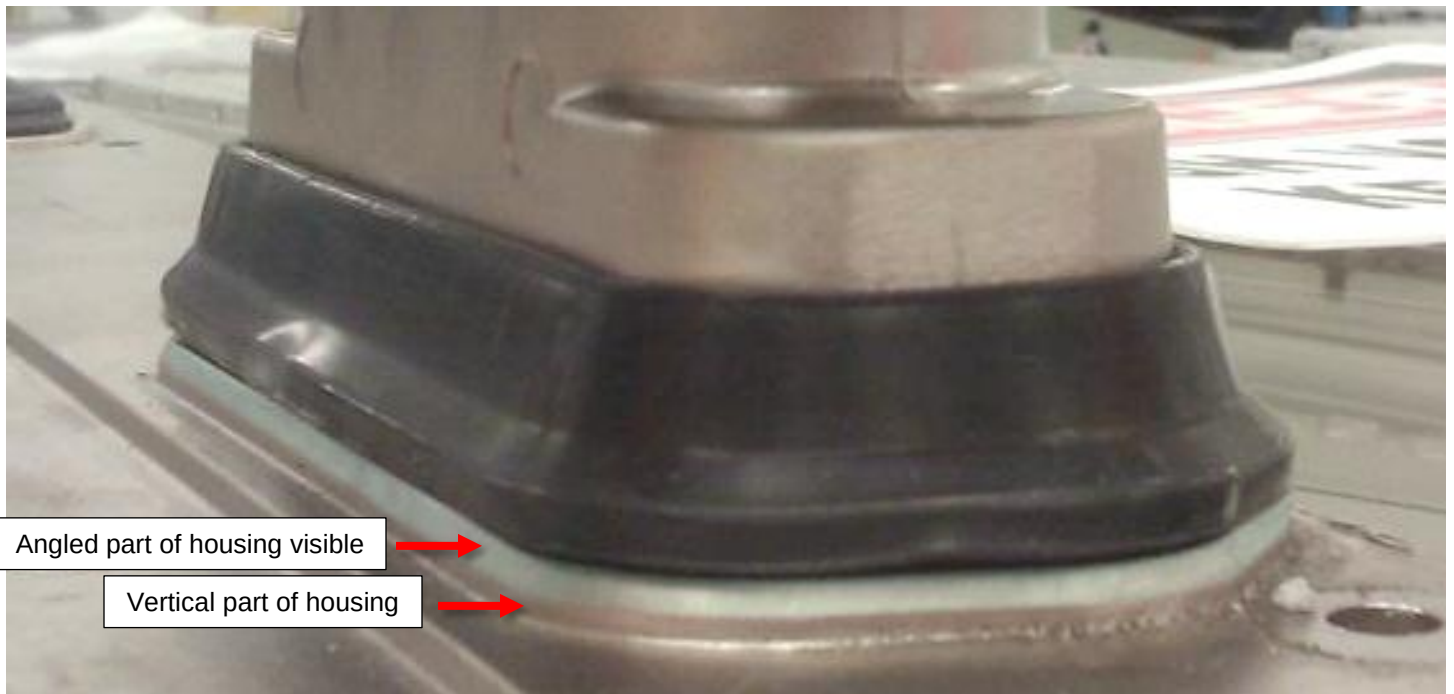
✗ Incorrect – Skirt seal not fully seated  
Figure 15

1. Reach in front of the rear subframe and pull down hard on the vehicle-side HV Rapid Mate to make sure that it is fully mated to the battery-side Rapid Mate.
2. Use a mirror or boroscope to check the HV Rapid Mate connection. Check whether the skirt seal is fully seated on the battery. The battery-side Rapid Mate housing is vertical at the bottom, then angles inward. The skirt seal must completely cover the angled part of the housing (Figures 15-18). If the skirt seal cannot fully seat, use a boroscope to take a picture of the seal, and attach it to the ATTAC case.

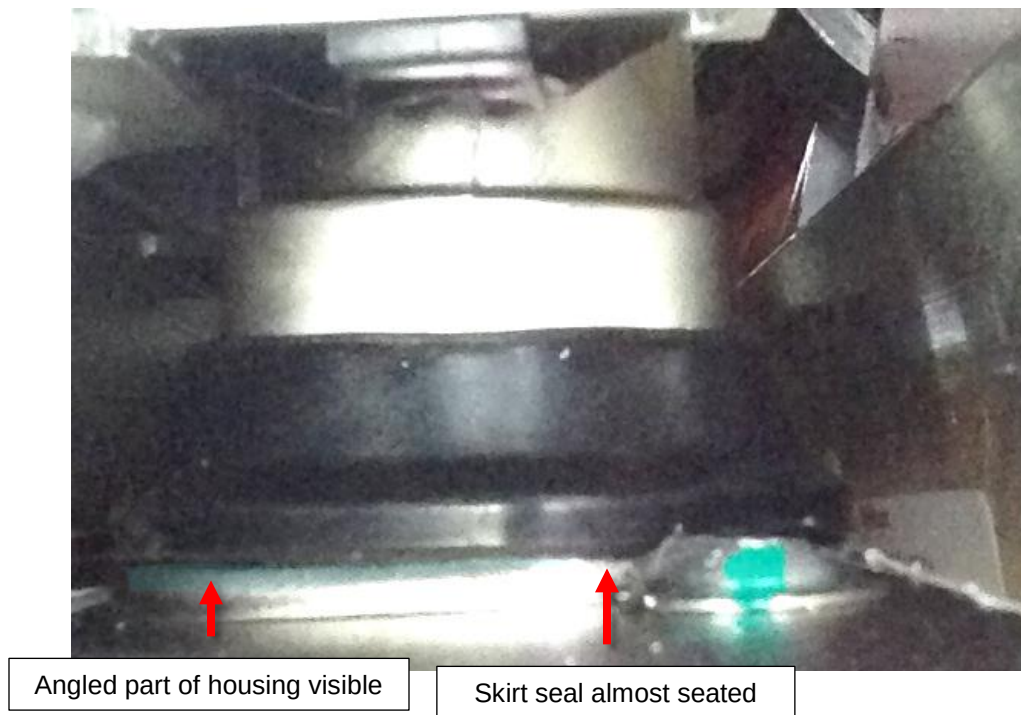
✗ Incorrect – Skirt seal not fully seated  
Figure 16

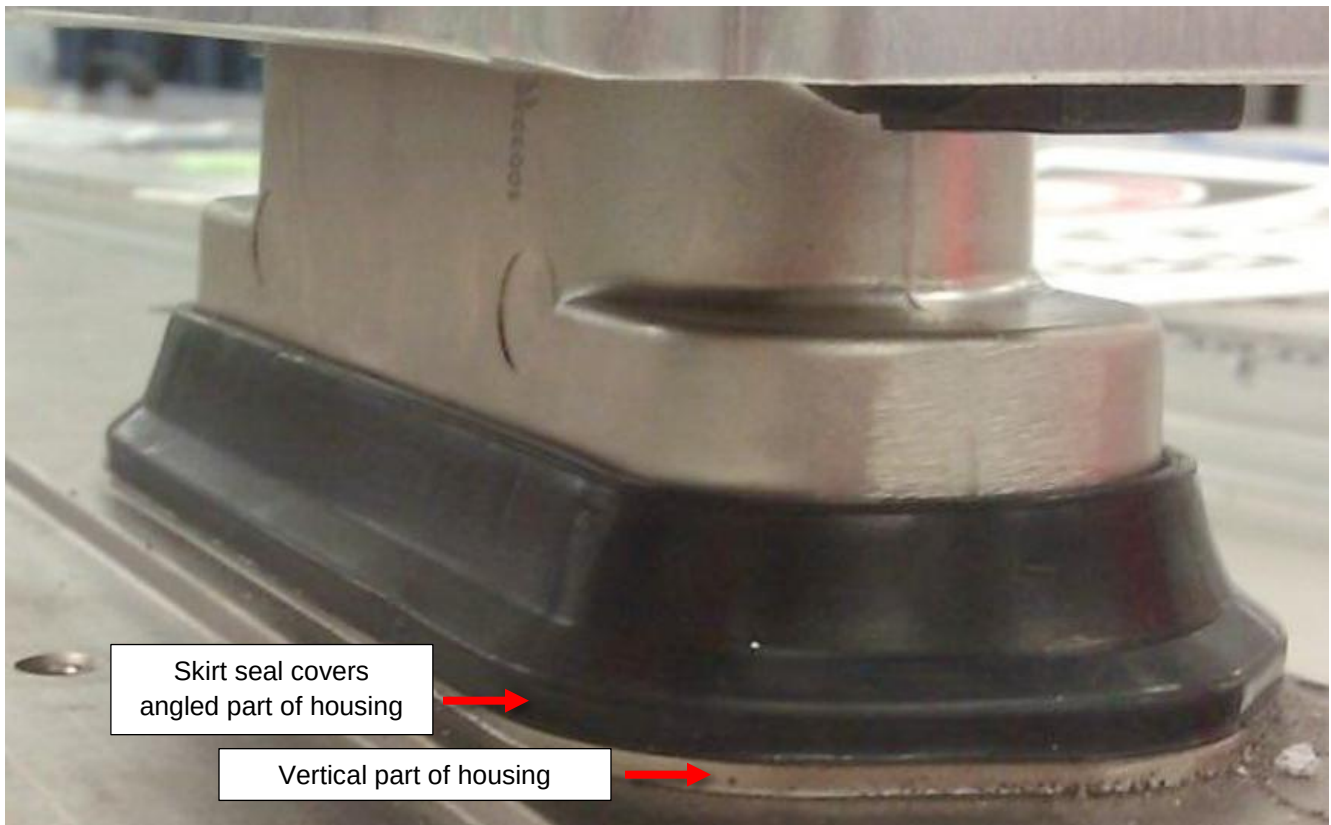
✓ Correct – Skirt fully seated  
Figure 17

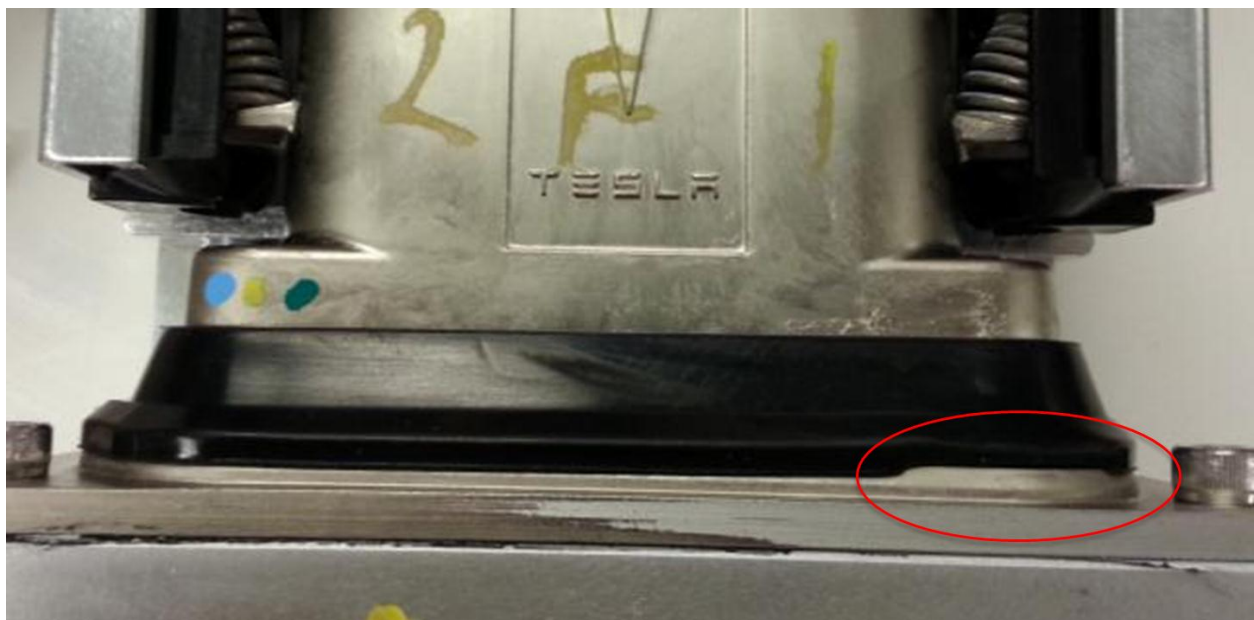
✗ Incorrect – Skirt seal caught on base  
Figure 18
