TN-18-16-001 R3 June 8, 2022

Tesla, Inc. Technical Note
Model:	Vehicle System:	Region:
Model 3 & Model Y (non-Structural)	16 - Battery System	All

Inspect the Model 3 and Model Y (Non-Structural) HV Battery for Underside Damage

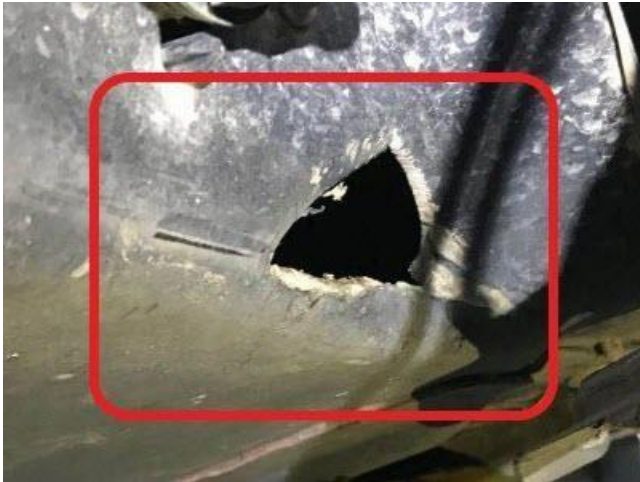
⚠ WARNING If the HV battery enclosure is compromised with a **visible open hole, crack, or tear** (Figures 1 and 2), the Service Center does not need to continue further with this document and should recommend the customer replace the HV battery to meet Tesla’s standards of quality and safety. Meanwhile, the HV battery might be compromised and needs to be taken care of diligently; refer to Toolbox article [29715](#) for assessing a compromised battery.

Figure 1 – Visible open hole

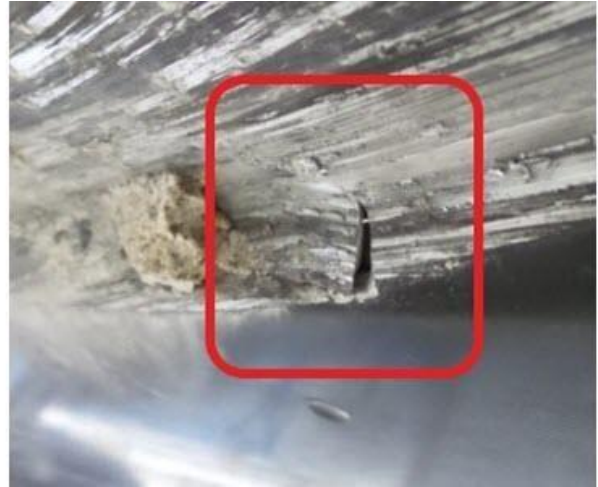
Figure 2 – Visible open crack

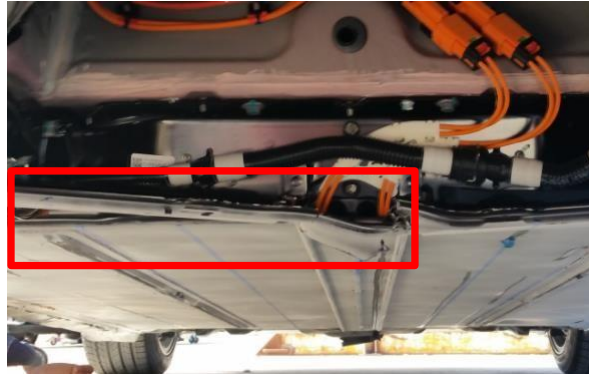
1. Visually inspect the front skid plate for tears, dents, or breaches (Figure 9).

**NOTE:** Replace the front skid plate if it does not cover front baseplate or its leading edge is dented, torn, or breached.

Figure 9 – Torn front skid plate

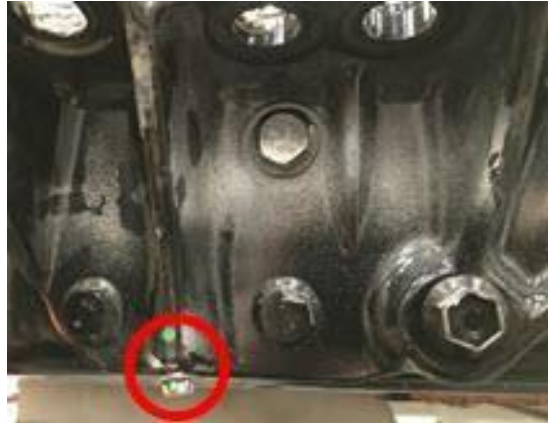
NOTE: The bolt that threads into the doubler is circled in Figure 11 and Figure 12. There is another bolt symmetrically on the other side of the vehicle. These bolts are prone to shearing in the event of front skid plate damage (Figure 12).

Figure 12 – Skid plate to doubler fastener sheared/bent

- Deburr the area with a hand deburring tool to remove the sharp edges if sharp edges are found.
- Re-tap the fastener hole if a fastener hole is damaged and the fastener cannot withstand full torque.
- Recommend replacement of the:
 - Fastener if a fastener attaching the front skid plate to the doubler is damaged or stripped.
 - Front skid plate if the front skid plate, or part of the skid plate, is detached, or not covering the baseplate.
 - HV cables if the HV cables are damaged above the front skid plate.
- Recommend HV battery replacement if:
 - A passthrough is damaged above the front skid plate.
 - The HV battery enclosure fails leak test due to impact.
 - The HV battery enclosure has low isolation due to impact.

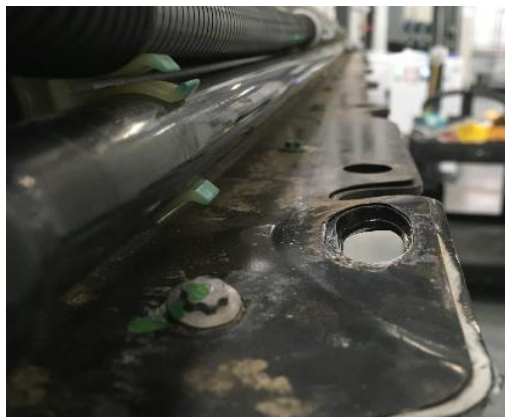
Figure 14 – Deburr the area to remove sharp edges

- Deburr the area with a hand deburring tool to remove the sharp edges if sharp edges are found (Figure 14).
- Re-tap the fastener hole if a fastener hole is damaged and the fastener cannot withstand full torque.
- Recommend the replacement of the fastener if a fastener attaching the HV battery to the vehicle is damaged or stripped.
- Recommend HV battery replacement if:
 - The ski, or part of the ski, is detached from the HV battery
 - A jack point has extensive damage where it cannot be used to safely lift the vehicle.
 - The HV battery enclosure fails leak test due to impact.
 - The HV battery enclosure has low isolation due to impact.

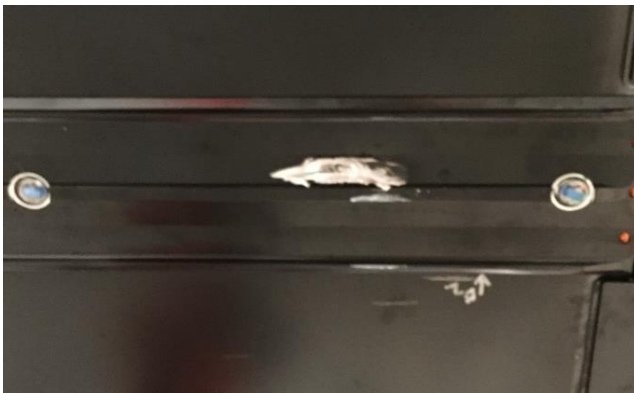
Figure 16 – Gouged center ski

NOTE: Figure 16 shows an example of torn center ski that also damaged the HV cables (Figure 17). It is important to inspect for damage to the HV cables and baseplate underneath the ski.

- Deburr the area with a hand deburring tool to remove the sharp edges if sharp edges are found.
- Re-tap the fastener hole if a fastener hole is damaged and the fastener cannot withstand full torque.
- Recommend replacement of the:
 - Center ski if the center ski, or part of the ski, is detached from the HV battery.
 - Fastener if a fastener attaching the center ski to the HV battery enclosure is damaged or stripped.
 - HV cables if the HV cables are damaged.
- Recommend HV battery replacement if:
 - The HV battery enclosure fails leak test due to impact.
 - The HV battery enclosure has low isolation due to impact.

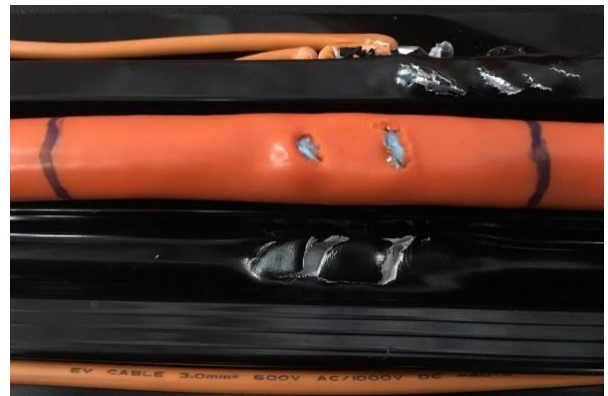
Figure 17 – Damaged cable under center ski

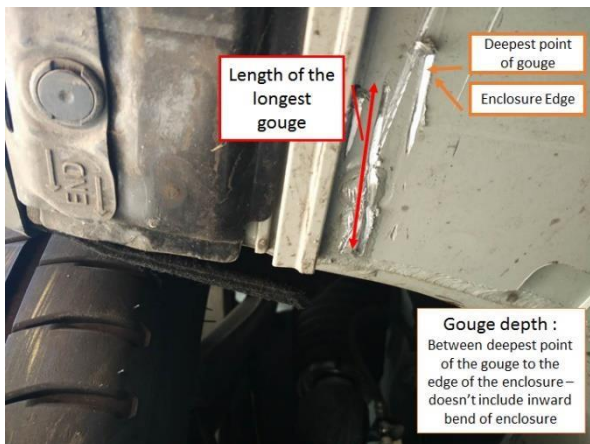
Figure 21 – Gouges in the baseplate

- Deburr the area with a hand deburring tool to remove the sharp edges if sharp edges are found.
- Recommend HV battery replacement if:
 - A dent or deepest point of gouge is **8 mm** or more in depth (Figures 21 and 22).
 - If the HV battery enclosure fails leak down test due to impact.
 - The HV battery enclosure has low isolation due to impact.

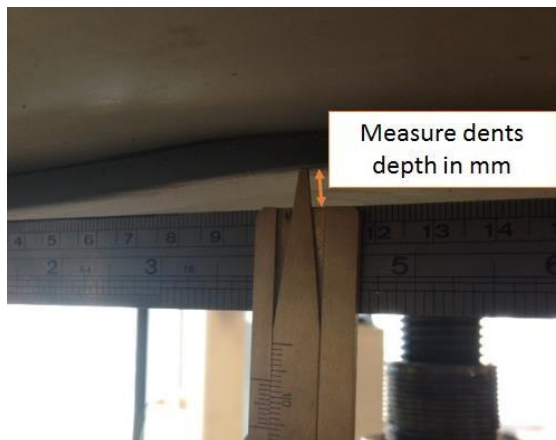
Figure 22 – Dents in the baseplate

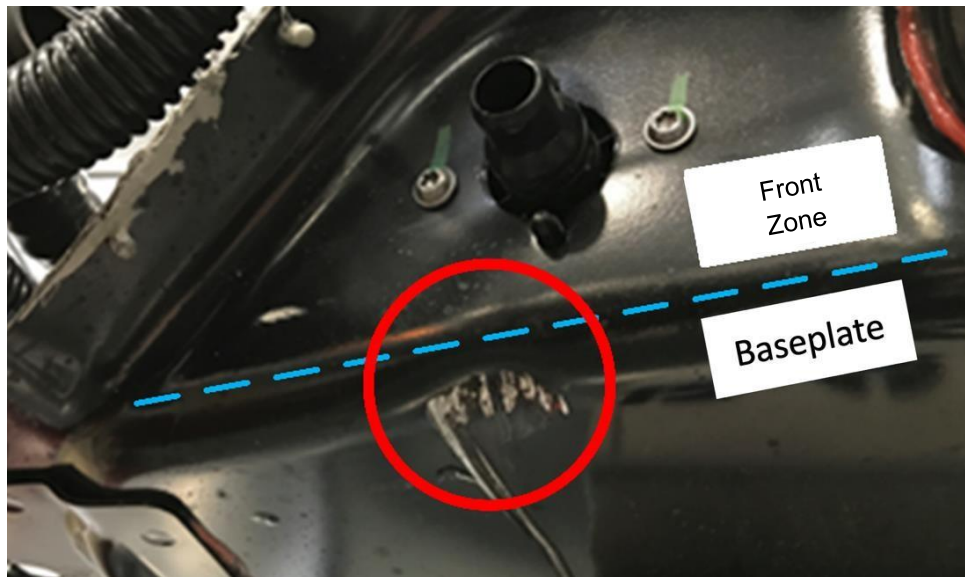
Figure 23 – Front zone

NOTE: The dent inside the red circle in Figure 23 is not considered to be within the front zone. The front zone of the HV battery is above the dashed line. Anything behind or below the dotted line is in the [Baseplate](#) section.
