TN-22-16-001 R1 January 5, 2024

Tesla, Inc. Technical Note
Model:	Vehicle System:	Region:
Model Y Structural Pack	16 - Battery System	All

Inspect the Model Y Structural HV Battery for Underside Damage

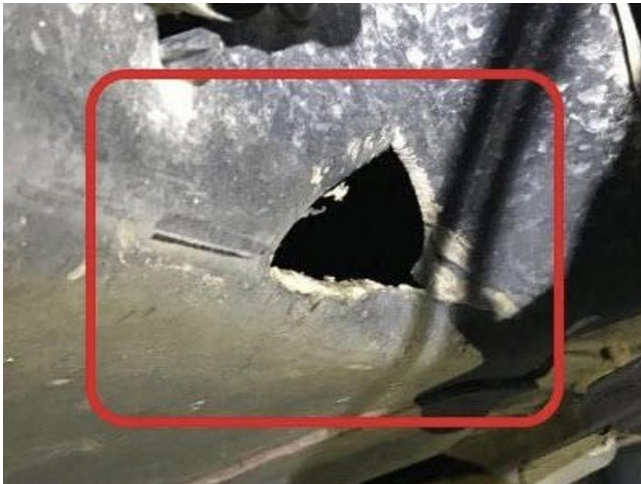
⚠ WARNING: If the HV battery enclosure is compromised with a **visible open hole, crack, or tear** (Figures 2 and 3), the Service Center doesn't need to continue further with this document and should recommend the customer replace the HV battery to meet Tesla's standards of quality and safety. Meanwhile, the HV battery might be compromised and needs to be taken care of diligently; refer to Toolbox article [29715](#) for assessing a compromised HV battery.

Figure 2 – Visible open hole

☰ NOTE: If at any point during the inspection the damage requires a HV battery replacement, advise the customer that the HV battery requires replacement to meet Tesla's standards of quality and safety. Tesla does not recommend driving the vehicle until the HV battery is replaced. Since the new HV battery replacement is not covered under the vehicle warranty, the Service Center should recommend that the customer replace the HV battery and provide the customer a price quote for the HV battery replacement. The warranty does not cover HV battery damage caused by an external impact.

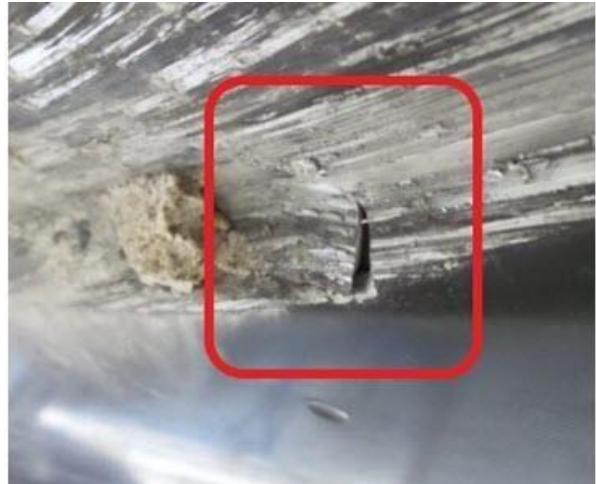
Figure 3 – Visible open crack

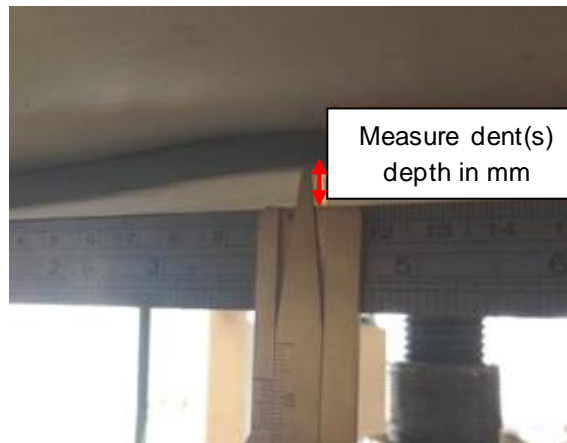
Figure 8 – Measuring the depth of enclosure damage

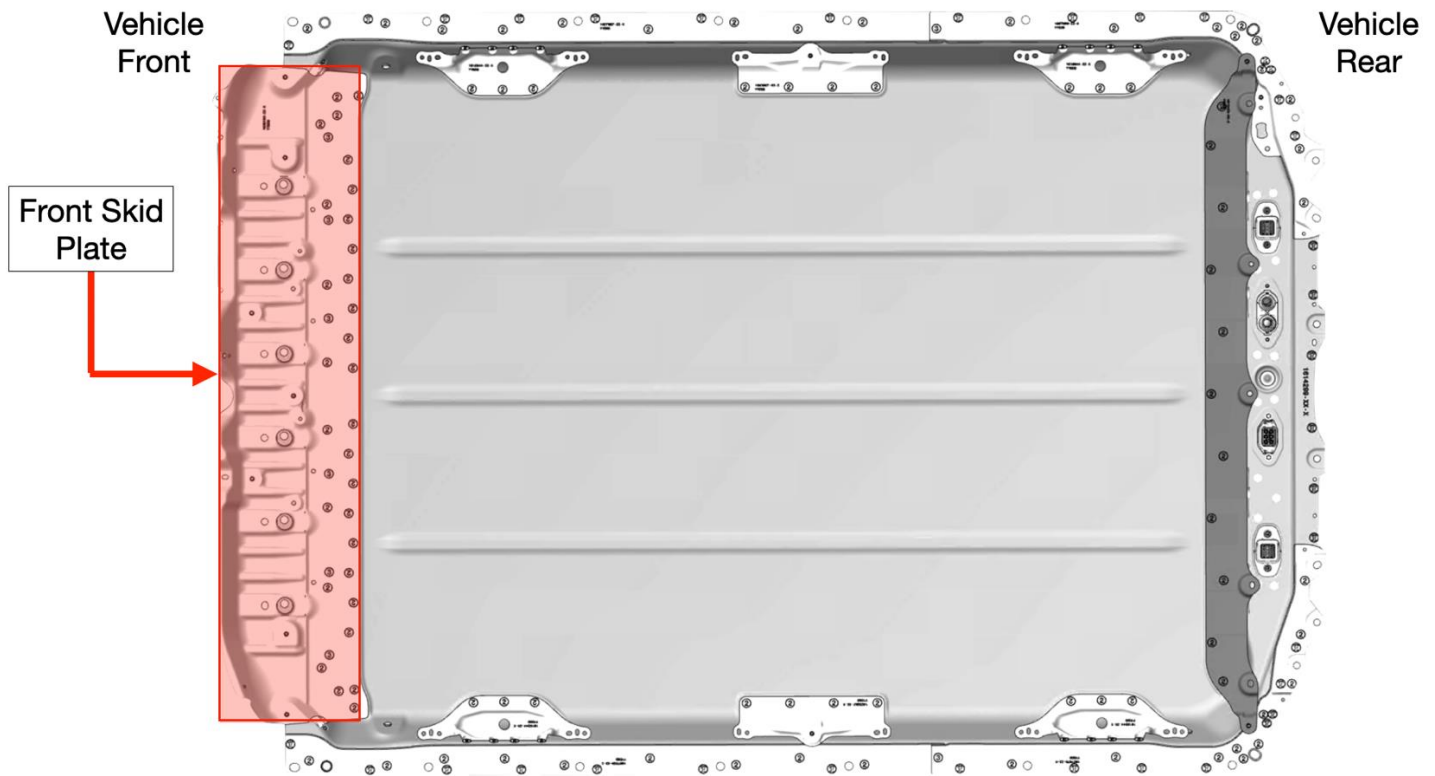
Figure 9 – Front skid plate location

1. Remove the front aero shield (refer to Service Manual procedure [12030112](#)).
2. Visually inspect the front skid plate for tears, dents, or breaches.
3. Inspect the HV cables, coolant hoses, baseplate, and passthroughs above the front skid plate.
4. If there is damage to the front of the enclosure above the front skid plate, see "[Front Zone](#)" section below.
5. If there is damage that extends onto the array baseplate, array barrier, or side zone, go to those specific sections below.

NOTE: The bolts that join the front aero shield and front skid plate are prone to shearing in the event of front skid plate damage.

- Deburr the area with a hand deburring tool to remove the sharp edges if sharp edges are found.
- Re-tap the fastener hole if a fastener hole is damaged and the fastener cannot withstand full torque.
- Recommend replacement of the:
 - Fastener if the fastener is damaged or stripped.
 - HV cables if the HV cables are damaged above the front skid plate.
 - Coolant hose if the coolant hose is damaged.
 - Front aero shield if the aero shield is damaged or cannot be secured properly.
- Recommend HV battery replacement if:
 - The front skid plate, or part of the front skid plate, is bent beyond repair, detached, or not covering the baseplate.
 - If the coolant passthrough is damaged.
 - The HV battery enclosure fails leak test due to impact.
 - The HV battery enclosure has low isolation due to impact.

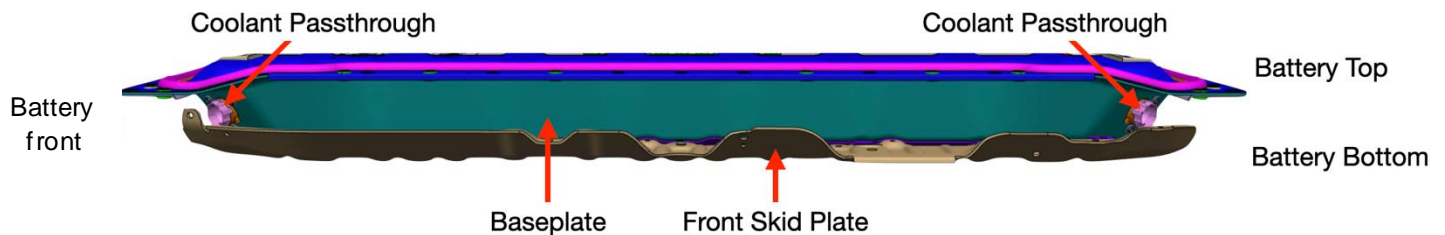
Figure 10 – Front zone

The front zone includes everything located at the front of the HV battery except the front skid plate (Figure 10).

- Deburr the area with a hand deburring tool to remove the sharp edges if sharp edges are found.
- Recommend replacement of the:
 - HV cables if the HV cables are damaged above the front skid plate.
 - Coolant hose if a coolant hose is damaged.
 - Front aero shield if the aero shield is damaged.
- Recommend HV battery replacement if:
 - A coolant passthrough is damaged.
 - The HV battery enclosure fails leak test due to impact.
 - The HV battery enclosure has low isolation due to impact.

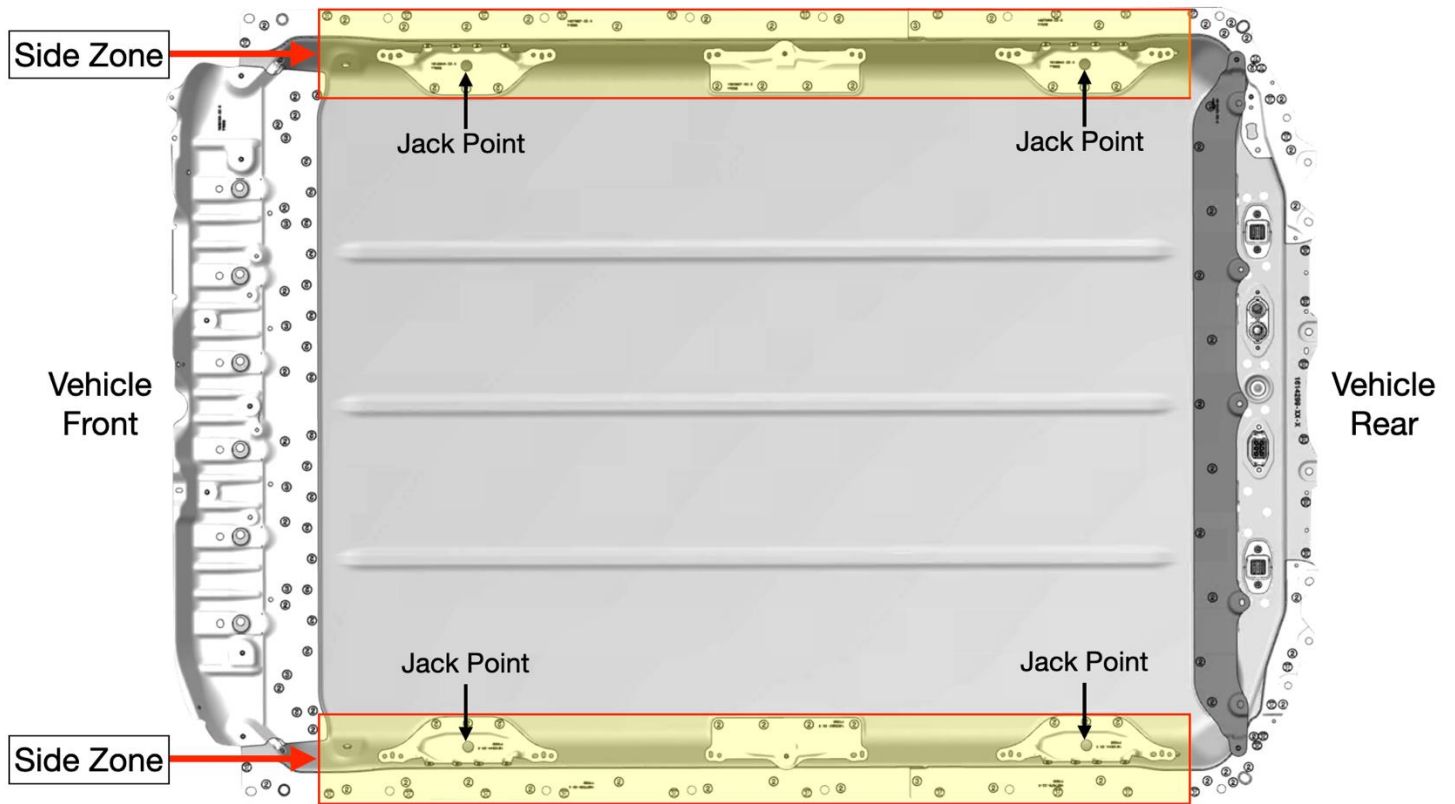
Figure 11 – Side zones

The HV battery has two side zones (Figure 11). For each side zone, there is a front and rear jack point, along with multiple rocker panel mounts which hold the rocker panels in place to protect the sides of the HV battery enclosure. The side zone includes both sides of the HV battery enclosure itself when the side rocker covers are removed.

- Deburr the area with a hand deburring tool to remove the sharp edges if sharp edges are found.
- Re-tap the fastener hole if a fastener hole is damaged and the fastener cannot withstand full torque.
- Recommend replacement of the:
 - Fastener if the fastener is damaged or stripped.
 - HV cables if the HV cables are damaged.
 - Coolant hose if the coolant hose is damaged.
 - Rocker cover if the rocker cover, or part of the cover is detached from the HV battery and cannot be secured properly.
- Recommend HV battery replacement if:
 - A jack point has extensive damage where it cannot be used to safely lift the vehicle.
 - The HV battery enclosure fails leak test due to impact.
 - The HV battery enclosure has low isolation due to impact.

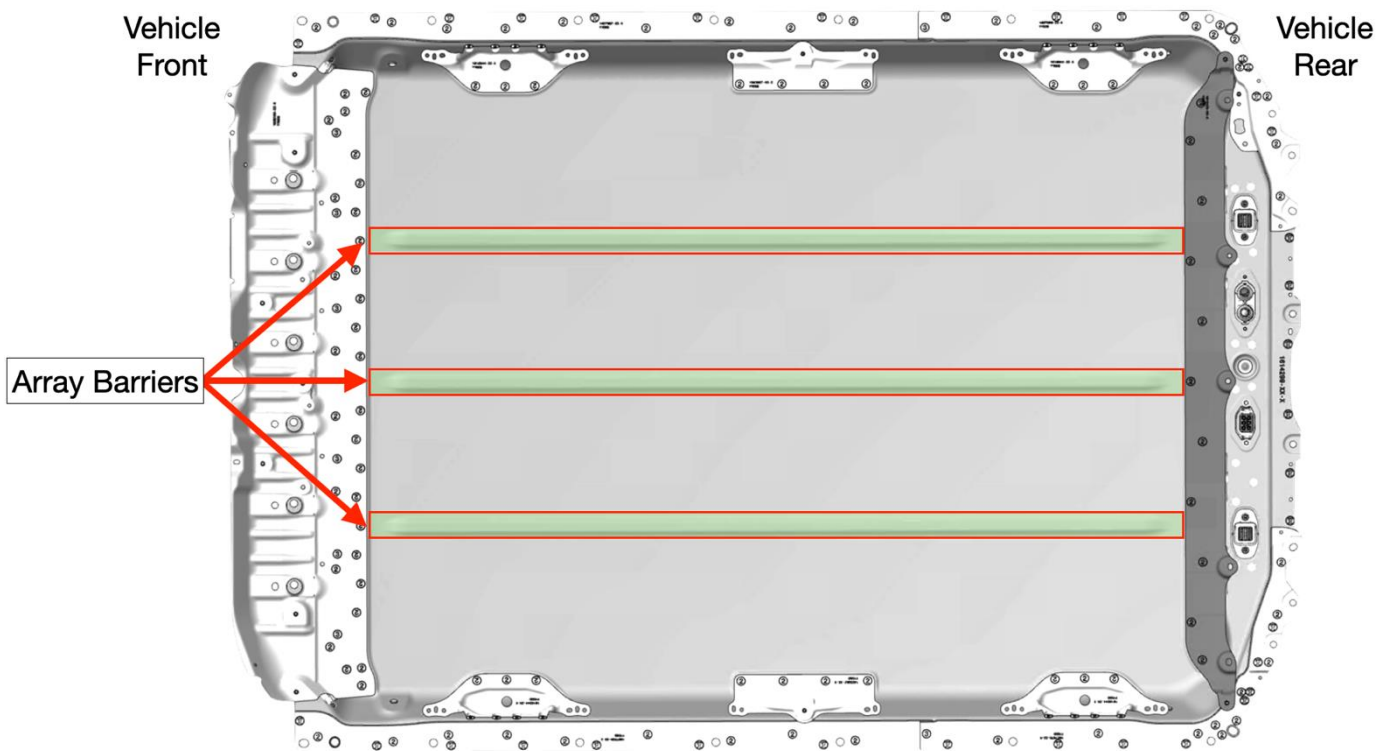
Figure 15 – Array barriers

NOTE: There is no depth measurement threshold for the array barrier zones since no cells are within these specific zones.

- Deburr the area with a hand deburring tool to remove the sharp edges if sharp edges are found.
- Recommend HV battery replacement if:
 - The HV battery enclosure fails leak test due to impact.
 - The HV battery enclosure has low isolation due to impact.

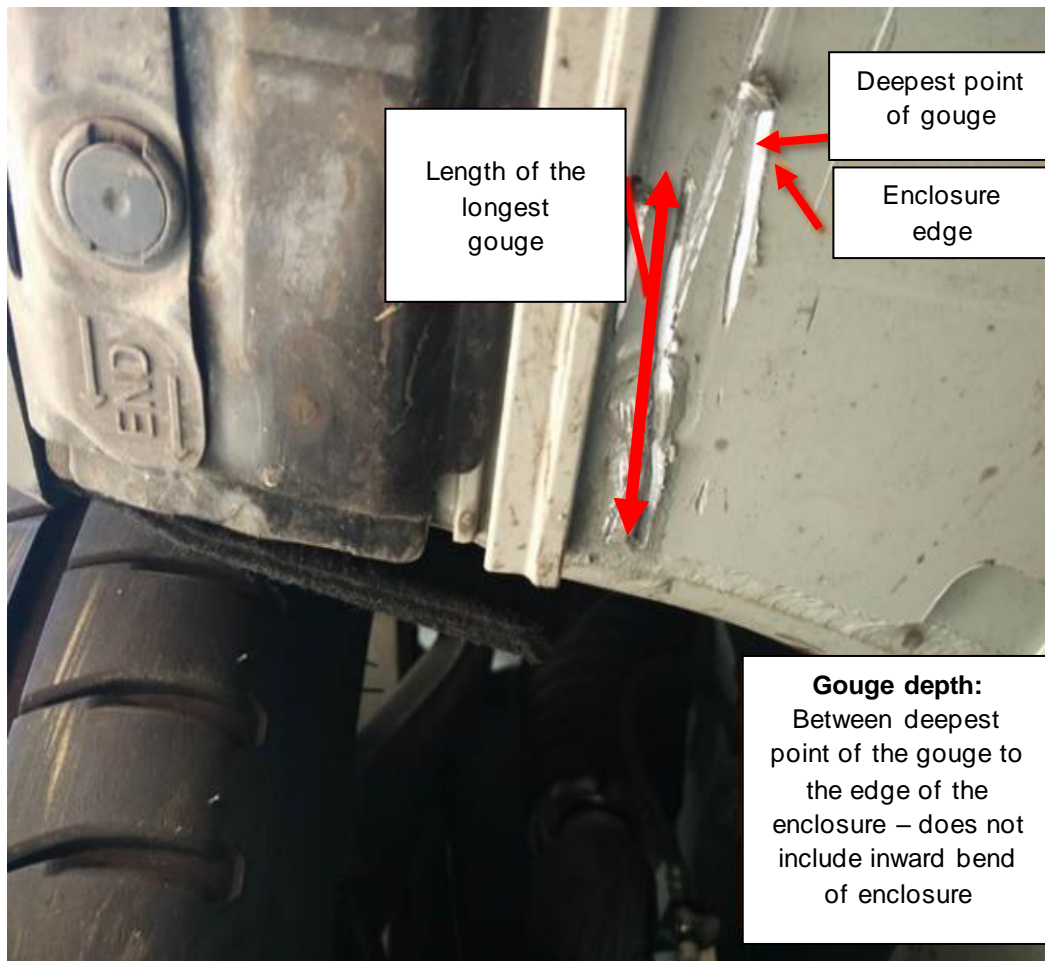
- Deburr the area with a hand deburring tool to remove the sharp edges if sharp edges are found.
- Recommend HV battery replacement if:
 - A dent or deepest point of gouge is **5 mm** or more in depth (Figures 17 and 18) within the array baseplate zone.

NOTE: Depth measurements should only be taken within the baseplate zones, **NOT** the array barrier zone. If a dent overlaps into an array barrier zone, measure the largest depth within just the baseplate zone, even though the deepest depth may be within the array barrier zone.

Figure 17 – Gouges in the baseplate

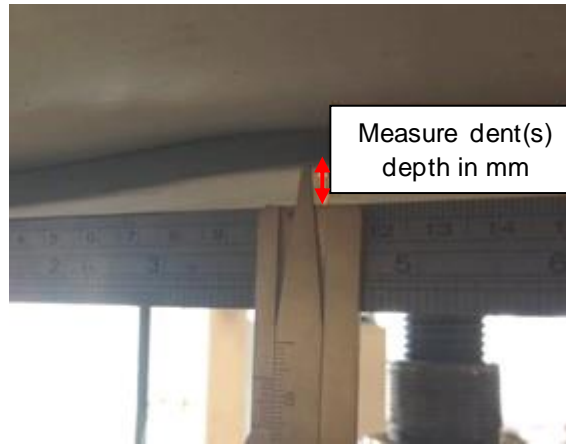
Figure 18 – Dents in the baseplate

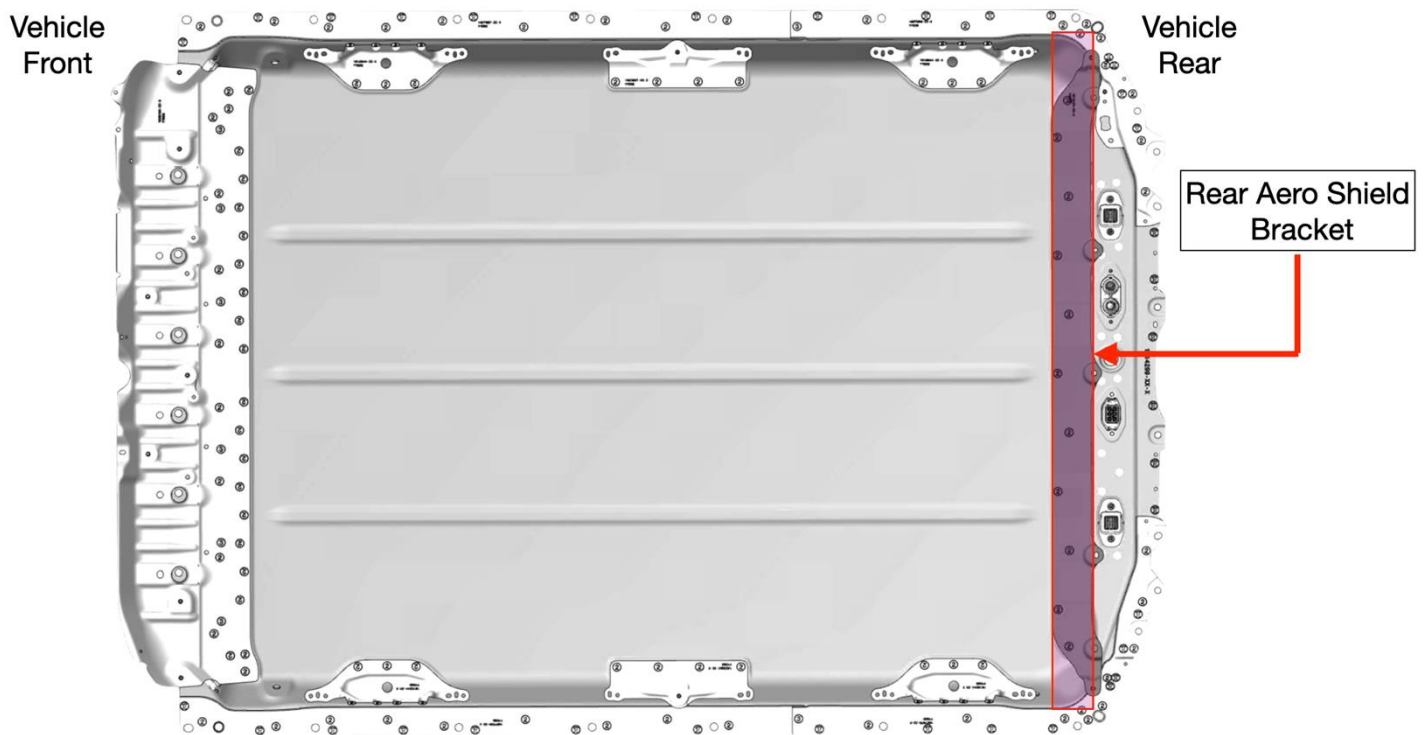
Figure 19 – Rear aero shield bracket

1. Remove the mid aero shield (refer to Service Manual procedure [12030502](#)).
2. Remove and assess damage to components at the rear of the HV battery such as HV harness cables, passthroughs, baseplate, fasteners, etc. If any components at the rear of the HV battery are damaged or missing, see "[Connector / Rear Zone](#)" section below.

- Deburr the area with a hand deburring tool to remove the sharp edges if sharp edges are found.
- Recommend replacement of the:
 - o Fastener if the fastener attaching the mid aero shield and rear aero shield bracket is damaged or stripped.
 - o Mid aero shield if the aero shield is damaged or cannot be secured properly.
- Recommend HV battery replacement if:
 - o The rear aero shield bracket, or part of the bracket, is bent beyond repair, detached, or not covering the baseplate.
 - o The HV battery enclosure fails leak test due to impact.
 - o The HV battery enclosure has low isolation due to impact.

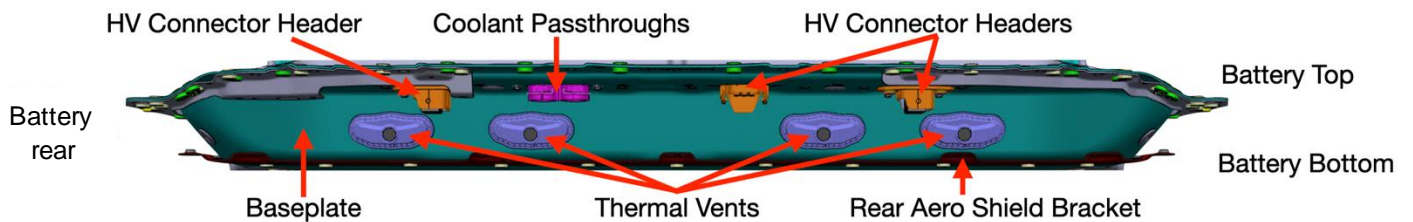
Figure 20 – Connector / rear zone

The connector / rear zone is located at the rear of the HV battery and above the rear aero shield bracket (Figure 20), and includes of all the major HV battery connection points and vents.

- Deburr the area with a hand deburring tool to remove the sharp edges if sharp edges are found.
- Recommend replacement of the:
 - Mid aero shield if the aero shield is damaged or cannot be secured properly.
 - HV cables if the HV cables are damaged above the front skid plate.
 - Coolant hose if a coolant hose is damaged.
 - HV connector header if the header is damaged.
 - Coolant passthrough if the passthrough is damaged.
- Recommend HV battery replacement if:
 - A thermal vent is damaged or missing.
 - The rear aero shield bracket, or part of the bracket, is bent beyond repair, detached, or not covering the baseplate.
 - The HV battery enclosure fails leak test due to impact.
 - The HV battery enclosure has low isolation due to impact.
