Roadster Issue Articles

Article #22638 - "Check left/right back turn signal bulb" alert, with improper output from switchpack

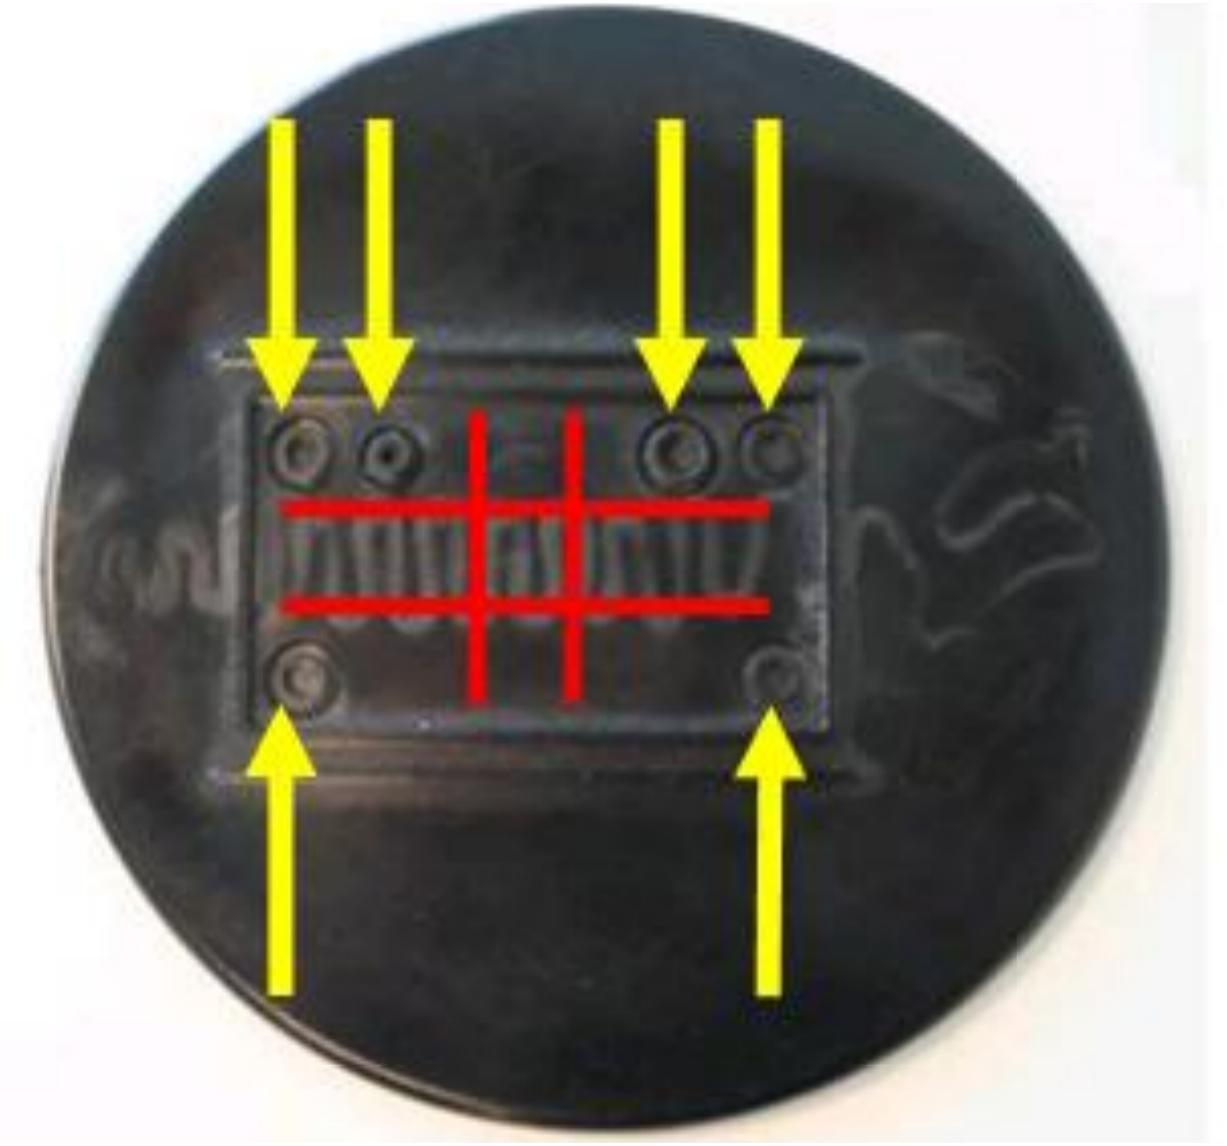
Due to an incorrect bonding process from the supplier, it is possible the painted charge door may separate from the mounting plate. A new bonding process and material has been developed to ensure the charge door will pass a 30lb. pull test. This bond strength will surpass any requirements in the field. If the charge door panel has disengaged and has been damaged, replace the entire charge door with the new complete part and have it painted to match. Be sure to follow the steps exactly to ensure a quality bond.

- 9. Apply a sparing amount of Betaseal 1701 to the charge door only. It is important to avoid applying so much that the sealer will push into the molded bosses (yellow arrows).
- 10. Apply the sealer in a cross pattern as shown in red.

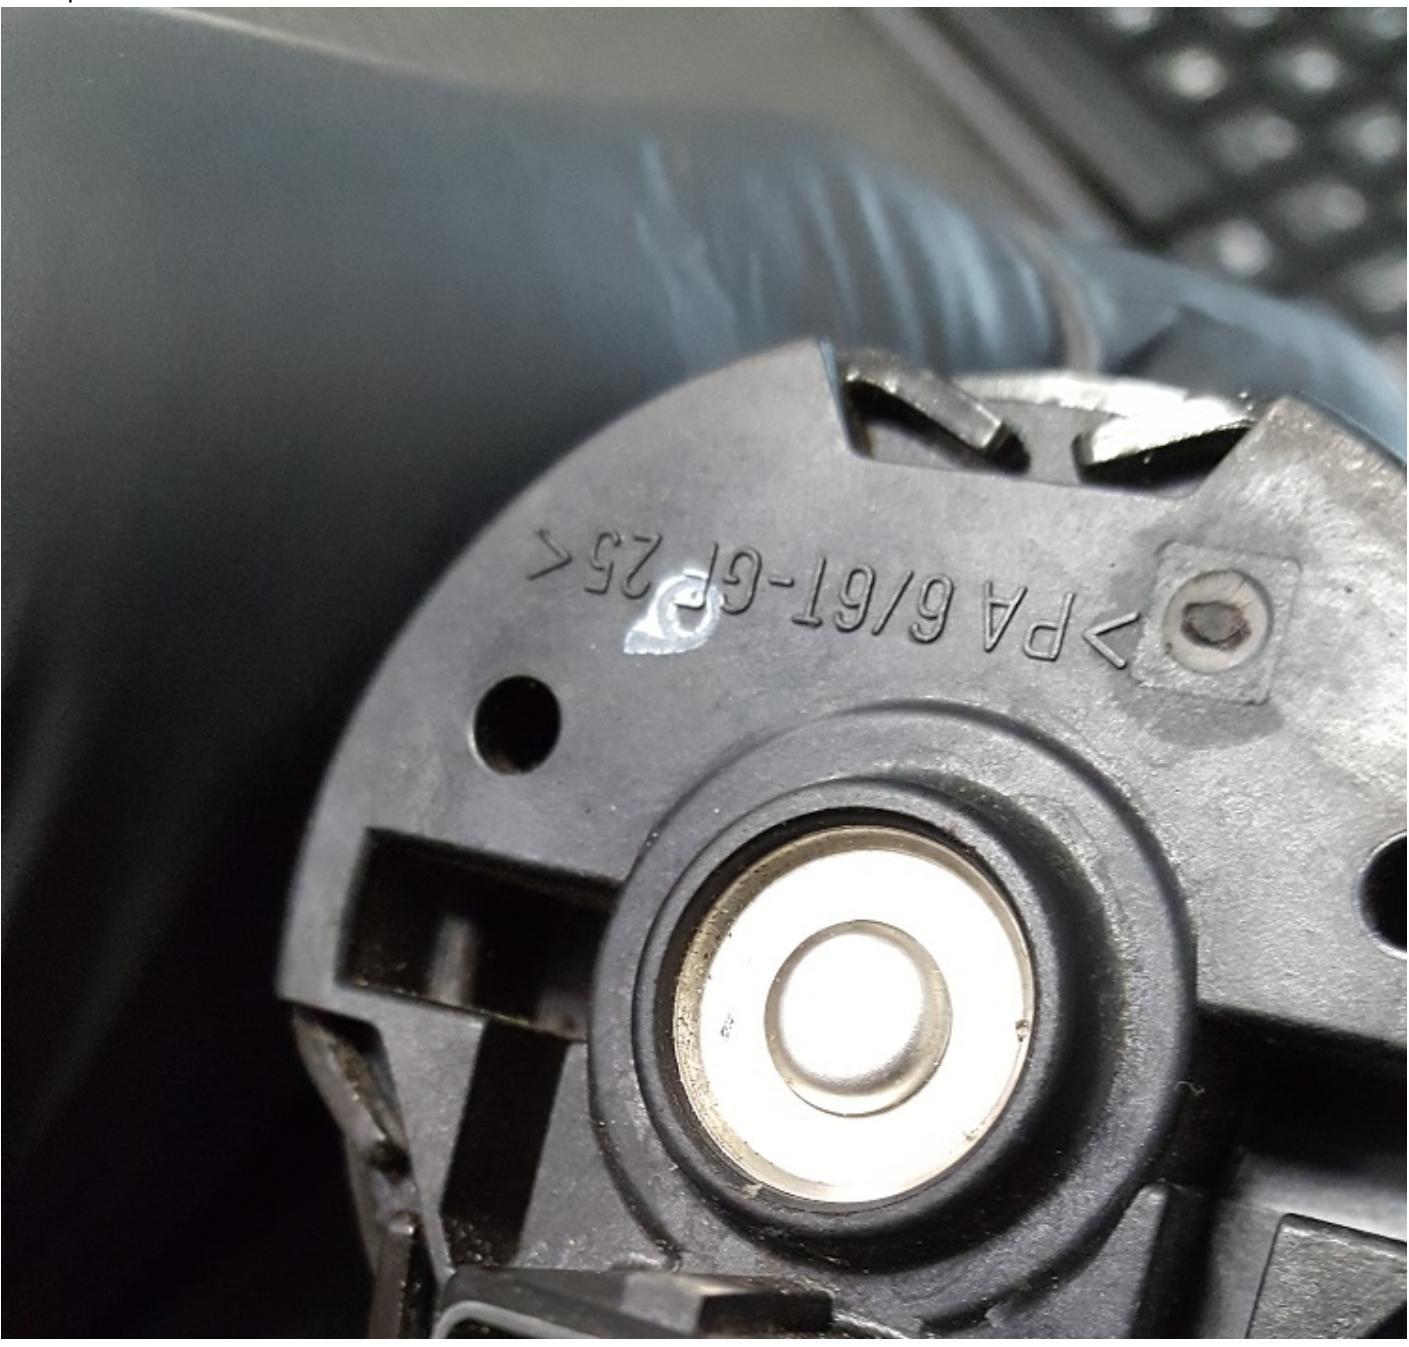
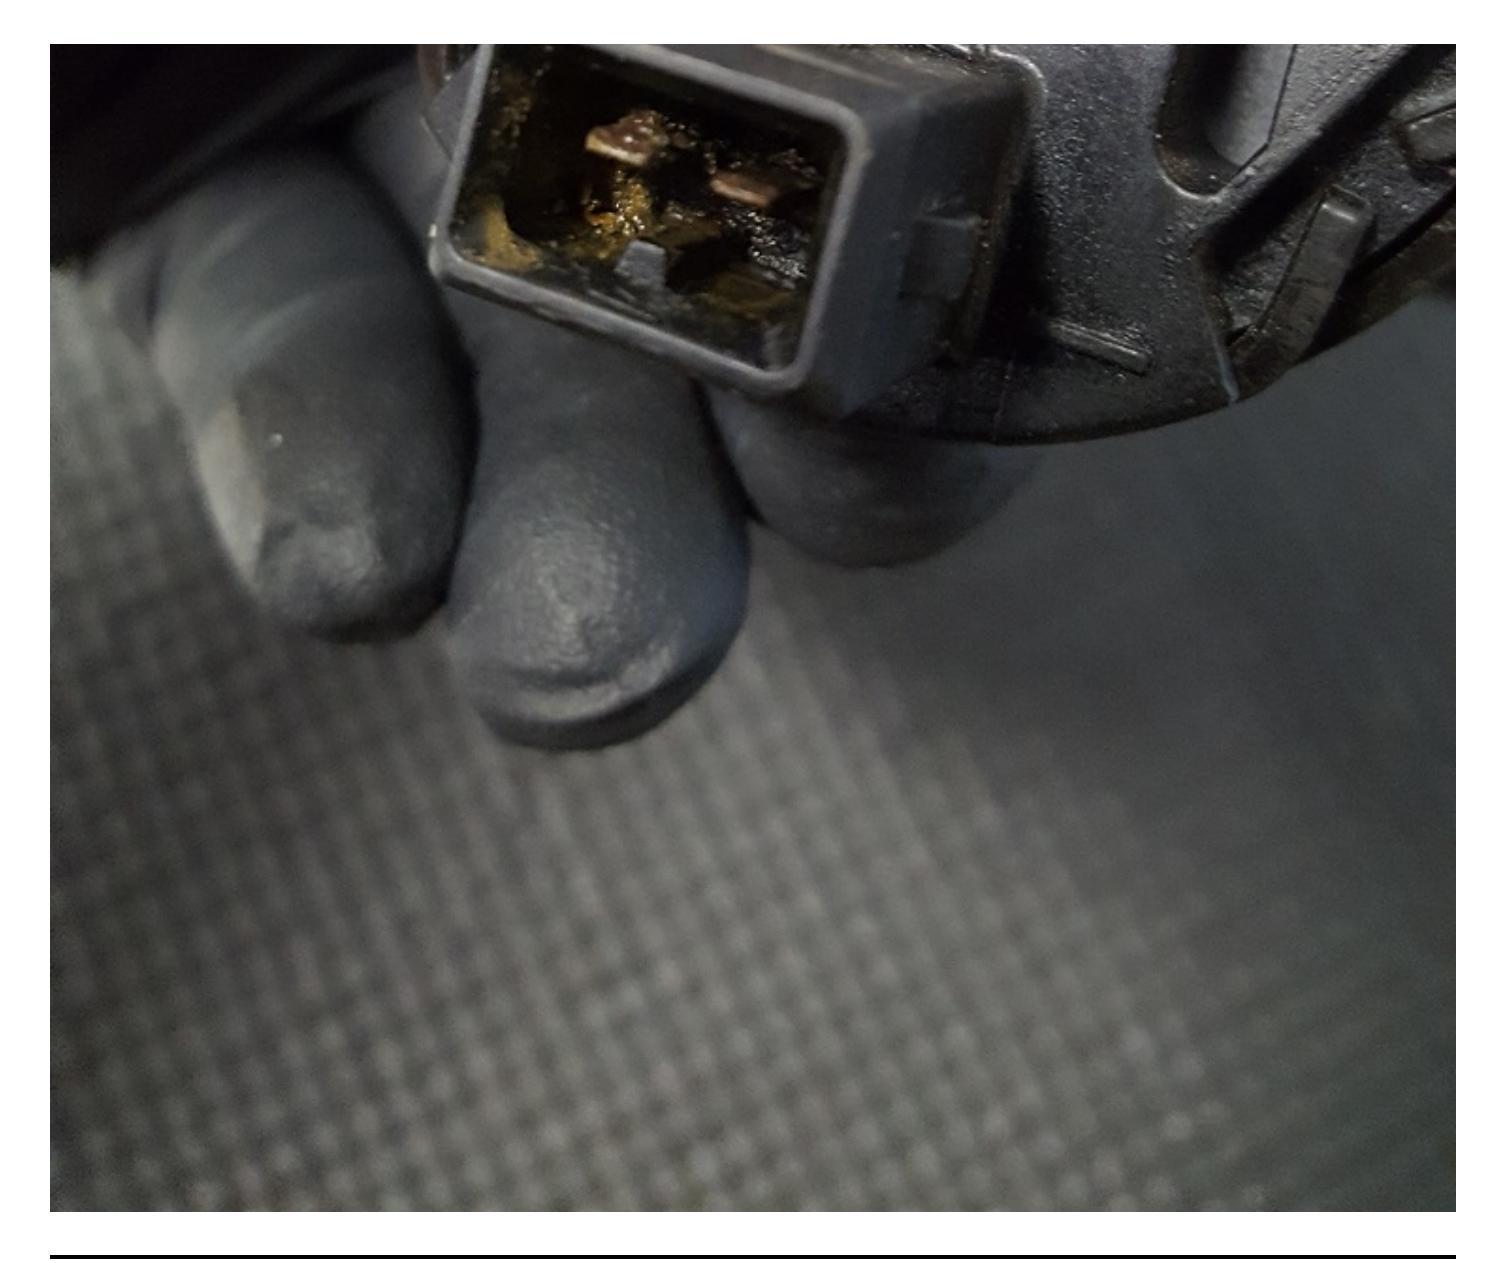
Visually inspect the coolant pump (1.5 vehicle shown) and connectors for a coolant leak.

Example of leak in the connector:

- 1. Replace coolant pump.
- 2. Clean connector with contact cleaner and shop air.
- 3. If there is excessive corrosion, repair harness as needed.

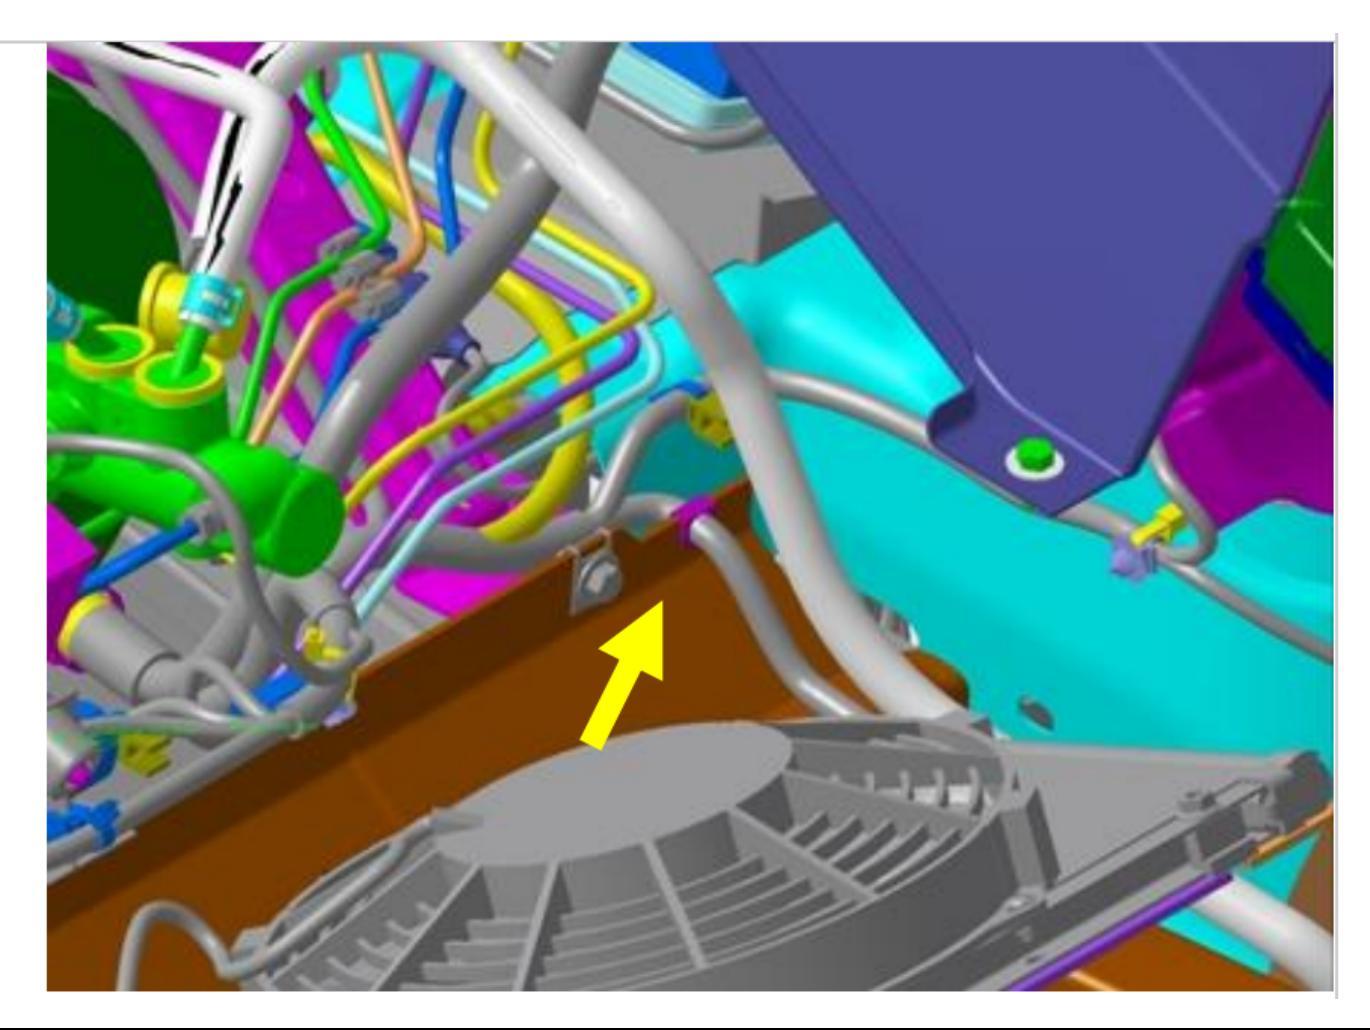
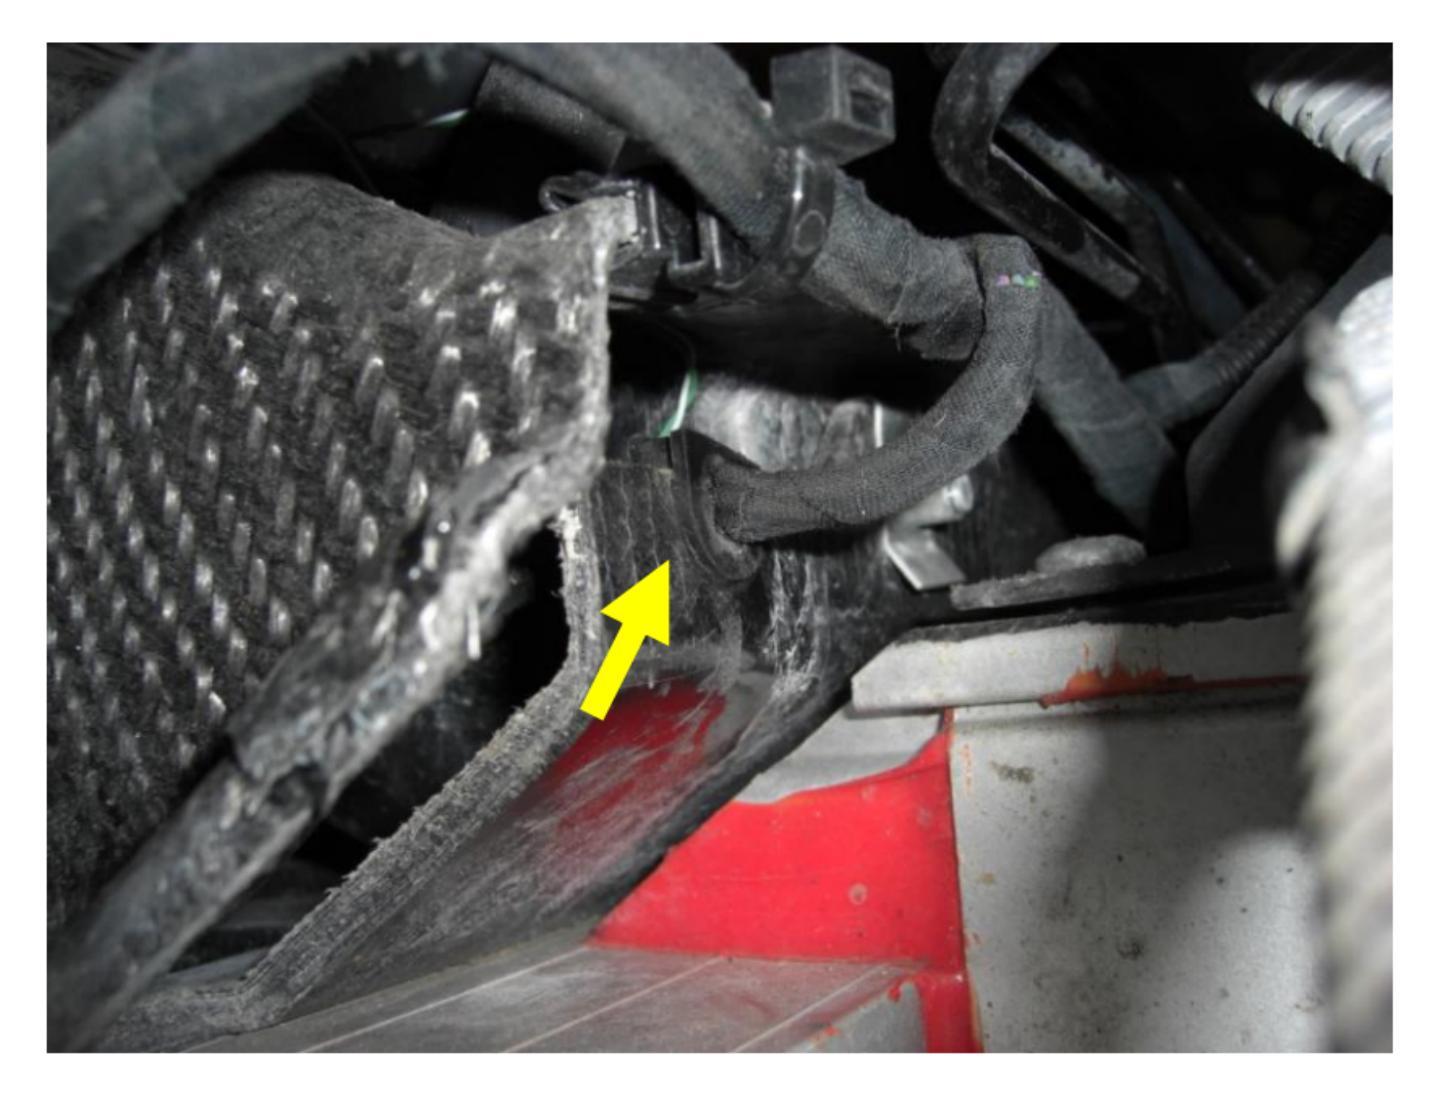
Dislodged bulkhead grommet.

Part of the front harness that runs through the bulkhead structure of the car is secured by a "U" shaped grommet. This grommet is designed to stop the wiring harness from chafing against the impact structure. See picture below that illustrates the position of the grommet.

- 1. Check to make sure that the grommet has not become dislodged from its mounting point in the carbon impact structure. Shown below is an example of a correctly placed grommet.
- 2. If the grommet is not correctly placed, then this is your issue.

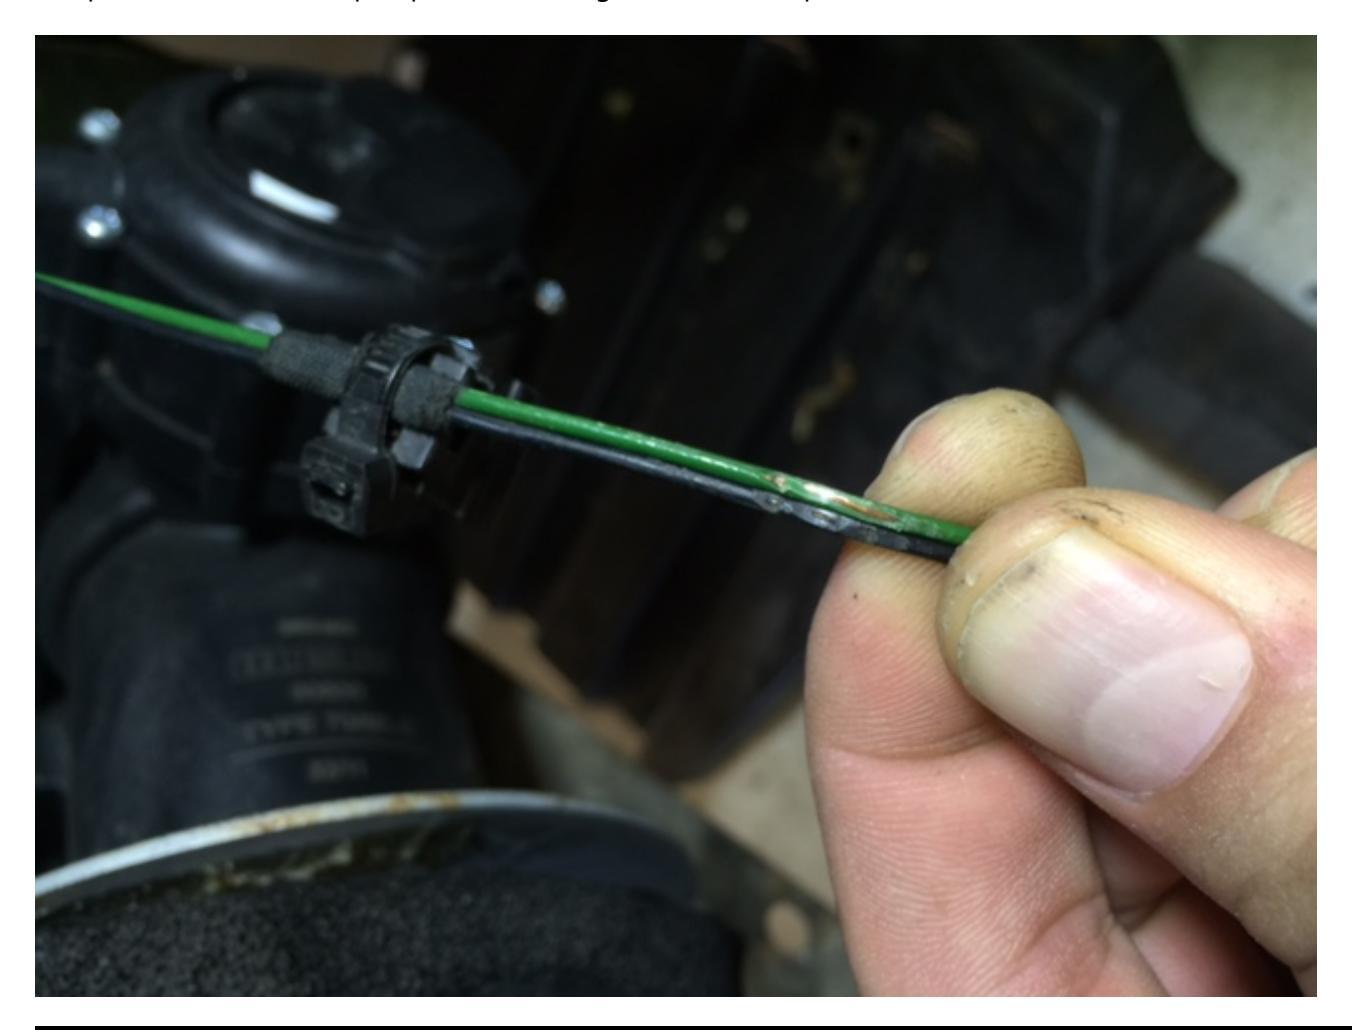
Check wiring for a short to ground around the vacuum pump assembly in the left front wheel arch area. There is a sharp bracket around the pump and the wiring can chafe. See photo below:

- 1. Repair the wiring and add foam tape or cloth tape to any sharp edges around the wiring.
- 2. Also wrap the wiring in electrical tape.

3. Install a wire loom around the wiring for added protection:

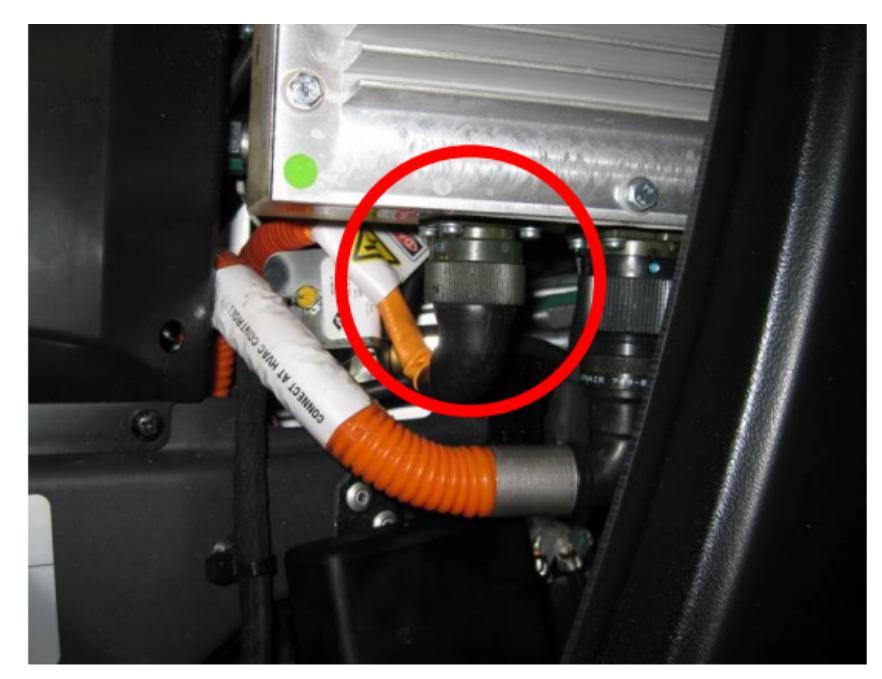
Some vehicles were assembled with misaligned pins on the compressor connector of the 400V Heating, Ventilation, Air-Conditioning (HVAC) controller. When assembly was completed, the pins would bend and cause a poor connection to and possible malfunction of the compressor.

- 1. Carefully straighten the pins using non-marring needle nose pliers.
- 2. Once the pins are straightened, re-install the connector.

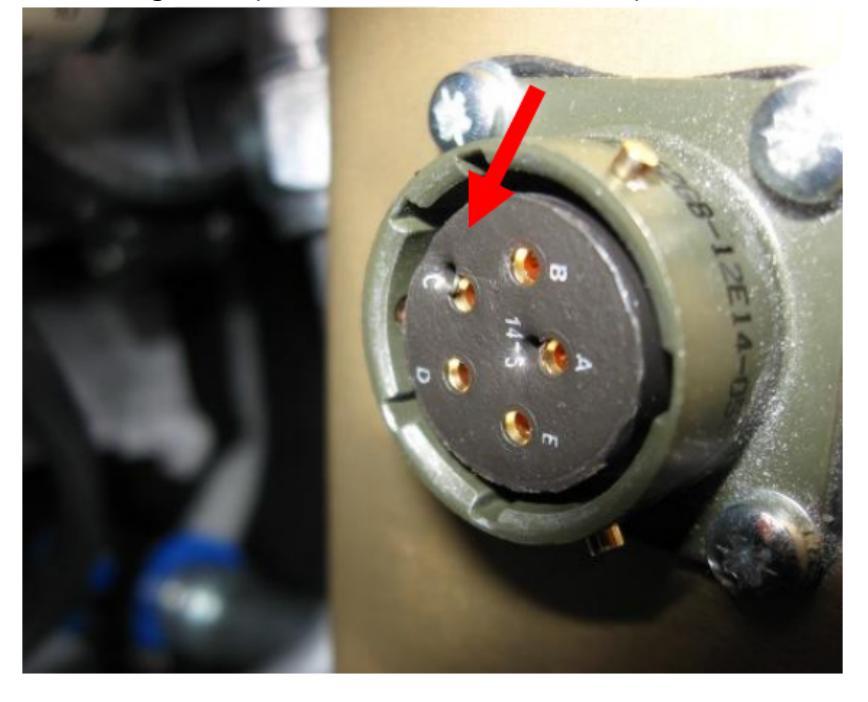
When the misaligned pins are forced onto the control unit, a mark is left in the 400V HVAC controller's connector.

Most commonly, pin C has misalignment problems, but others are susceptible as well.

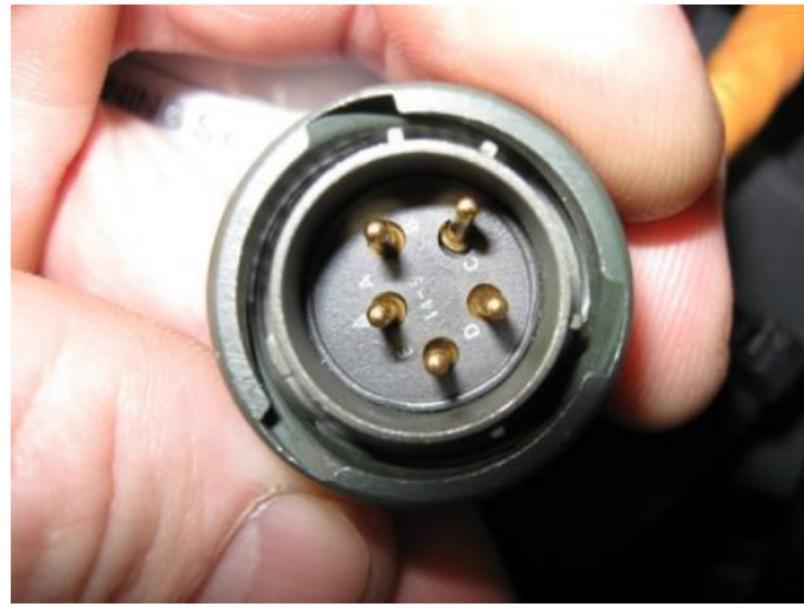
- 1. Open the hood.
- 2. Disconnect the compressor connector,
- 3. Inspect for bent pins.
- 4. If any bent pins are discovered, this is the issue.

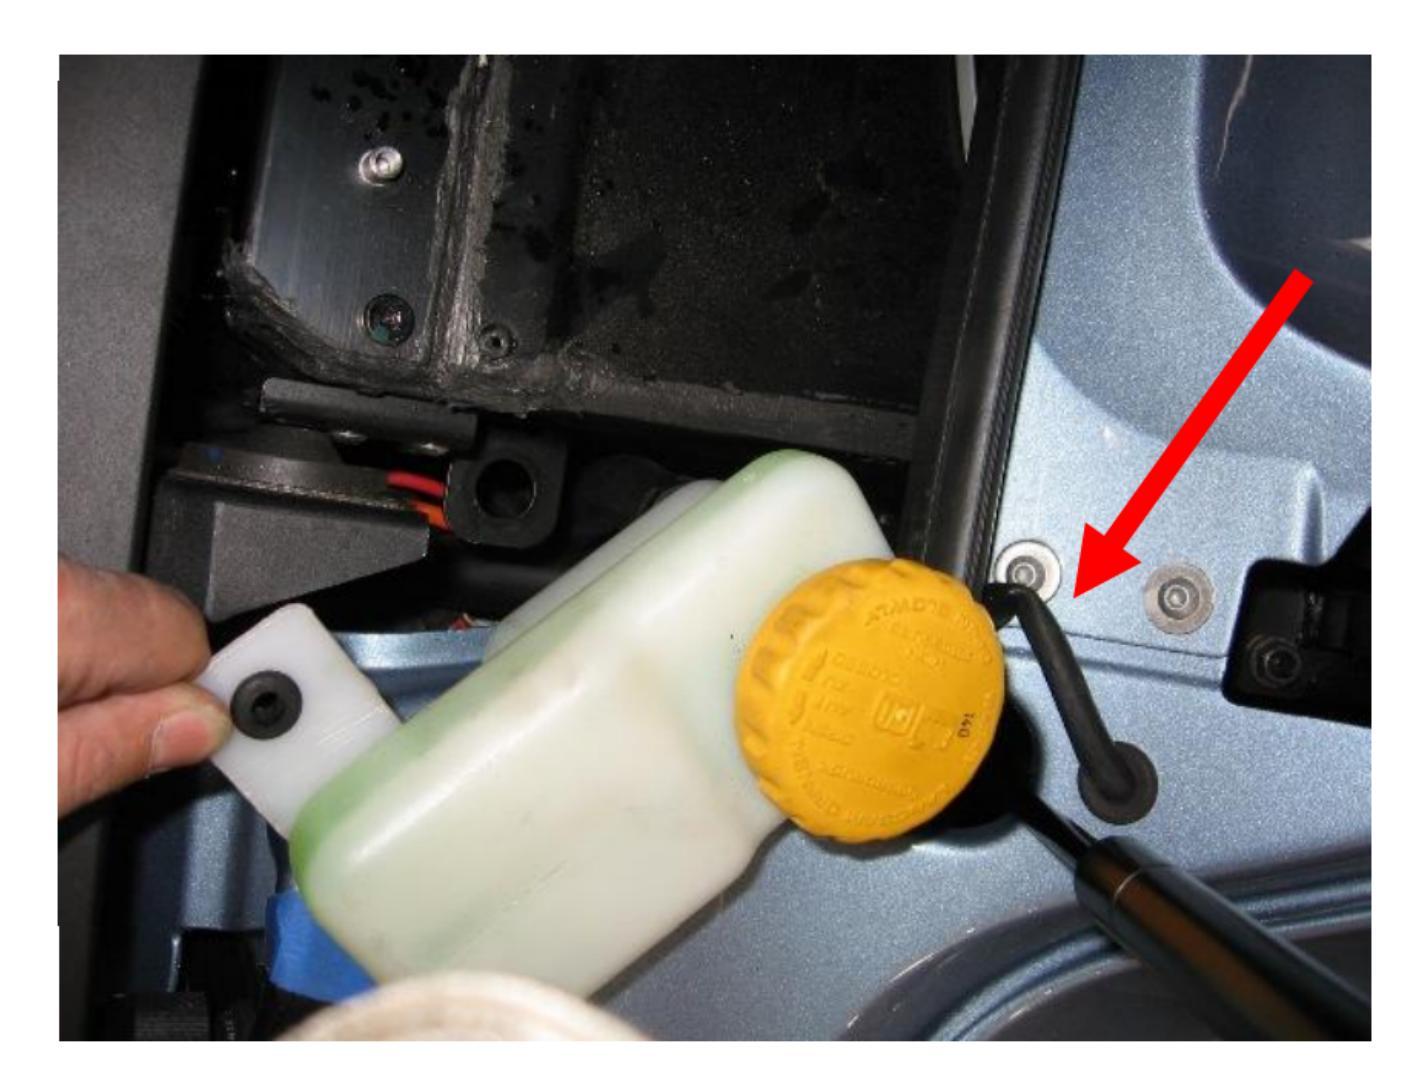
Restriction in coolant return hose to reservoir. Coolant leakage can be caused by a kinked coolant return hose at the reservoir.

Bypass hose may be pinched when shifting expansion tank to remove and install the Power Electronics Module (PEM). The pinched hose may cause a coolant leak.

The coolant return line to the reservoir should be inspected for potential restriction due to improper installation. This can happen during battery (ESS) removal when shifting coolant reservoir to the side.

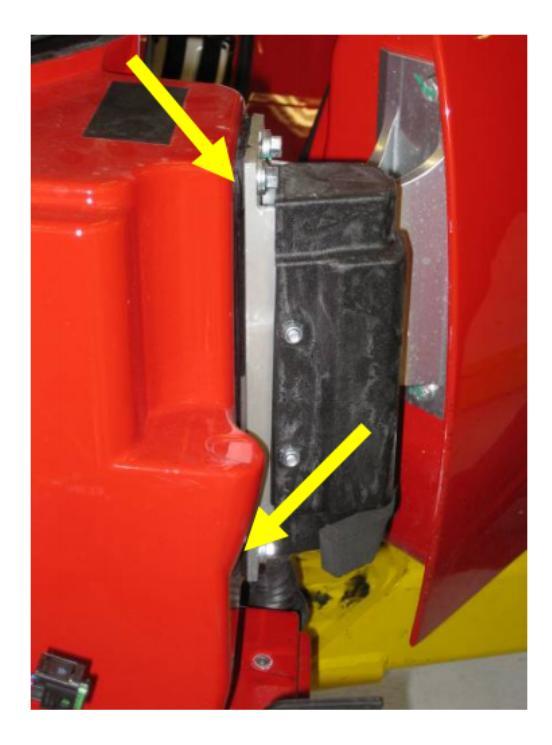
Leak Point around Door Hinge.

There is potential for water to ingress into the forward sill cavity of the body side panel. Water strikes this area as run off from the windshield and passes over the top of the body side panel and onto the door hinge area. Small points of ingress between the door hinge and the body side potentially exist.

This area houses electronics and connectors that can be damaged by moisture.
