General Information

The guidelines provided in this document apply to High Voltage (HV) batteries from Tesla vehicles, and are intended to be used by 3rd parties in Europe to evaluate if a Tesla HV battery is critically damaged prior to shipment defined by the European transport regulation by road (ADR).

HV Battery Inspection

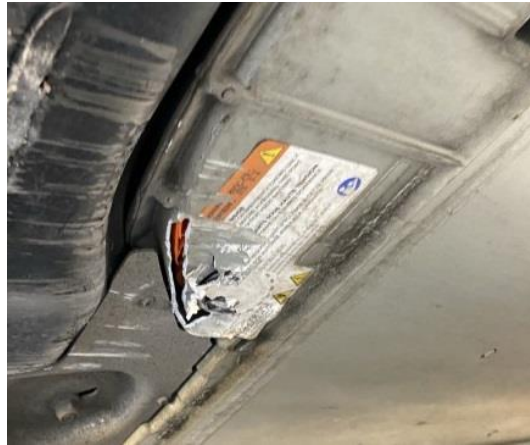
Figure 1 – Rupture of the enclosure exposing internal electronics

A rupture is where a structural damage to the HV battery metal enclosure exposes internal components. The rupture damage can be anything from a small crack to part of the HV battery torn off.

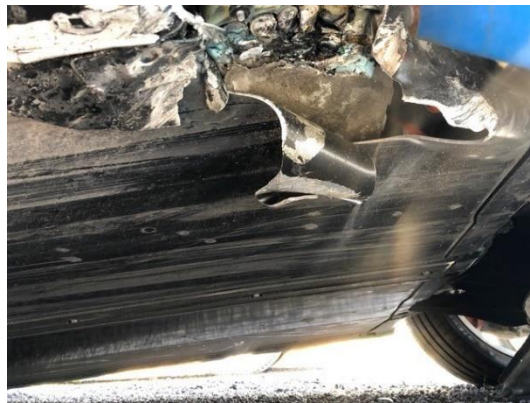
Figure 2 – Enclosure underside tear exposing internal cells

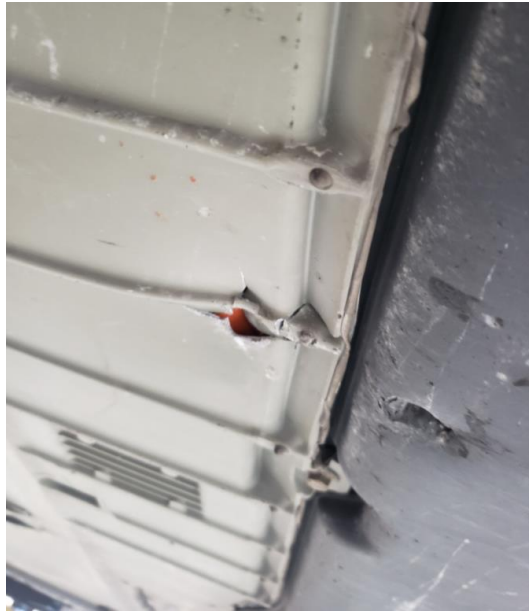
Figure 3 – Enclosure underside rupture exposing internal components

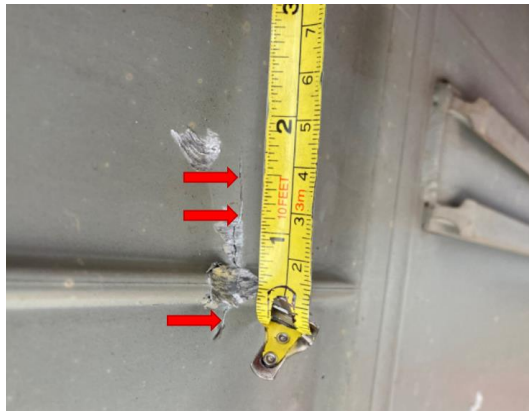
Figure 4 – Large enclosure crack breaking the enclosure sealing

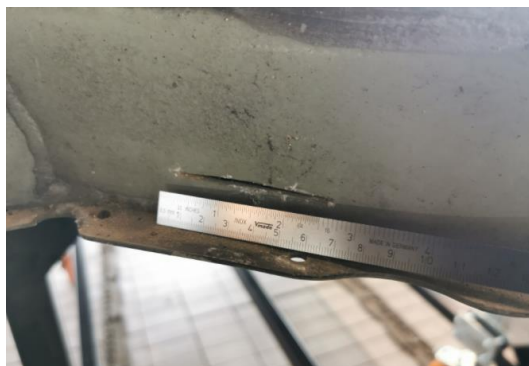
Figure 5 – Large enclosure crack breaking the enclosure sealing

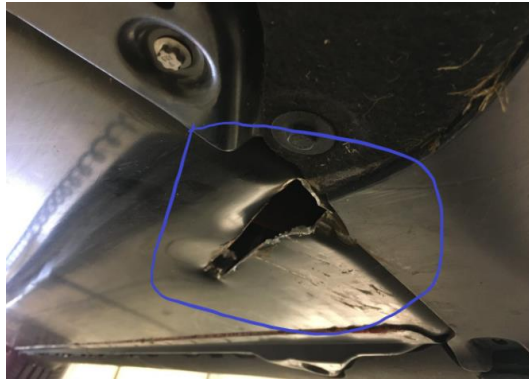
Figure 6 – Enclosure rupture exposing internal components

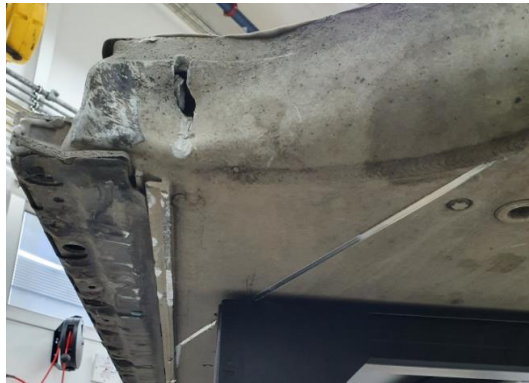
Figure 7 – Enclosure rupture exposing internal components

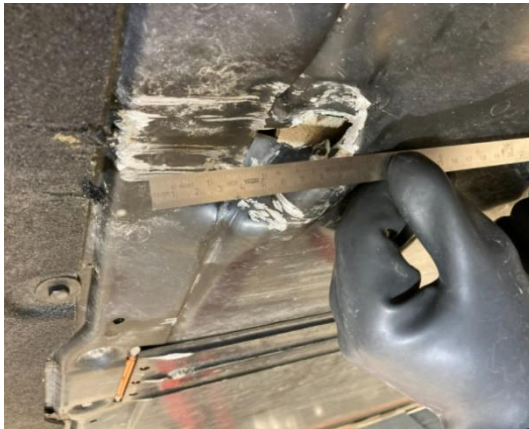
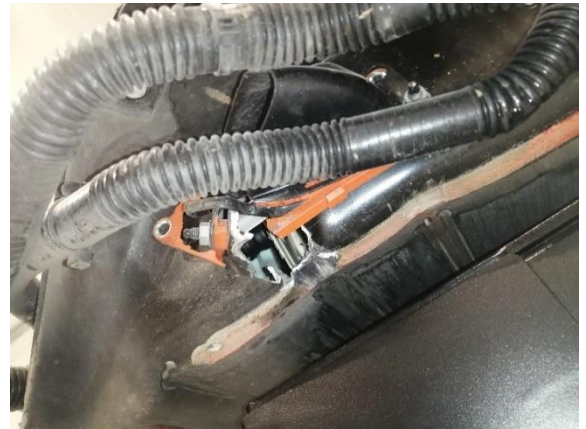
Figure 8 – Enclosure rupture exposing internal components

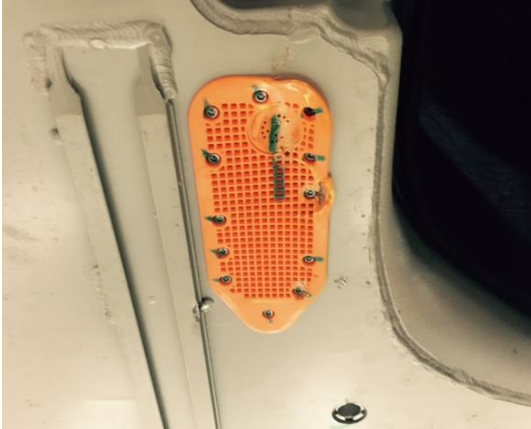
Figure 9 – Light plastic deformation of the front baffle cover

The following examples are not considered a rupture in the HV battery metal enclosure:

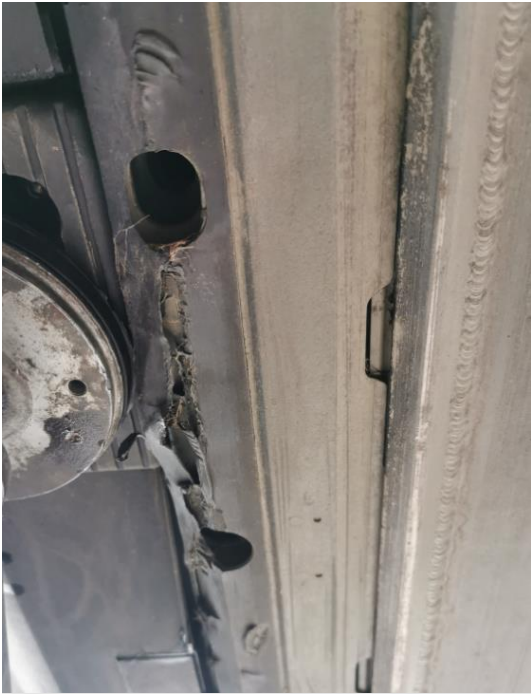
Figure 10 – Side ski plastic cover damage

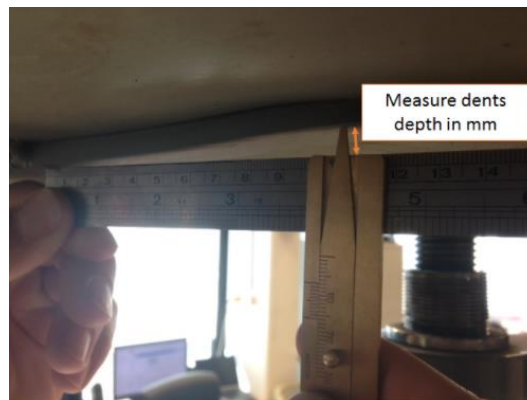
Figure 11 – Dent exceeding the maximum threshold

A dent is where a structural damage to the HV battery metal enclosure does not expose internal components. A dent is quantified by measuring its depth in relation to the surrounding, undamaged surfaces using a ruler and depth gauge.

Model	Maximum threshold
Model S, Model X (2012-2020)	6 mm
Model S, Model X (2021+)	7 mm
Model 3, Model Y	8 mm
Model Y Structural Pack	5 mm

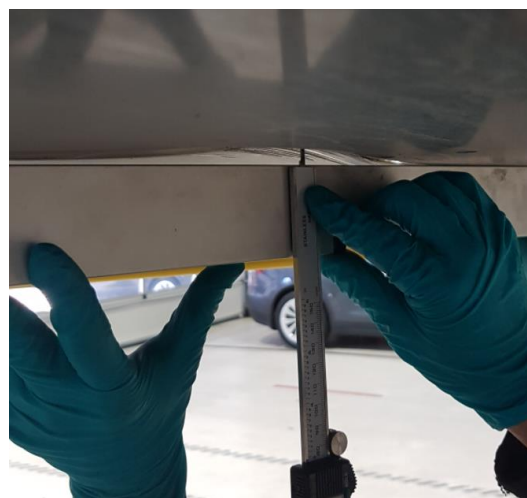
Figure 12 – Dent exceeding the maximum threshold

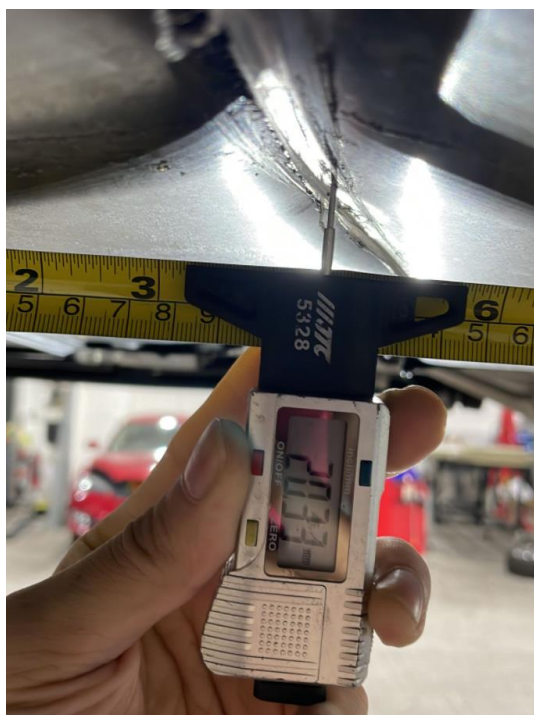
Figure 13 – Dent exceeding the maximum threshold

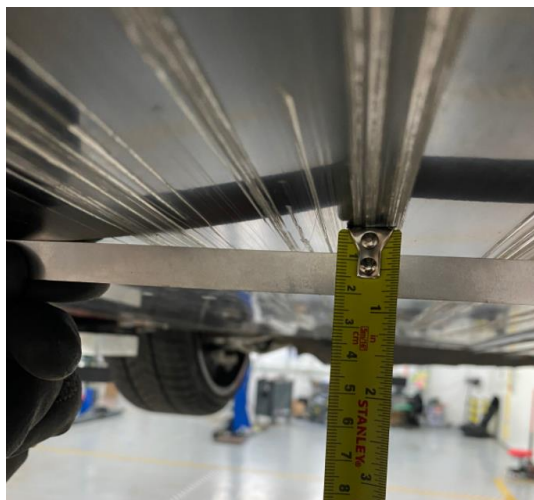
Figure 14 – Dent exceeding the maximum threshold

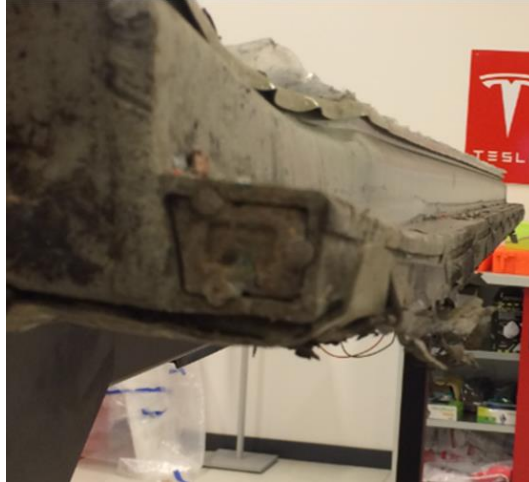
Figure 15 – Enclosure visually bent

A bend, twist, or warp is where a structural damage to the HV battery metal enclosure causes the fundamental shape of the HV battery to be no longer visually straight or flat.

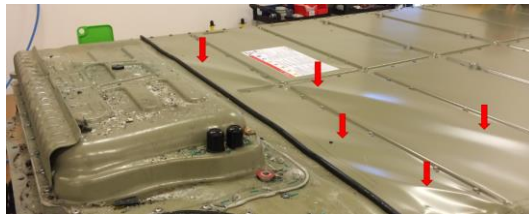
Figure 16 – Enclosure top cover visually warped

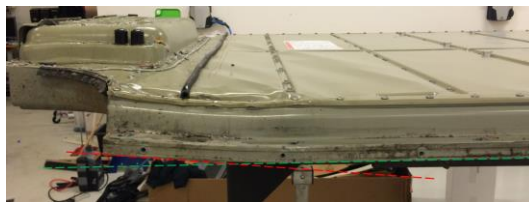
Figure 17 – Enclosure visually bent

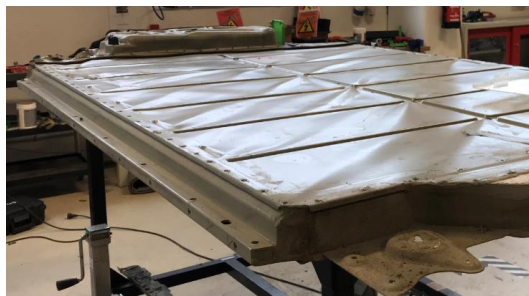
Figure 18 – Enclosure top cover visually warped

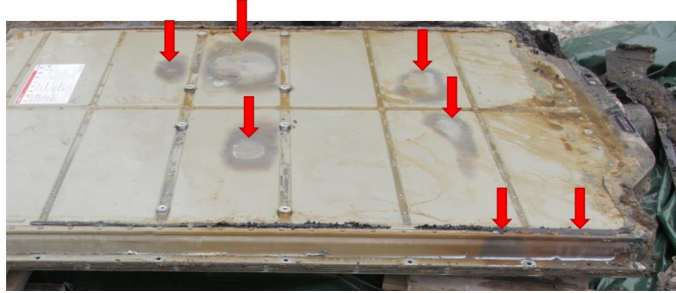
Figure 19 – Several heat discoloration spots on enclosure top cover

A soot-like, brown, or other discoloration to the HV battery metal enclosure can be indicative of internal or external heat exposure. Severe heat exposure can also cause enclosure rupture, exposing internal components.

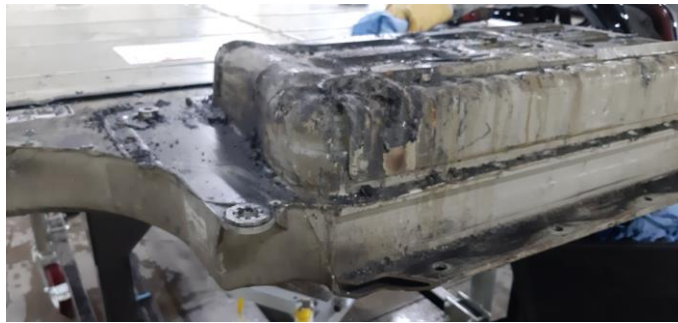
Figure 20 – Soot-like discoloration on enclosure

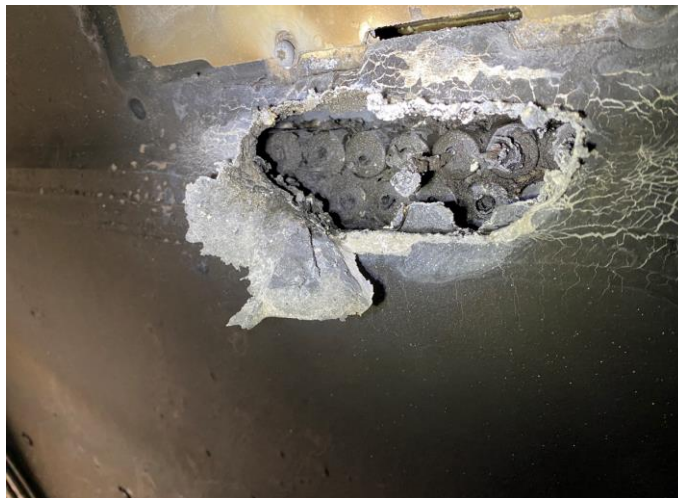
Figure 21 – Heat exposure causing enclosure rupture with internal components exposed

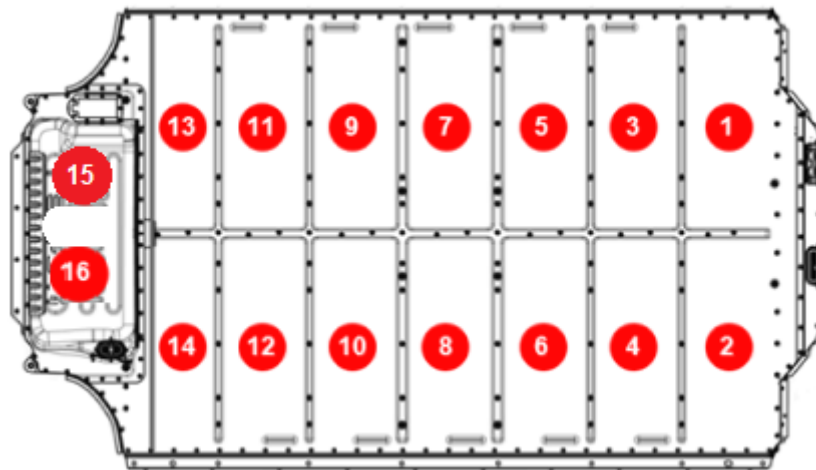
Figure 22 – Model S and Model X (20HV battery pack)

- Make sure that the HV battery is at ambient temperature, in a location with stable temperatures. For example, the battery should not be in direct sunlight or near a heating or air conditioning duct.
- If an insulating blanket is mounted on the top side of the HV battery, remove this blanket to be able to make a measurement on the HV battery metal enclosure.
- Use a non-contact infrared thermometer to measure the top or bottom surface of the battery enclosure at the indicated locations.

To pass the Thermal Inspection, all 16 measurements must be below 40 °C, with no more than 5 °C difference between 2 measurements.

**CAUTION:** If there is a temperature difference of more than 5 °C between 2 measurement points, or if the maximum temperature exceeds 40 °C, the HV battery should be evaluated as critically damaged.

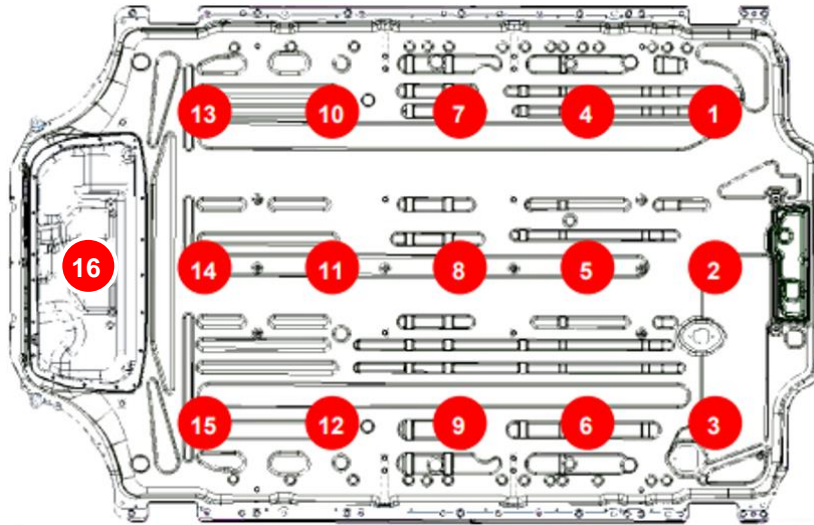
Figure 23 – Model S and Model X (2021+) HV battery pack

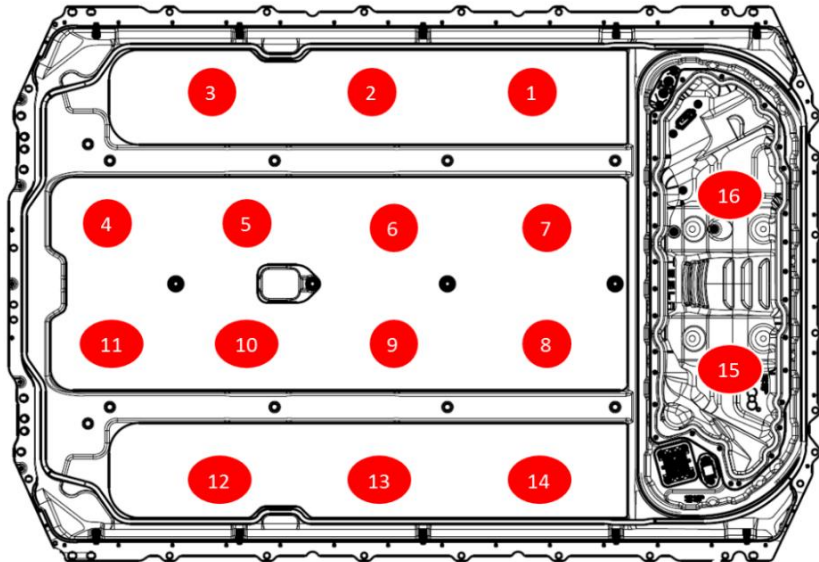
Figure 24 – Model 3 and Model Y HV battery pack
