Ground Terminal Bolts and Paths Retrofit

Classification Campaign Bulletin **Section/Group** 17 - Electrical **Country/Region** North America

Year 2017 **Model** Model 3 **Version** All

Certain Model 3 vehicles might have increased resistance at ground terminals, and might not provide sufficient signal reference ground at specific connectors.

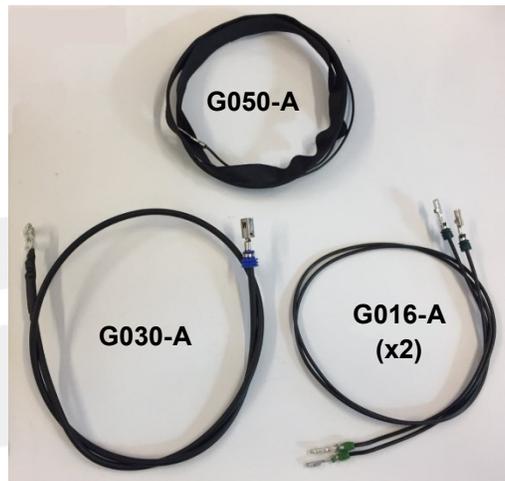
Figure 1 (Retrofit wires)

Service kit 1144125-00-A contains four retrofit wires which are not individually labeled. Figure 1 shows the four retrofit wires.

- Wire G050-A has a small eyelet, a tape strip, and connects X121-15 to G022.
- Wire G030-A has a large eyelet and connects X151-13 to G013.
- Wires G016-A have no eyelets and connect X260-3 to G011-3 and connect X261-3 to G012-2.

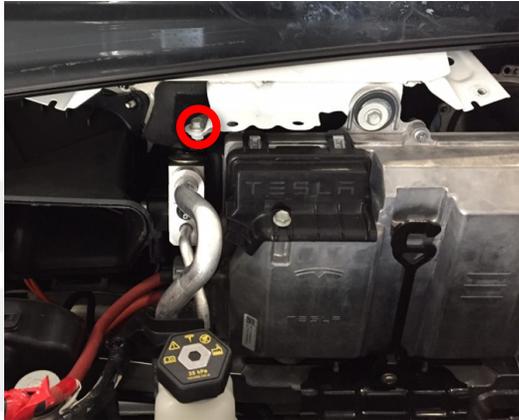
Figure 2

3. Remove the cowl screen panel (refer to Service Manual procedure 12250902).
4. Disconnect 12V power (refer to Service Manual procedure 17010200).
5. Remove and discard the ground terminal bolt at VCFRONT (Figure 2).

6. Use compressed air to clean any debris or shavings from the weld nut.
7. Hand install a new bolt, and then torque the bolt to 8 Nm.
8. Remove and discard the ground terminal bolts on the LH shear wall (Figure 3).

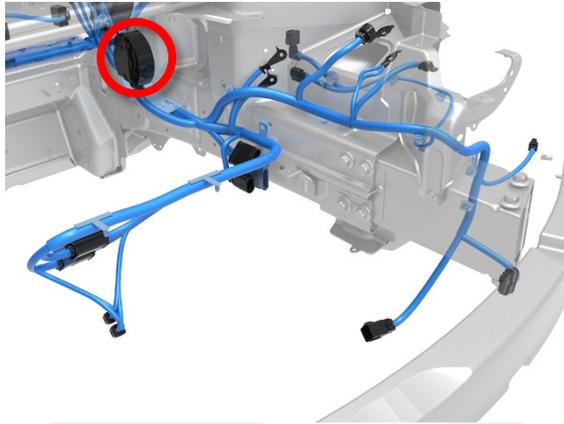
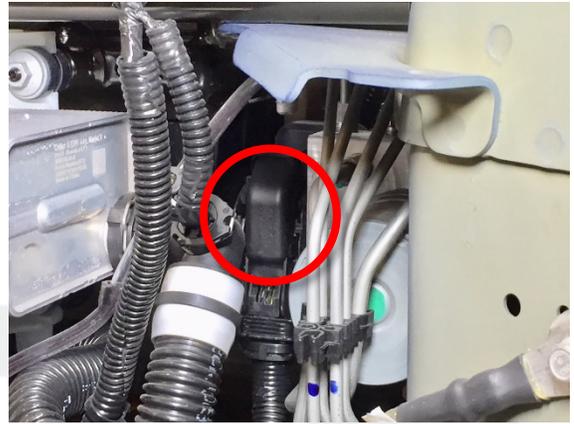
Figure 4 (Connector X151 location)

11. Disconnect connector X151 from the ABS modulator (Figures 4 and 5).

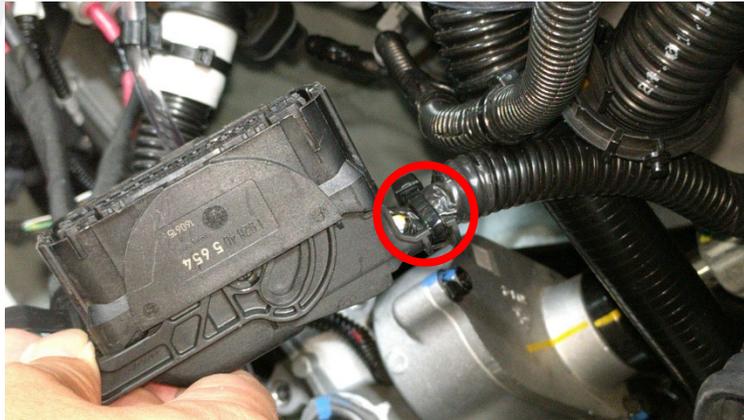
Figure 6

12. Carefully remove the cable tie that secures the electrical harness to the connector X151 backshell (Figure 6).

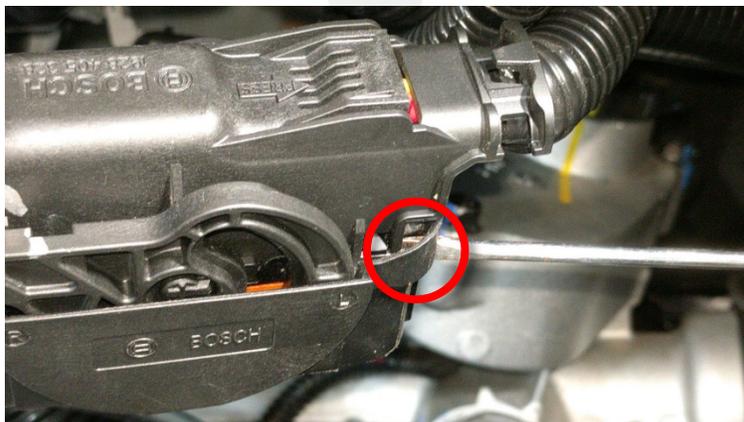
Figure 7

13. Release the clips that secure the connector backshell to the connector body, and then remove the backshell from the connector body (Figure 7).

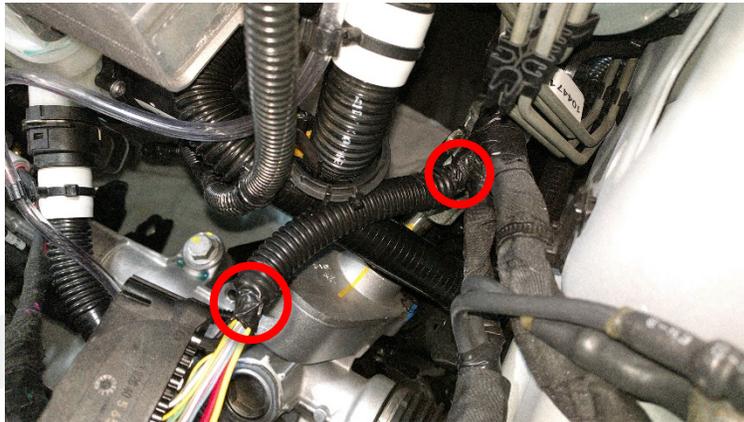
Figure 8

14. Remove the electrical tape from both ends of the corrugated tubing surrounding the electrical harness at connector X151 (Figure 8).

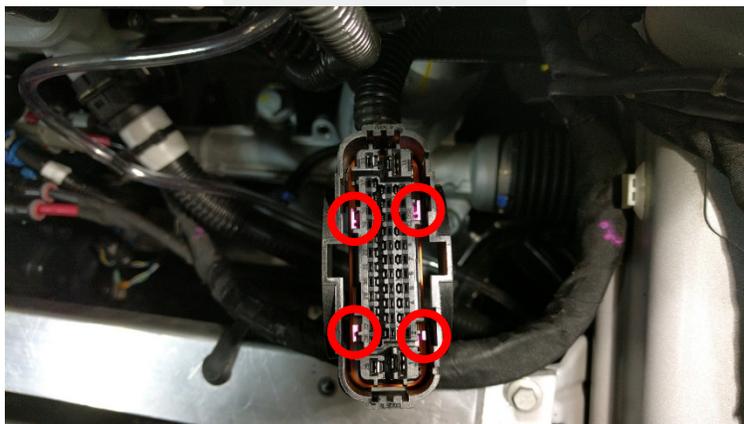
Figure 9 (Slide up to open, down to close)

15. Slide the terminal locking clips (x4) on connector X151 up towards the harness, to the open position (Figure 9).

18. Insert the terminal end of wire G030-A into connector X151 at pin 13 (Figure 10).
19. Slide the terminal locking clips (x4) on connector X151 down away from the harness, to the closed position (Figure 9).
20. Insert wire G030-A into the corrugated tubing and tape both ends of the tubing with electrical tape (Figure 8).
21. Install the connector X151 backshell onto the connector body, and then fasten the clips that secure the backshell to the body (Figure 7).
22. Install a cable tie to secure the electrical harness to the connector X151 backshell, and then remove excess cable tie (Figure 6).
23. Connect connector X151 to the ABS modulator (Figures 4 and 5).
24. Route wire G030-A along the electrical harness and forward across the LH shear wall to ground point G013 (Figure 11).

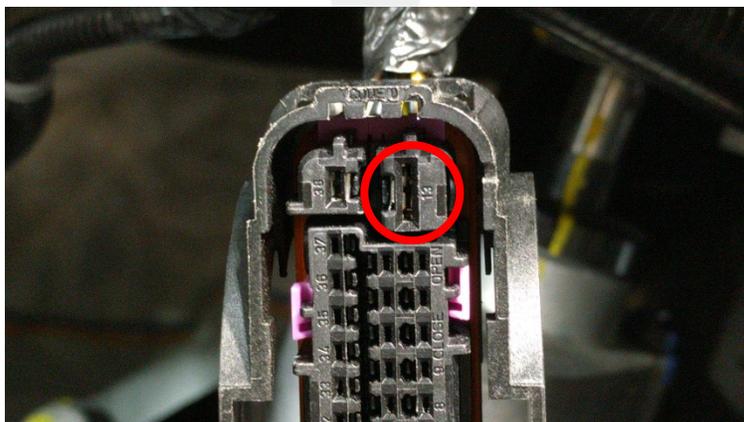
Figure 10 (Pin 13)

16. Use the pin drag kit to extract pin 13 (black wire) from the connector (Figure 10).

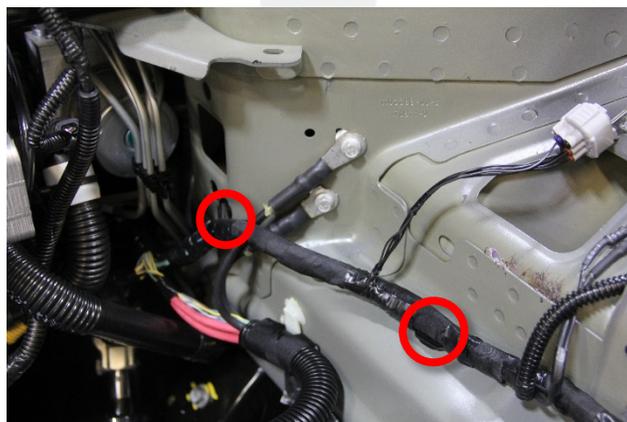
Figure 12 (Harness clips)

25. Release the electrical harness clips (x2) from the body along the wire path (Figure 12).

19. Insert the terminal end of wire G016-A into connector G011 at pin 3 (Figure 26).
20. Install the terminal locking cover into connector G011 (Figure 25).
21. Connect ground connector G011 to the LH shear wall ground receptacle (Figures 23 and 24).
22. Fasten the electrical harness clips to the body (Figure 12).

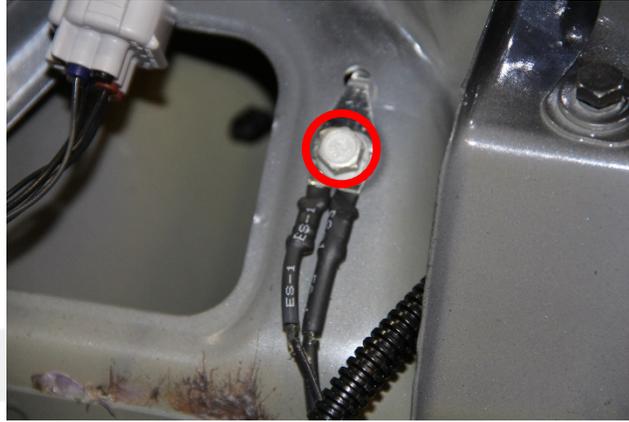
Figure 13

27. Remove and discard the bolt that secures ground terminal G013 to the LH shear wall (Figure 13).

31. Secure ground terminal G013 to the LH shear wall with a new bolt (Figure 13).

- a) Use compressed air to clean any debris or shavings from the weld nut.
- b) Hand install a new bolt, and then torque the bolt to 8 Nm.

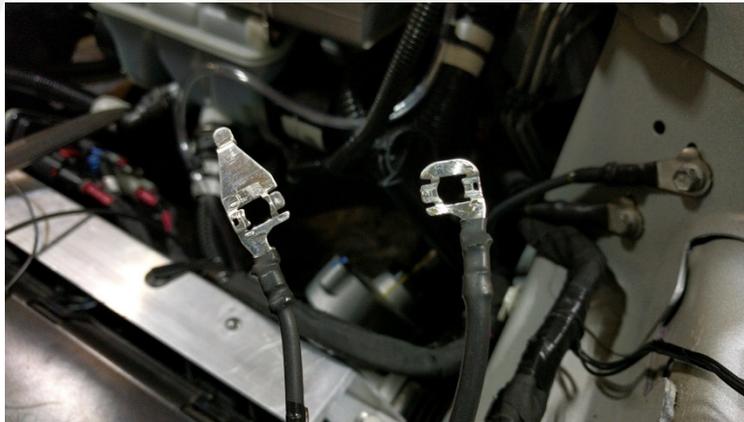
Figure 14 (LH and RH eyelets)

28. Separate the RH and LH eyelets of ground terminal G013 (Figure 14).

29. Cut the RH eyelet from the black wire.

NOTE: The RH eyelet is stamped with an "R".

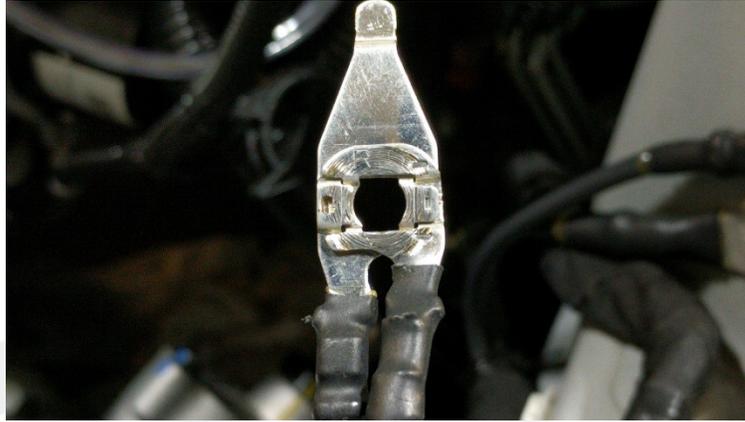
Figure 15

30. Join the new RH and old LH eyelets together to make ground terminal G013 (Figure 15).

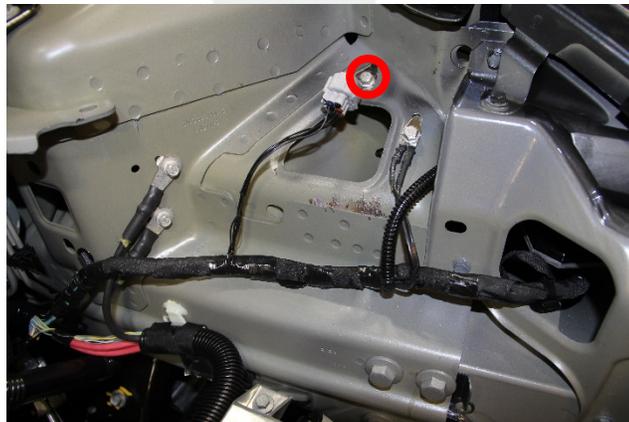
Figure 16

1. Remove and discard the ground terminal bolt that secures connector G011 to the LH shear wall (Figure 16).

2. Use compressed air to clean any debris or shavings from the weld nut.
3. Hand install a new bolt, and then torque the bolt to 8 Nm.

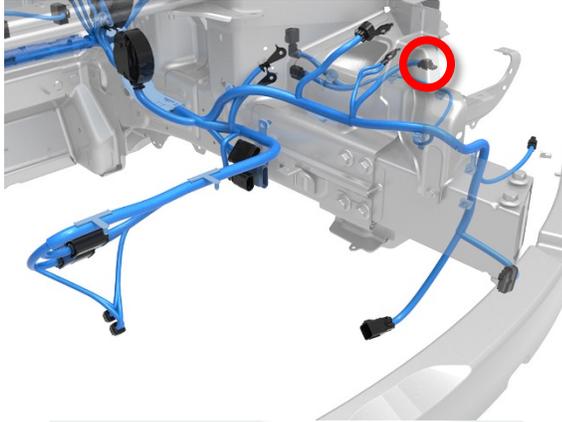
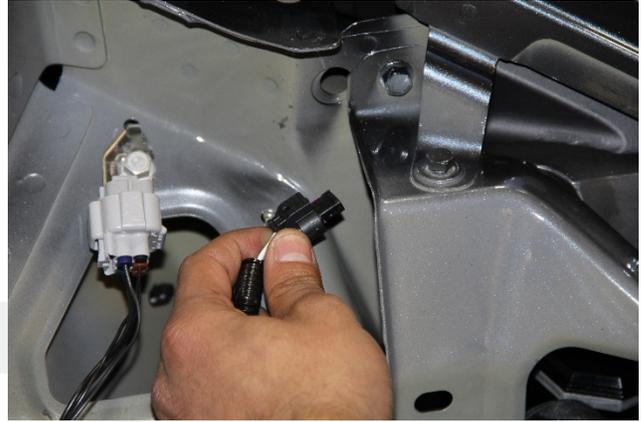
Figure 17 (Connector X260 location)

4. Disconnect connector X260 from the LH headlight (Figures 17 and 18).

12. Connect connector X260 to the LH headlight (Figures 17 and 18).
13. Route wire G016-A along the electrical harness, down, and back up to ground connector G011 (Figure 22).

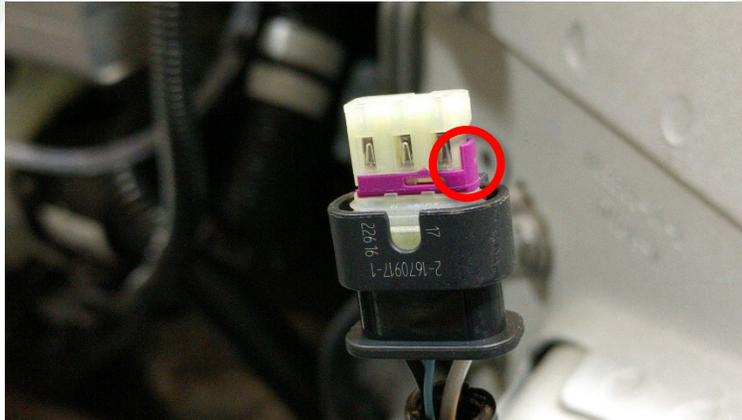
Figure 19 (Slide out to open, in to close)

5. Slide the terminal locking clip on connector X260 out to the open position (Figure 19).

8. Cut the exposed terminal from the extracted black wire.
9. Insert the correct end of wire G016-A into connector X260 at pin 3 (Figure 20).
10. Slide the terminal locking clip on connector X260 into the closed position (Figure 19).
11. Bundle the wires at the connector and secure them with electrical tape (Figure 21).

5. Slide the terminal locking clip on connector X261 out to the open position (Figure 19).

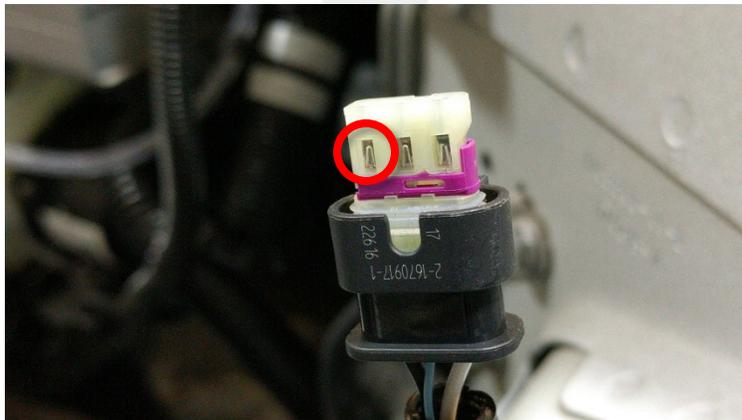
Figure 20 (Pin 3)

6. Use the pin drag kit to extract pin 3 (black wire) from the connector (Figure 20).

6. Use the pin drag kit to extract pin 3 (black wire) from the connector (Figure 20).
7. Compare the exposed terminal with the ends of wire G016-A to determine the correct end to insert into connector X261.
8. Cut the exposed terminal from the extracted black wire.
9. Insert the correct end of wire G016-A into connector X261 at pin 3 (Figure 20).
10. Slide the terminal locking clip on connector X261 into the closed position (Figure 19).
11. Bundle the wires at the connector and secure them with electrical tape (Figure 21).
12. Connect connector X261 to the RH headlight (Figures 28 and 29).
13. Route wire G016-A along the electrical harness, down, and back up to ground connector G012 (Figure 30).

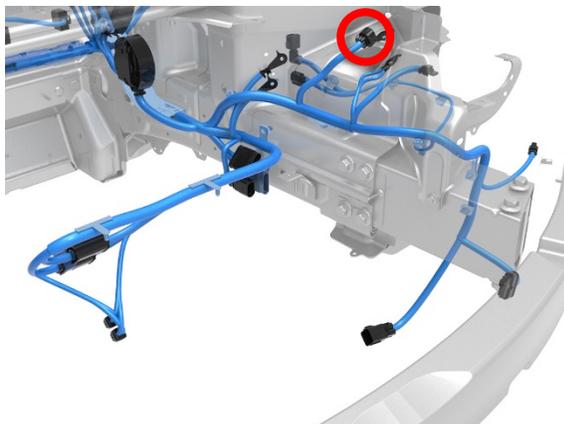
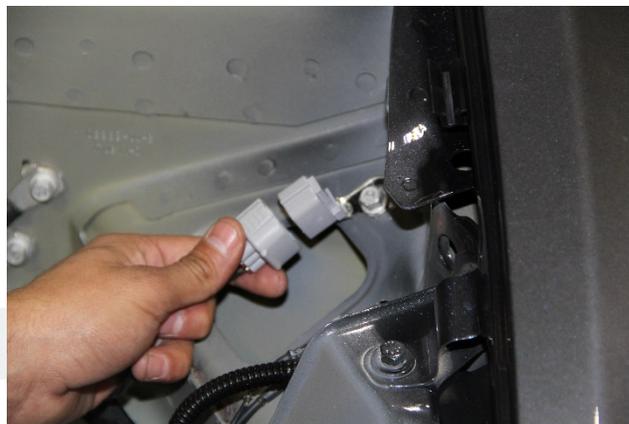
Figure 23 (Connector G011 location)

15. Disconnect ground connector G011 from the LH shear wall ground receptacle (Figures 23 and 24).

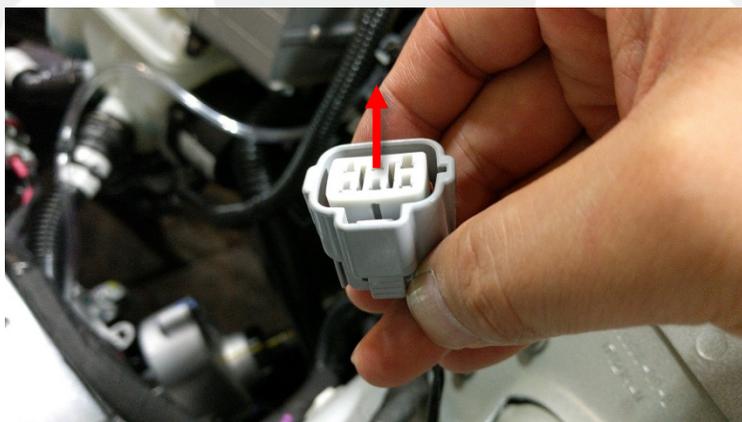
Figure 25 (Removal direction shown)

16. Remove the terminal locking cover from connector G011 (Figure 25).

17. Remove the terminal locking cover from connector G012 (Figure 25).

21. Install the terminal locking cover into connector G012 (Figure 25).

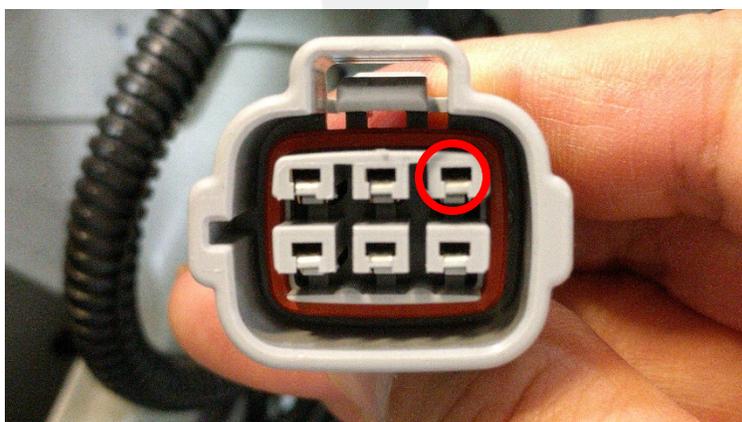
Figure 26 (Pin 3)

17. Use the pin drag kit to extract pin 3 from the connector (Figure 26).

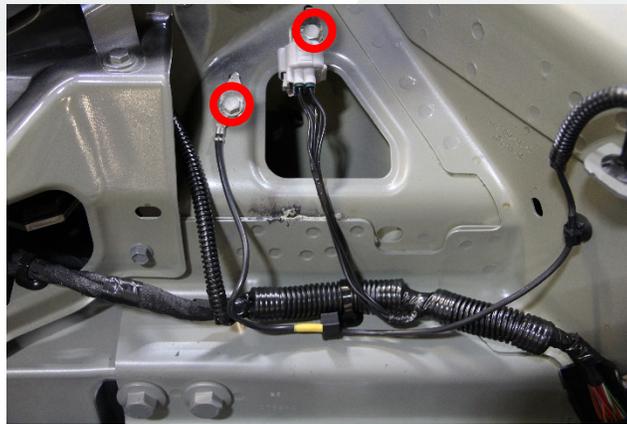
Figure 27

1. Remove and discard the ground terminal bolts on the RH shear wall, as identified in Figure 27.

2. Use compressed air to clean any debris or shavings from the weld nuts.
3. Hand install a new bolt in both locations on the RH shear wall, and then torque the bolts to 8 Nm.
4. Disconnect connector X261 from the RH headlight (Figures 28 and 29).

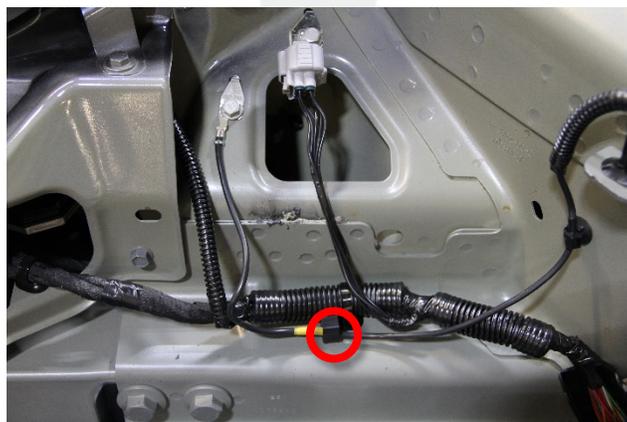
Figure 31 (Harness clip)

14. Release the electrical harness clip from the body along the path (Figure 31).

23. Fasten the electrical harness clip to the body (Figure 31).

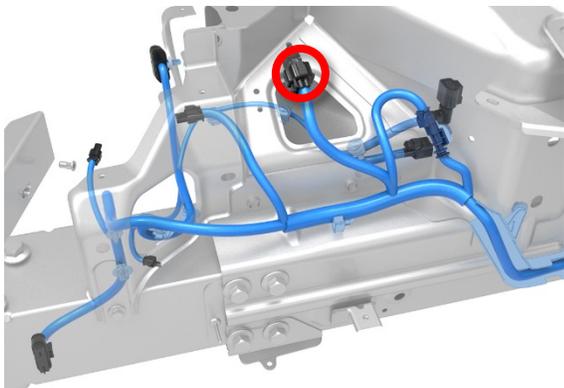
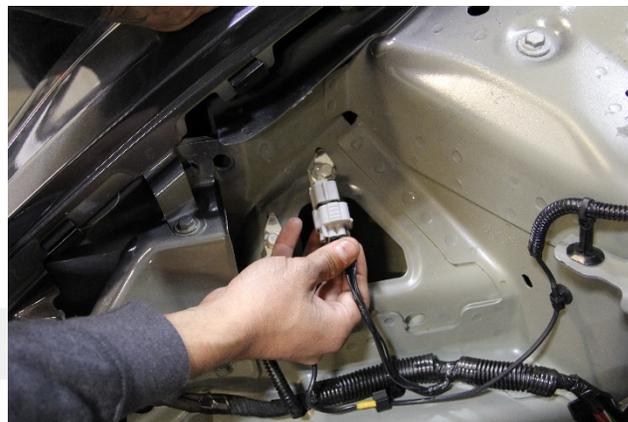
Figure 32 (Connector G012 location)

16. Disconnect ground connector G012 from the RH shear wall ground receptacle (Figures 32 and 33).

22. Connect ground connector G012 to the RH shear wall ground receptacle (Figures 32 and 33).

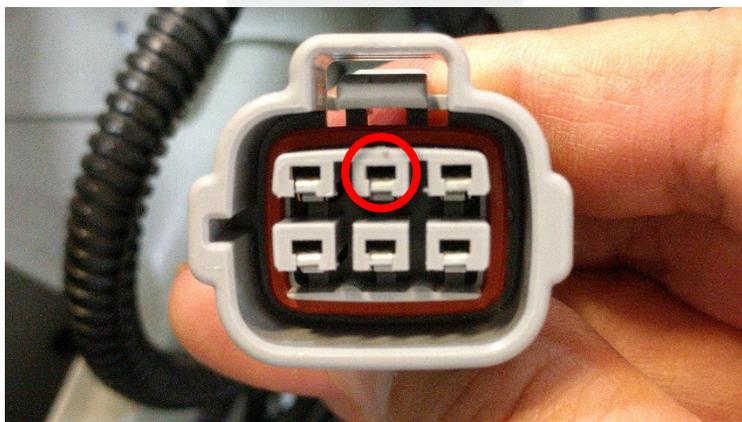
Figure 34 (Pin 2)

18. Use the pin drag kit to extract pin 2 from the connector (Figure 34).

20. Insert the terminal end of wire G016-A into connector G012 at pin 2 (Figure 34).

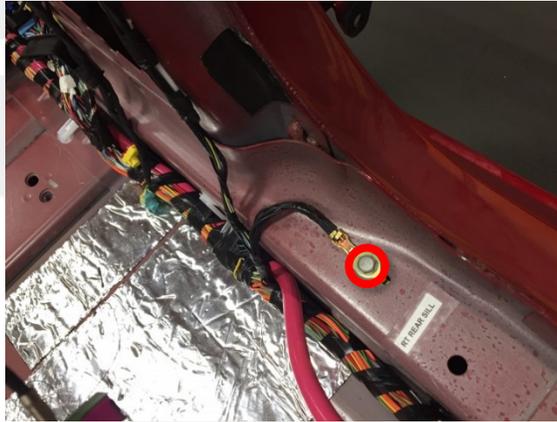
Figure 35

1. Remove the nuts that secure the car computer to the body.
2. Remove the RH lower B-pillar trim (refer to Service Manual procedure 15183402).
3. Remove and discard the ground terminal bolt, located to the rear of the B-pillar (Figure 35).

4. Use compressed air to clean any debris or shavings from the weld nut.
5. Hand install a new bolt, and then torque the bolt to 8 Nm.
6. Remove the RH footwell cover (refer to Service Manual procedure 14055402).
7. Remove the RH center console side panel carpet (refer to Service Manual procedure 15195402).

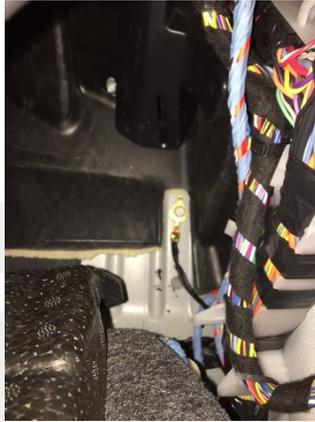
Figure 36

8. Release the clips (x3) that secure the carpeting to the body in the RH footwell, and then pull back the carpeting to expose the RH toeboard ground terminal (Figure 36).

NOTE: The foam on the back of the carpet resists pulling the carpet back.

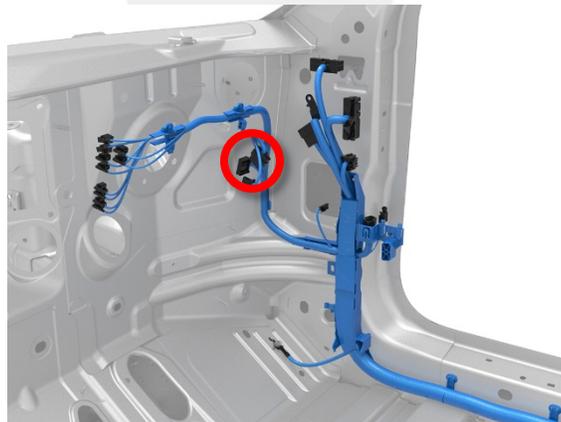
Figure 37 (Connector X172 and X121 locations)

9. Disconnect connectors X172 (black) and X121 (white) from the car computer (Figure 37).

15. Connect connectors X121 and X172 to the car computer (Figure 37).

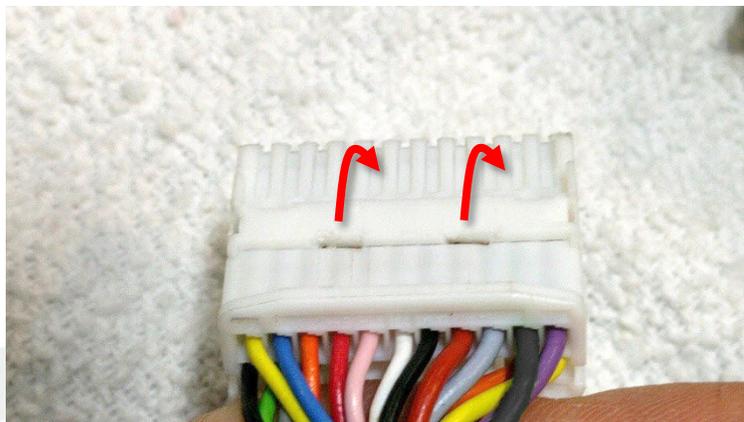
Figure 38 (Opening direction shown)

10. Open the terminal locking clips on connector X121 (Figure 38).

14. Close the terminal locking clip on connector X121 (Figure 38).

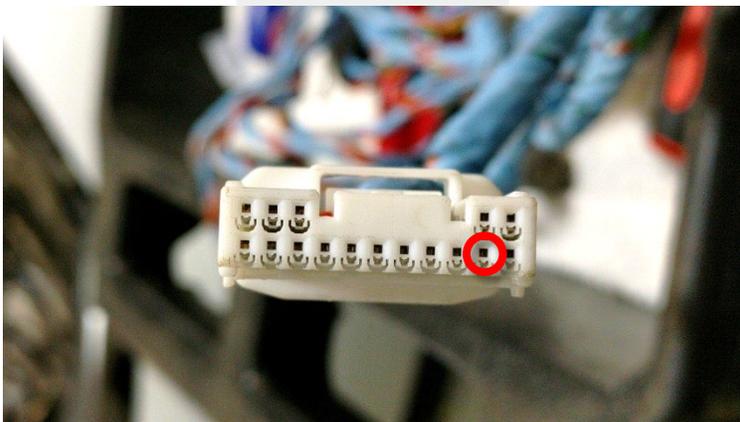
Figure 39 (Pin 15)

11. Use the pin drag kit to extract pin 15 (black wire) from the connector (Figure 39).

⚠ CAUTION: If there is a green wire at pin 15, stop this procedure and contact Service Engineering for further instruction.

13. Insert the terminal end of wire G050-A into connector X121 at pin 15 (Figure 39).

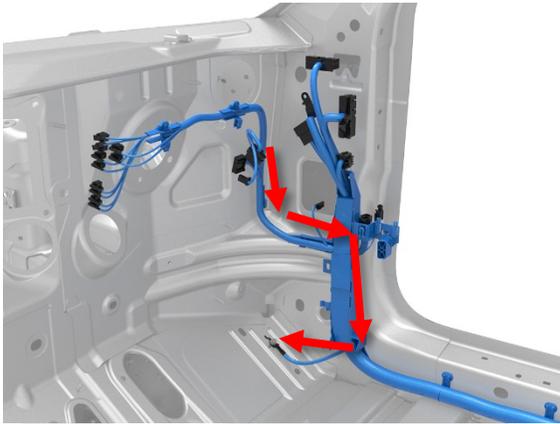
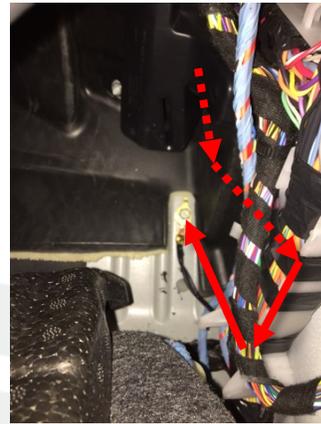
Figure 40 (Wire path location)

17. Route wire G050-A along the electrical harness and down to the RH toeboard ground terminal G022 (Figures 40 and 41).

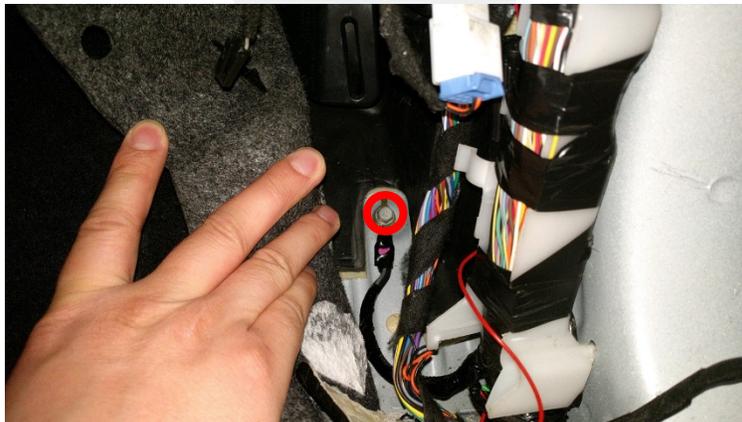
Figure 42

19. Remove and discard the bolt that secures ground terminal G022 to the RH toeboard (Figure 42).

22. Secure the terminals to the RH toeboard with the new bolt (Figure 42).
 - a) Use compressed air to clean any debris or shavings from the weld nut.
 - b) Hand install a new bolt, and then torque the bolt to 8 Nm.
23. Push the carpeting forward and fasten the clips (x3) that secure the carpeting to the body in the RH footwell.
24. Install the RH center console side panel carpet (refer to Service Manual procedure 15195402).
25. Install the passenger footwell cover (refer to Service Manual procedure 14055402).
26. Install the RH lower B-pillar trim (refer to Service Manual procedure 15183402).
27. Install the cowl screen panel (refer to Service Manual procedure 12250902).

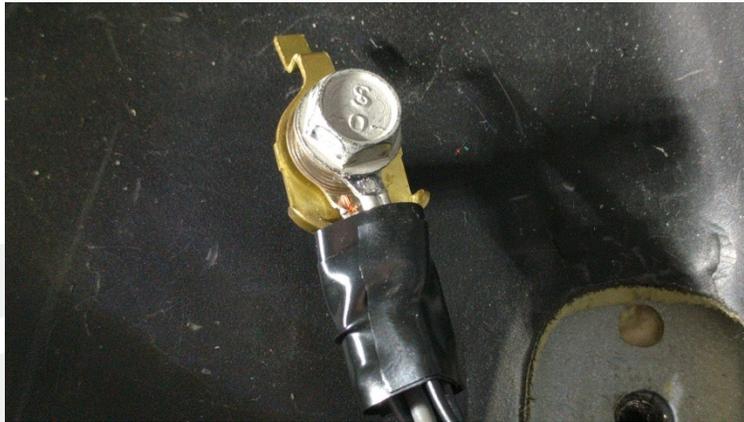
Figure 43

21. Insert a new bolt to temporarily align the eyelet of wire G050-A on top of ground terminal G022, and then wrap both terminal shanks with electrical tape (Figure 43).

NOTE: Do not wrap the bolt or eyelets with tape.

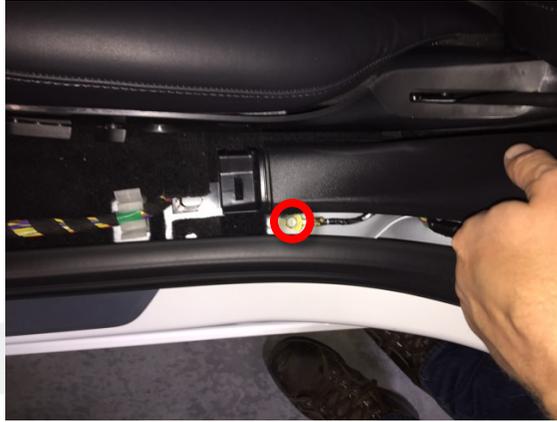
Figure 44

2. Remove and discard the ground terminal bolt adjacent to the driver seat, at the B-pillar (Figure 44).

3. Use compressed air to clean any debris or shavings from the weld nut.
4. Hand install a new bolt, and then torque the bolt to 8 Nm.
5. Remove the driver footwell cover (refer to Service Manual procedure 14055302).
6. Remove the LH center console side panel carpet (refer to Service Manual procedure 15195402).
7. Release the clips (x3) that secure the carpeting to the body in the LH footwell, and then pull back the carpeting to expose the LH toeboard ground terminal (Figure 45).

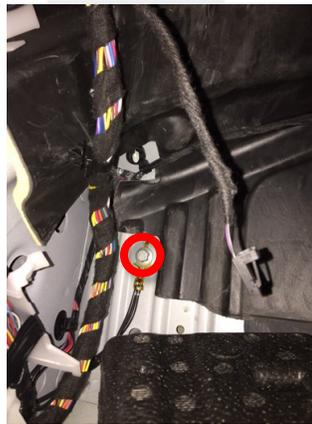
Figure 45

8. Remove and discard the ground terminal bolt on the LH toeboard (Figure 45).
9. Use compressed air to clean any debris or shavings from the weld nut.
10. Hand install a new bolt, and then torque the bolt to 8 Nm.
11. Push the carpeting forward and fasten the clips (x3) that secure the carpeting to the body in the LH footwell.

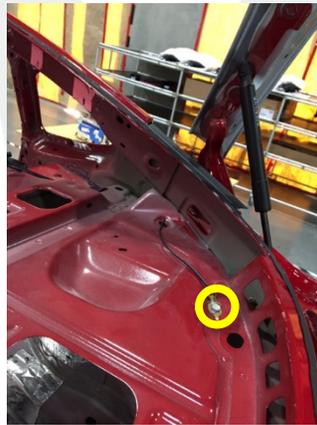
Figure 46

1. Remove the package tray trim (refer to Service Manual procedure 15243002).
2. Remove and discard the ground terminal bolt on the parcel shelf (Figure 46).

3. Use compressed air to clean any debris or shavings from the weld nut.
4. Hand install a new bolt, and then torque the bolt to 8 Nm.
5. Install the package tray trim (refer to Service Manual procedure 15243002).

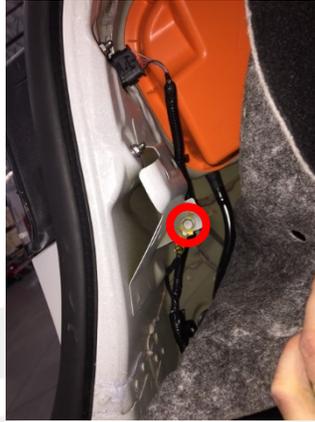
Figure 47

3. Remove and discard the ground terminal bolt on the LH rear quarter below the taillight (Figure 47).

4. Use compressed air to clean any debris or shavings from the weld nut.
5. Hand install a new bolt, and then torque the bolt to 8 Nm.
6. Remove and discard the ground terminal bolt on the RH rear quarter, below the taillight and rear of the amplifier (Figure 48).

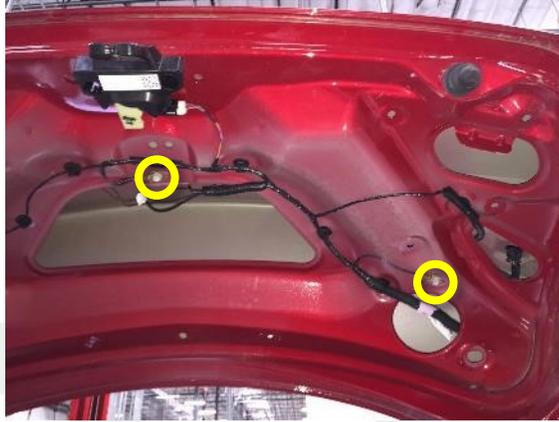
Figure 49

12. Remove and discard the ground terminal bolts (x2) on the underside of the trunk lid (Figure 49).

13. Use compressed air to clean any debris or shavings from the weld nuts.

14. Hand install a new bolt in both locations, and then torque the bolts to 8 Nm.
