Roadster Issue Articles

Article #22638 - "Check left/right back turn signal bulb" alert, with improper output from switchpack

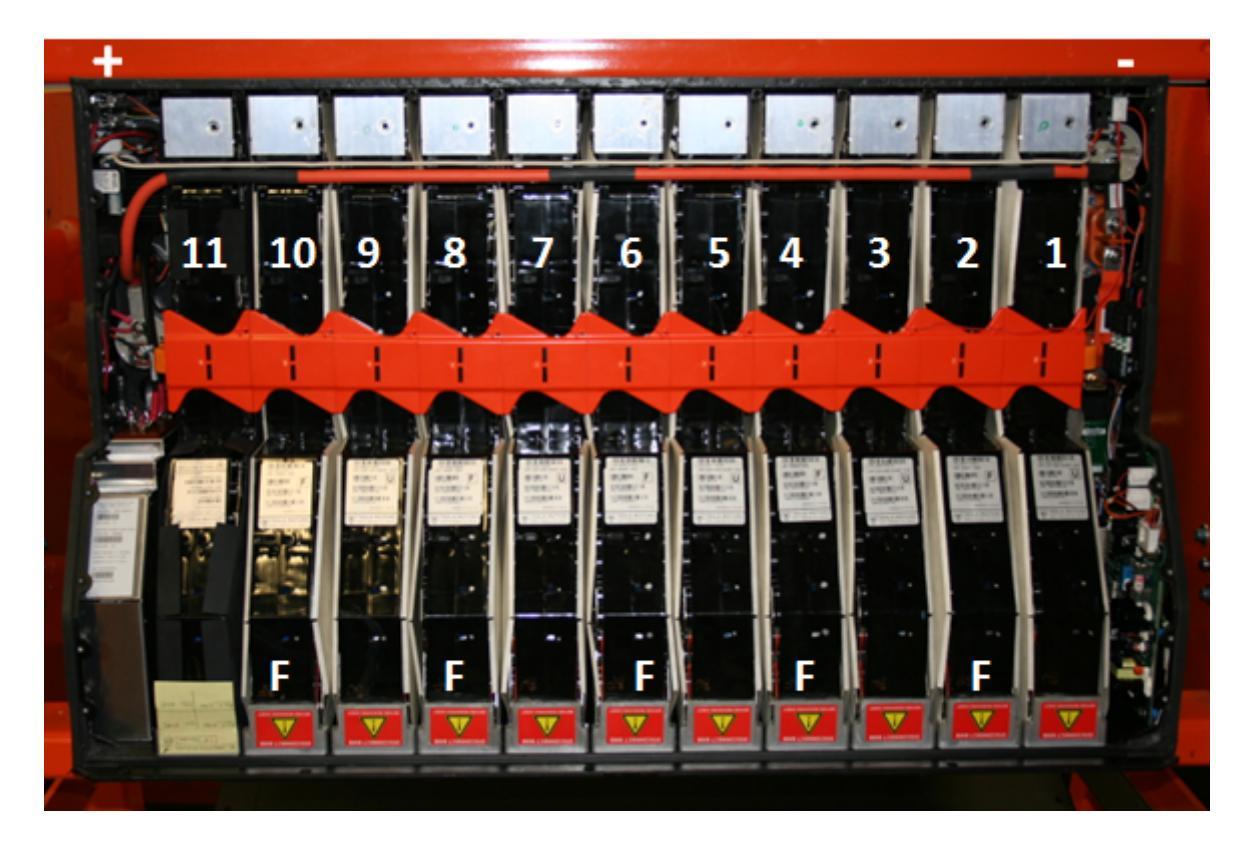
- 1. Obtain the log files using the MTS-2/Engineering Tool.
- 2. Read the sheet number and brick number overvoltage from the log. (Sheet number brick (1-11) / Thermistor number (1-9))
- 3. Read the voltage from MTS-2/Linux-based Engineering Tool to verify brick failures for both a high and low voltage adjacent to each other.

If there are adjacent high and low voltages, replace the BMB, and verify that the fault has been resolved. If the fault

does not clear, escalate your session for assistance. Otherwise, pursue possible causes to investigate further.

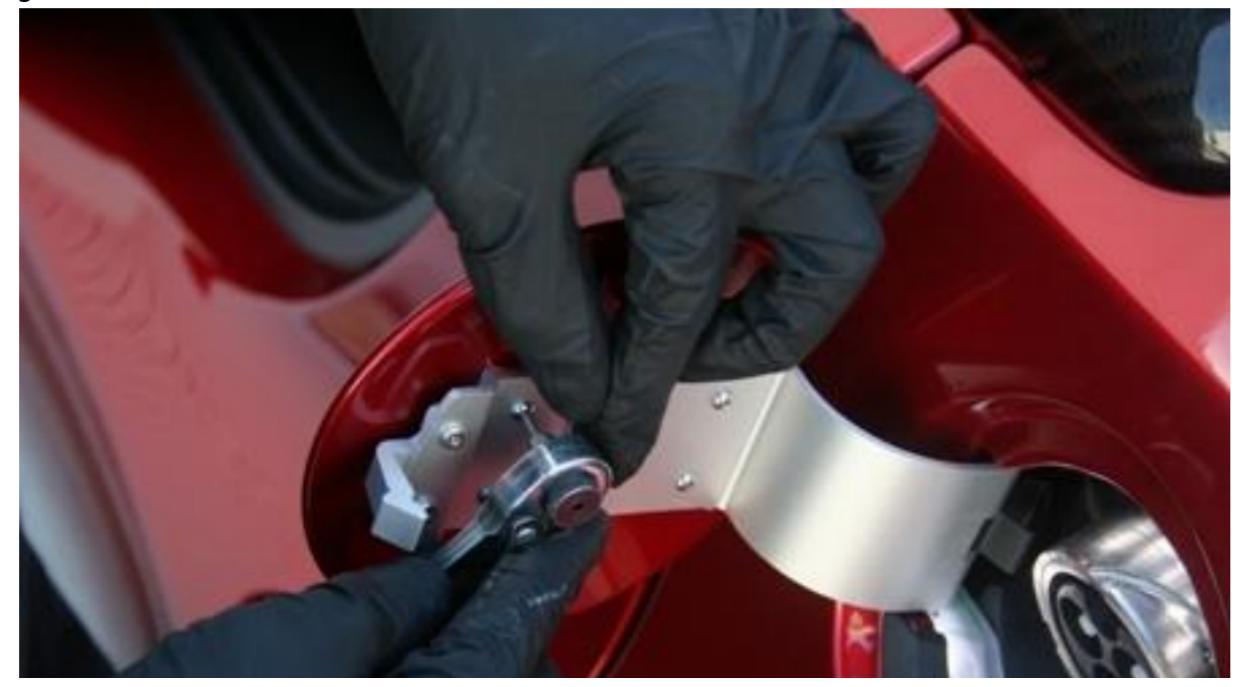
Due to an incorrect bonding process from the supplier, it is possible the painted charge door may separate from the mounting plate. A new bonding process and material has been developed to ensure the charge door will pass a 30lb. pull test. This bond strength will surpass any requirements in the field. If the charge door panel has disengaged and has been damaged, replace the entire charge door with the new complete part and have it painted to match. Be sure to follow the steps exactly to ensure a quality bond.

1. If door has broken off remove 4 screws holding mounting plate to charge door hinge. (picture shown with charge door attached)

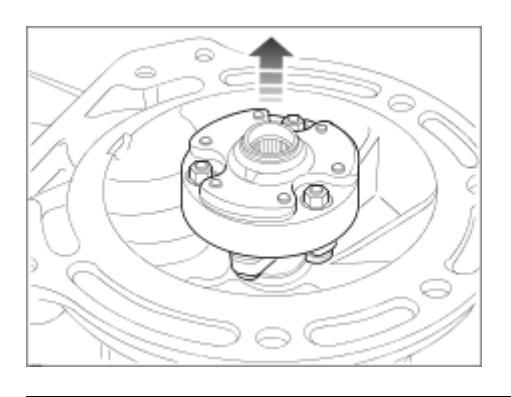
- 1. Attempt to duplicate concern by driving the vehicle at low speed and shifting from drive to reverse or on off throttle application.
- 2. The noise may be caused by a loose or damaged transmission mount or in some cases a damaged or loose drive coupler between the motor and transmission.
- 3. If the noise is present, then this is likely your issue.

If concern persists the noise may be caused by a loose drive coupler between the motor and transmission. Removal of the PEM and drive motor assembly will be required to inspect this component. You will also need to separate the motor from the transmission assembly (special tools are required) See the Service Manual procedure: DRIVE COUPLER - MOTOR TO TRANSMISSION - ROADSTER 1.5 - Correction code 47030402

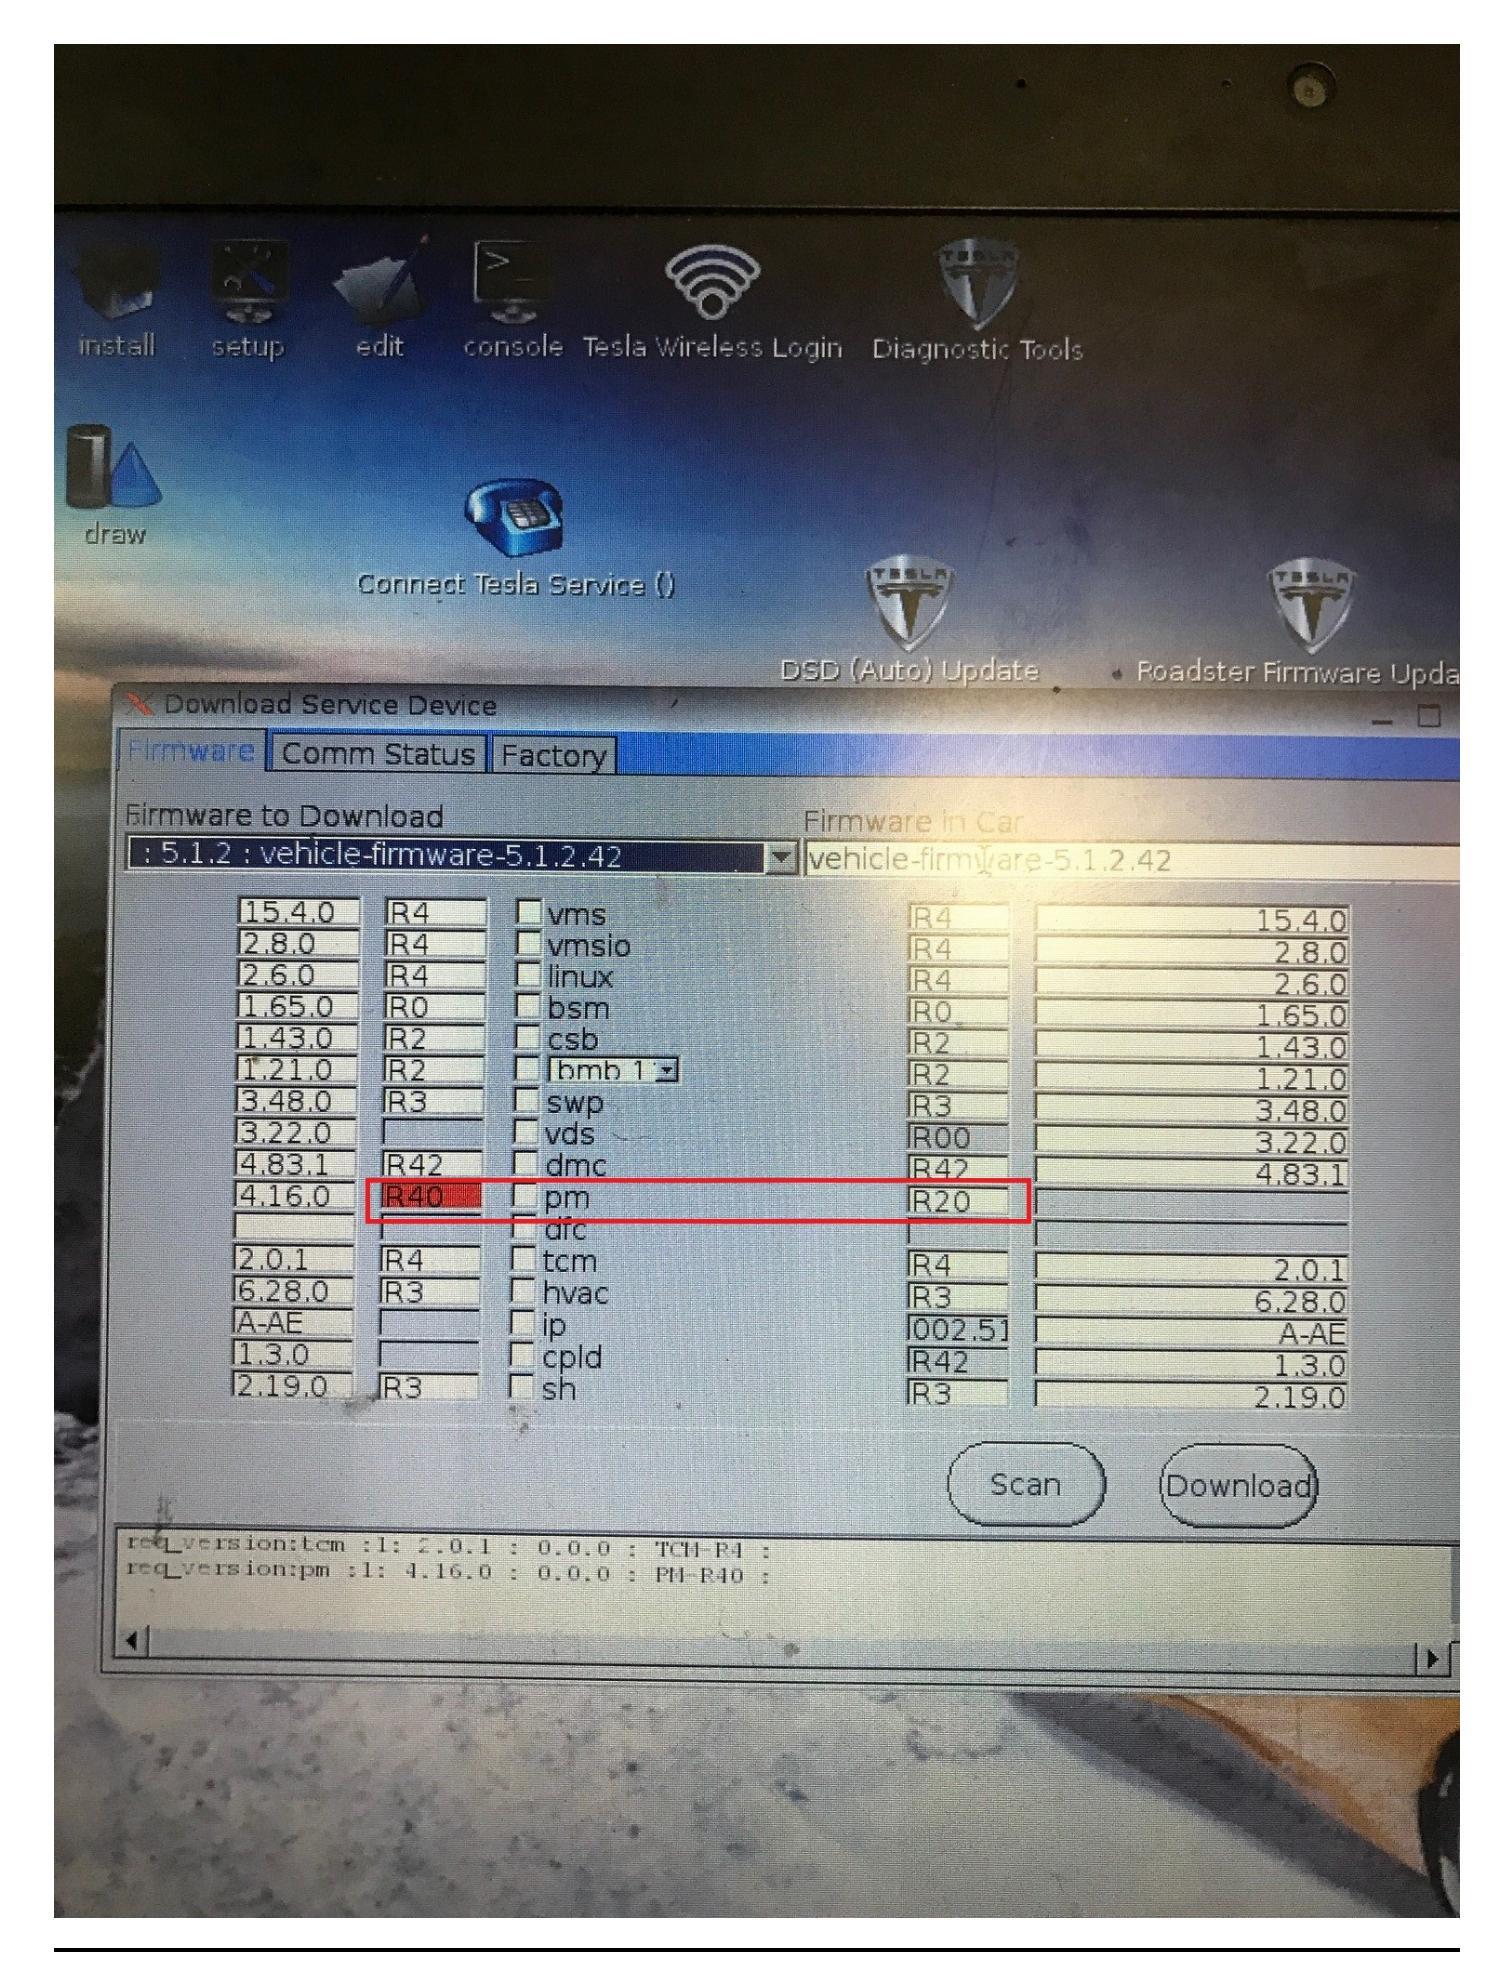
- 1. Open the Roadster Firmware Update tool.
- 2. Navigate to the Factory Tab.
- 3. Click STOP VMS.
- 4. Navigate to the Firmware Tab.
- 5. Click SCAN.
- 6. Select the firmware package you intend to download to the vehicle from the drop down in the upper left.
- 7. compare the second column of the intended package to the first column of the vehicle firmware. In the example below, the firmware package requires R40, while the installed component is R20. If you cannot communicate with the PM, both columns on the vehicle package would be blank.

Bootloader updates cannot be done in Service. MRB the component so that it can be updated in remanufacturing and re used. Order a new PEC board.

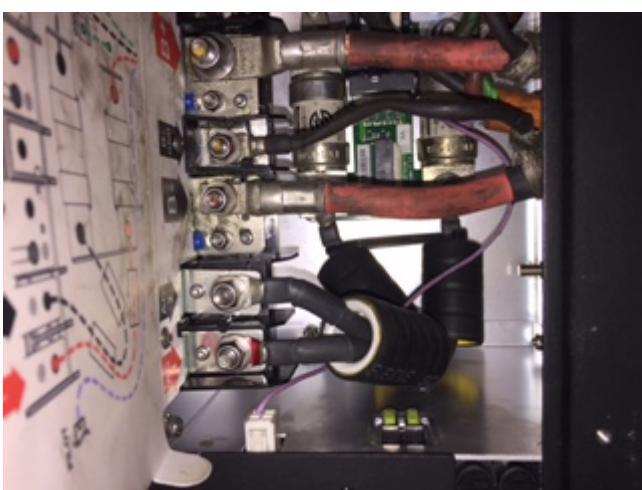
3. Inspect two yellow mini fuses pictured below:

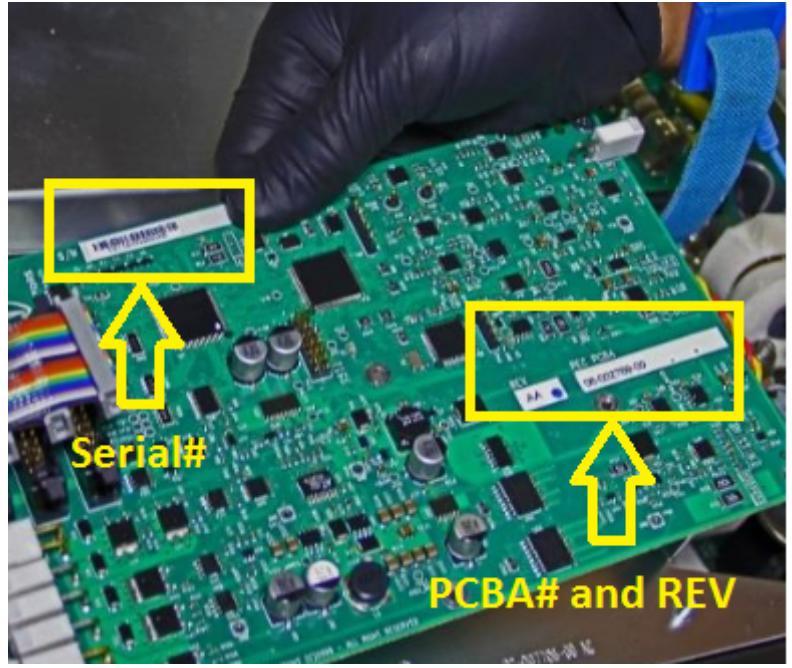
- 1. Check ASY-Number or PCBA-Number on PEC Board.
 - This number may be covered by a label stating the 3.0 PEC-board PN 1071438-00-A
- 2. Verify the numbers match the 3.0 Requirements below:
 - **PEM 2.0 PEC PCBA Base = DO NOT USE FOR 3.0** ASY: 06-002583-00 PCBA: 09-000232-00 Rev AA
 - **PEM 2.01 PEC PCBA Sport =** <u>OK TO USE FOR 3.0</u> ASY: 06-002769-00 PCBA: 09-000232-00 Rev AB

Location of the serial number and the RCBA rev number on the PEC board:

- 1. If an incompatible PEC-board was sent and installed, please order a new PEC-board (PN 1071438-00-A) from Fremont and return the incompatible board through MRB.
 - All 3.0 PEC-Boards distributed as of September 2017 should match the Hardware requirements.
