Tesla, Inc. Service Bulletin	Rework Electrical Harness Due To Water Ingress	
SB-20-17-002 February 29, 2020		R1		
Classification		Section/Group		Mobile Service
Campaign Bulletin		17 - Electrical		Can Perform (where permitted)
Model Year	Model	Country/Region		Version
2019	Model 3	Europe, Middle East, Africa, Asia Pacific		RHD
The model(s) and model year(s) listed are a general approximation of the affected VIN list. Refer to the VIN/Bulletin Tracker or Customer/Vehicle profile to determine applicability of this bulletin for a particular vehicle.

On certain RHD Model 3 vehicles, the front main harness upper CAN connectors to the steering rack might not have been properly weatherproofed. Consequently, water might have entered the connectors, and possibly corroded the terminals.

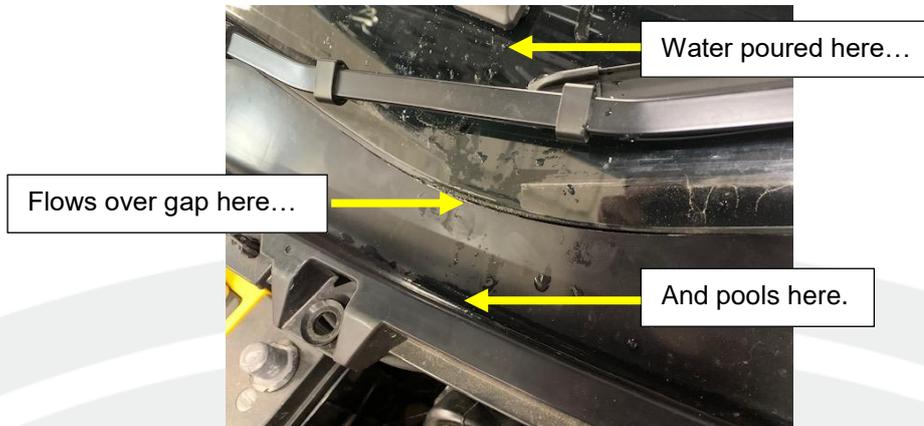
Figure 1

**NOTE:** A gap is tight when poured water flows over the gap and not through it (Figure 1).

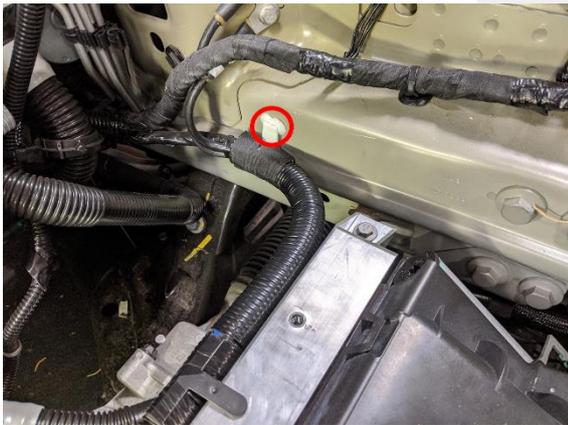
Figure 20 – RWD vehicles have 1 clip

1. Release the clips that attach the main front harness to the LH frame rail (Figures 20 and 21).

11. Fasten the clips that attach the main front harness to the LH frame rail (Figures 20 and 21).
12. Install the underhood storage unit (refer to Service Manual procedure 15240702).
13. Connect 12V power (refer to Service Manual procedure 17010200).

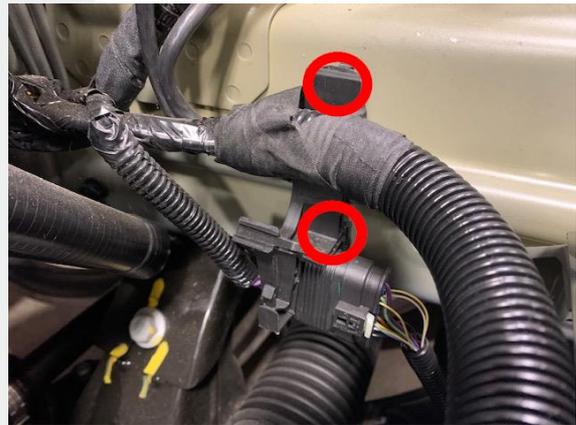
Figure 21 – Dual Motor vehicles have 2 clips

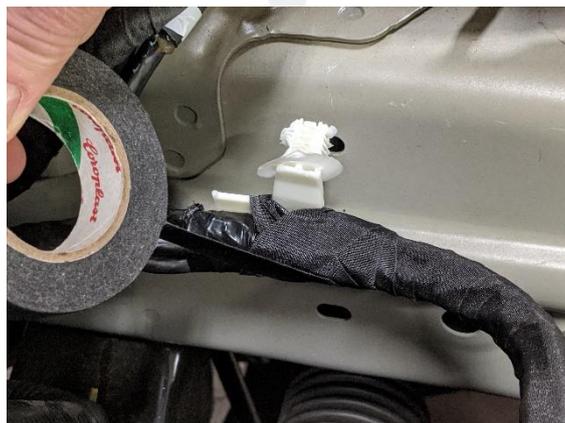
Figure 28 – RWD vehicle frame rail clip shown, Dual Motor vehicle similar

10. If possible, reinstall the corrugated tubing segment, and then use anti-abrasion tape to wrap the corrugated tubing (if installed) and to attach the frame rail clips to the main front harness (Figure 28).
