Tesla, Inc.
Service Bulletin

Install Flat Flex Cable Harness Guide

SB-24-17-004

September 10, 2024

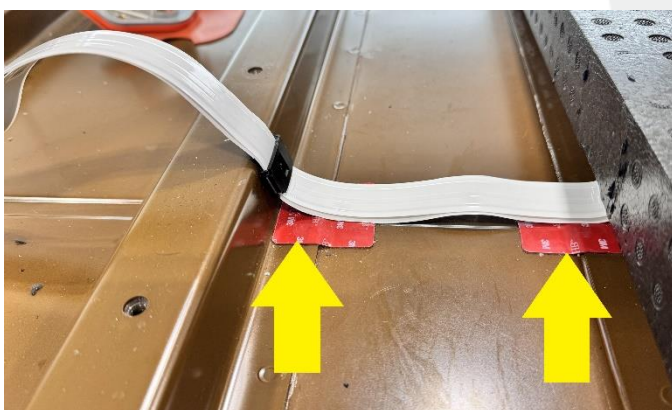
Figure 13 – Red 3M VHB Foam

13. Inspect the rearmost rib under the FFC for the presence of red 3M VHB foam (PN: 1879451-00-B) (Figure 13) or black anti-abrasion tape (Figure 14), or if the tape is missing.

17. If black anti-abrasion tape is available, apply the tape to the vehicle, making sure the tape covers both seams where the FFC may contact the vehicle (Figure 14). If black anti-abrasion tape is not available, apply red 3M VHB Foam to the exposed seam(s) (Figure 13).

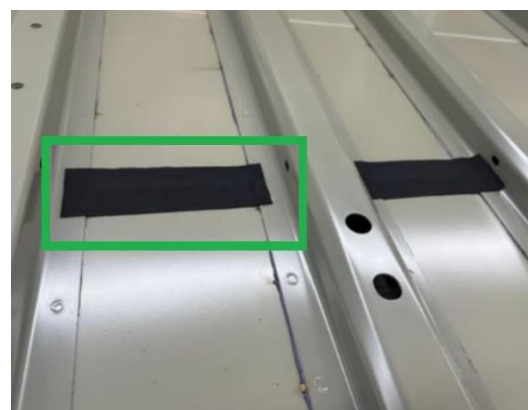
Figure 14 – Black Anti-Abrasion Tape

- If black anti-abrasion tape is installed (Figure 14), no action is required. Skip to step 19.
- If red 3M VHB Foam is installed on both seams (Figure 13), and black anti-abrasion tape is not available, no action is required. Skip to step 19.
- If black anti-abrasion tape is available, or if tape is not installed on either seam, continue to step 14.

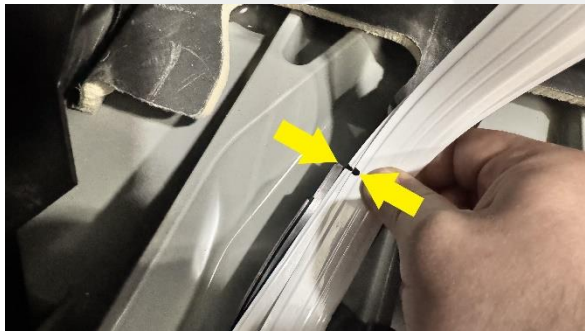
Figure 21 – Mark FFC at front edge of harness guide

23. Position the FFC so that it lays flat on the harness guide, and then use a paint pen to mark the FFC at the front (Figure 21) and rear (Figure 22) edges of the harness guide.

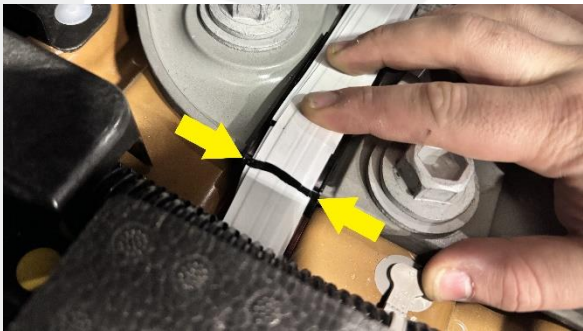
Figure 22 – Mark FFC at rear edge of harness guide

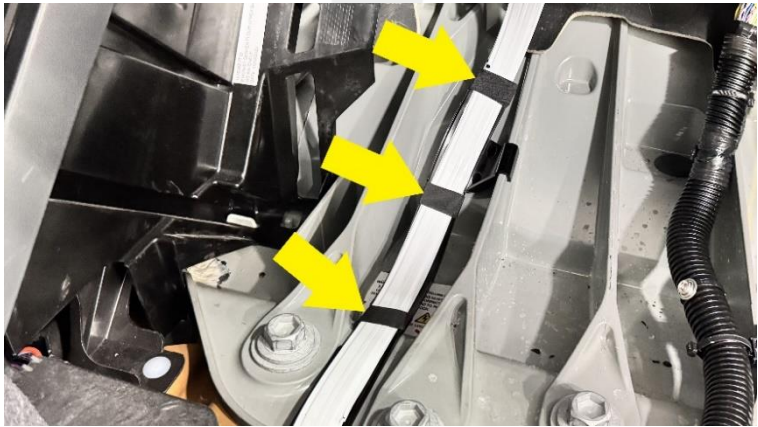
Figure 23 – Electrical tape positions

24. Remove the harness guide from the casting once the FFC has been marked.
25. Position the FFC into the harness guide using the alignment marks (Figures 21 and 22) made in the previous step, and then use electrical tape to secure the harness to the guide.

NOTE: Refer to Figure 23 for electrical tape positions (x3).
