<b>Tesla, Inc.</b> Service Bulletin		<h2 style="margin: 0;">Inspect Front Knuckles And Front Upper Control Arms</h2>	
<b>SB-24-31-001</b> January 4, 2024			
<b>Classification</b>		<b>Section/Group</b>	<b>Mobile Service</b>
Campaign Bulletin		31 - Suspension	Cannot Perform
			Configuration
			All
<b>Model Year</b>	<b>Model</b>	<b>Country/Region</b>	<b>Build Location</b>
2023	Cybertruck	United States	Giga Austin
<small>The model(s) and model year(s) listed are a general approximation of the affected VIN list. Refer to the VIN/Bulletin Tracker or Customer/Vehicle profile to determine applicability of this bulletin for a particular vehicle.</small>

On some Cybertruck vehicles, the Front Upper Control Arms (FUCA) and/or knuckles may require replacement to address possible front suspension noise or separation of the front knuckle from the FUCA.

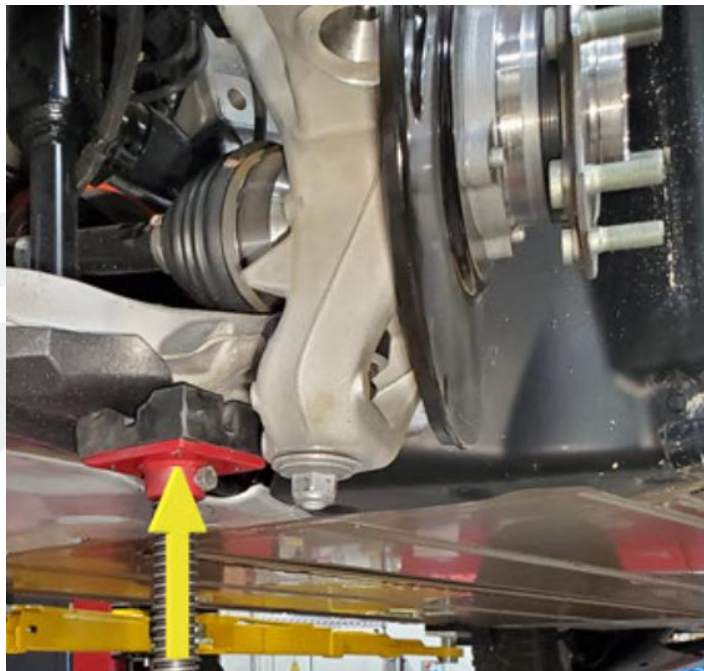
Figure 1

1. Remove both front wheels (refer to Service Manual procedure [34015001](#)).
2. Raise the vehicle to the proper working height, and then engage the safety locks on the 2 post lift (refer to the Service Manual [procedure](#)).
3. Support the LH front lower control arm with the underhoist stand (Figure 1).

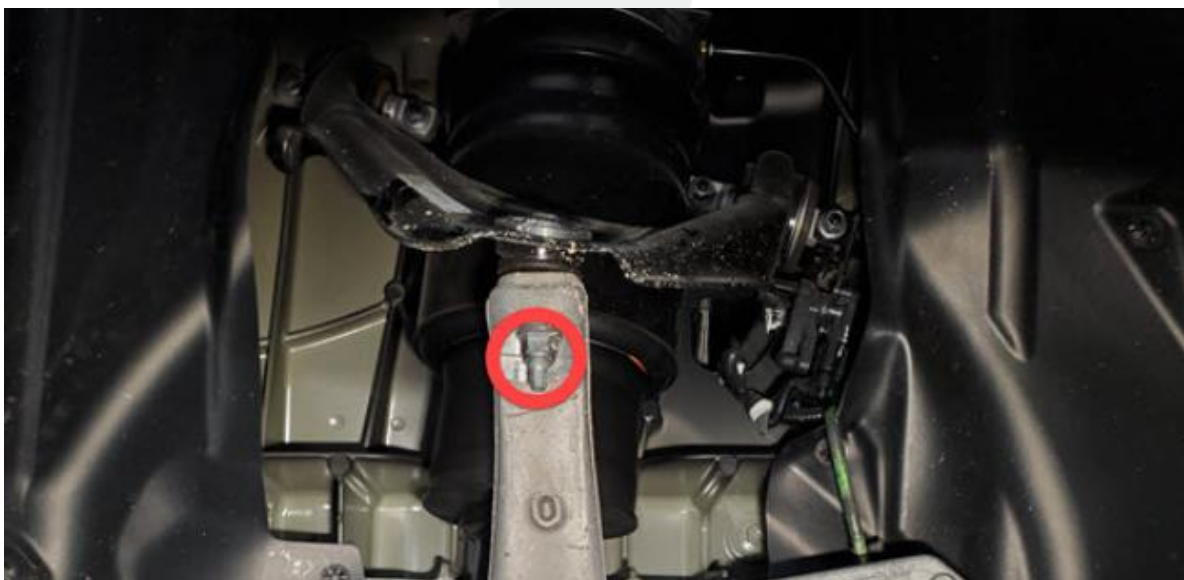
Figure 2

4. Remove and discard the nut that attaches the LH FUCA to the LH front knuckle (torque 85 Nm) (Figure 2).

- If the top of the knuckle has a cone-shaped recess (Figure 3) and the FUCA ball joint stud has an alignment cone (Figure 4), replacement is unnecessary. Position the parts for reinstallation and install a new nut that attaches the LH FUCA to the LH front knuckle (torque 85 Nm) (Figure 2).
