<b>Tesla, Inc.</b> Service Bulletin		<b><i>Inspect Front Seat Back for Unintended Noise</i></b>	
<b>SB-25-13-002</b> July 11, 2025					
<b>Classification</b>		<b>Section/Group</b>	<b>Mobile Service</b>	<b>Configuration</b>	
Repair Bulletin		13 - Seats	Can Perform (where permitted)	All	
<b>Model</b>	<b>Model Year</b>	<b>Country/Region</b>	<b>Build Location</b>		
Model 3	All	Europe, Middle East, Africa	All		
Model Y	All				
Model S	2021+				
Model X	2021+				
Cybertruck	All				
The model(s) and model year(s) listed are a general approximation of the affected VIN list. Refer to the VIN/Bulletin Tracker or Customer/Vehicle profile to determine applicability of this bulletin for a particular vehicle.

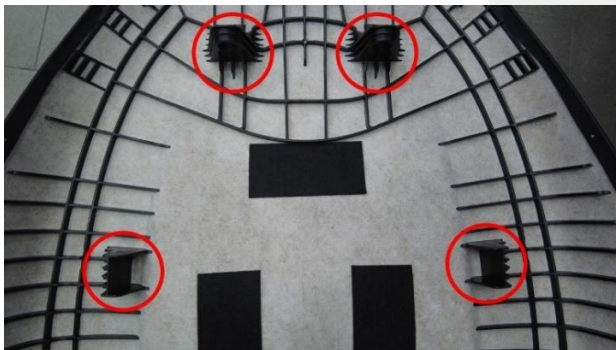
Figure 3 – Clips at top of seat back shell

- **Standard seat:** release the clips (x8) that attach the seat back shell to the seat (Figures 3 and 4), and then remove the seat back shell.

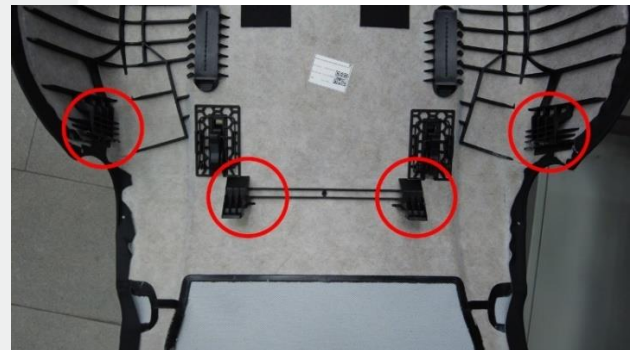
Figure 4 – Clips at bottom of seat back shell
