TN-18-16-001 R3 June 8, 2022

Tesla, Inc. Technical Note
Model:	Vehicle System:	Region:
Model 3 & Model Y (non-Structural)	16 - Battery System	All

Inspect the Model 3 and Model Y (Non-Structural) HV Battery for Underside Damage

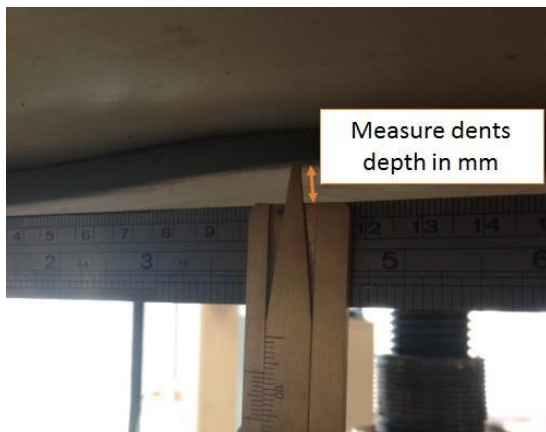
Figure 7 – Measuring the depth of enclosure damage

3. Collect the following information and upload it to the session:
 - a. Several pictures of the damage, taken with a high-resolution camera: If there isn't a visible open hole, crack, or tear, measure the depth of the HV battery enclosure damage (Figure 7) **while wearing proper PPE**. If the damage is not obvious, take an overall picture of the HV battery, with pointers to the damaged area or areas.

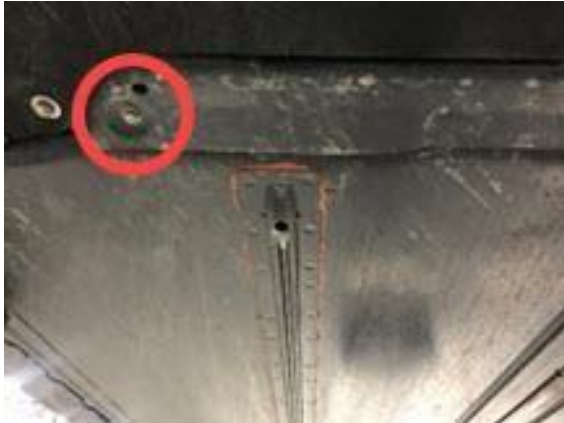
Figure 11 – Skid plate to doubler fastener

NOTE: The bolt that threads into the doubler is circled in Figure 11 and Figure 12. There is another bolt symmetrically on the other side of the vehicle. These bolts are prone to shearing in the event of front skid plate damage (Figure 12).

Suggest repair to customer:

- Deburr the area with a hand deburring tool to remove the sharp edges if sharp edges are found.
- Re-tap the fastener hole if a fastener hole is damaged and the fastener cannot withstand full torque.
- Recommend replacement of the:
 - Fastener if a fastener attaching the front skid plate to the doubler is damaged or stripped.
 - Front skid plate if the front skid plate, or part of the skid plate, is detached, or not covering the baseplate.
 - HV cables if the HV cables are damaged above the front skid plate.
- Recommend HV battery replacement if:
 - A passthrough is damaged above the front skid plate.
 - The HV battery enclosure fails leak test due to impact.
 - The HV battery enclosure has low isolation due to impact.
