TN-22-16-001 R1 January 5, 2024

Tesla, Inc. Technical Note
Model:	Vehicle System:	Region:
Model Y Structural Pack	16 - Battery System	All

Inspect the Model Y Structural HV Battery for Underside Damage

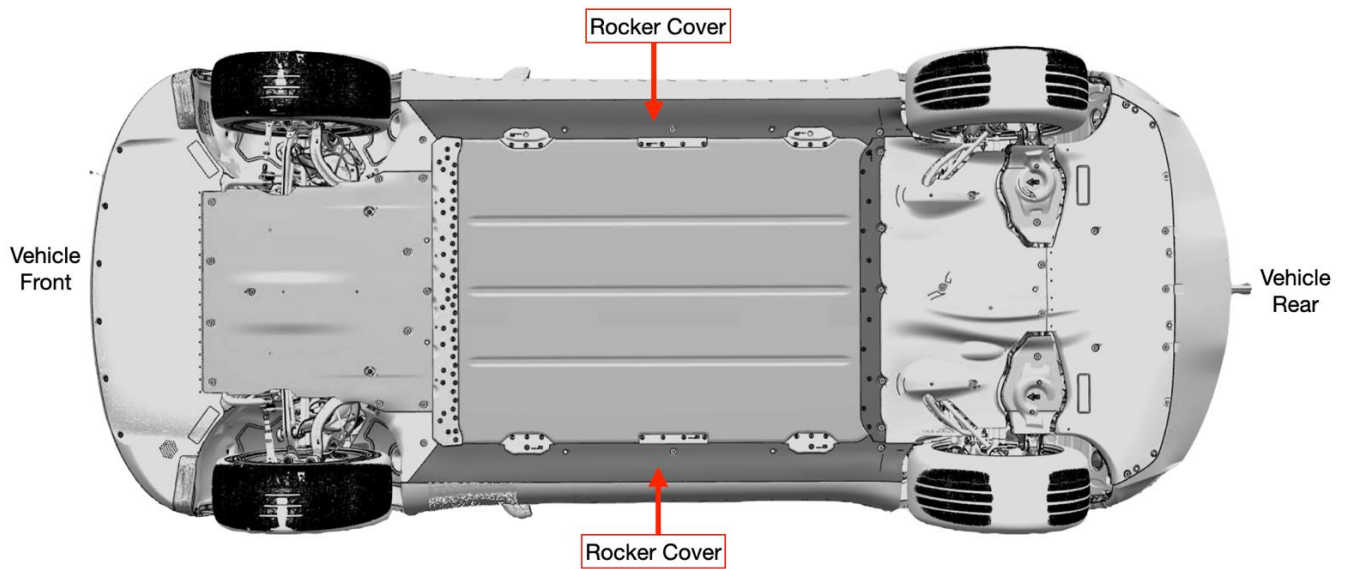
Figure 12 – Side rocker covers

1. Visually inspect the side rocker covers (Figure 12).

Suggest repair to customer:

- Deburr the area with a hand deburring tool to remove the sharp edges if sharp edges are found.
- Re-tap the fastener hole if a fastener hole is damaged and the fastener cannot withstand full torque.
- Recommend replacement of the:
 - Fastener if the fastener is damaged or stripped.
 - HV cables if the HV cables are damaged.
 - Coolant hose if the coolant hose is damaged.
 - Rocker cover if the rocker cover, or part of the cover is detached from the HV battery and cannot be secured properly.
- Recommend HV battery replacement if:
 - A jack point has extensive damage where it cannot be used to safely lift the vehicle.
 - The HV battery enclosure fails leak test due to impact.
 - The HV battery enclosure has low isolation due to impact.

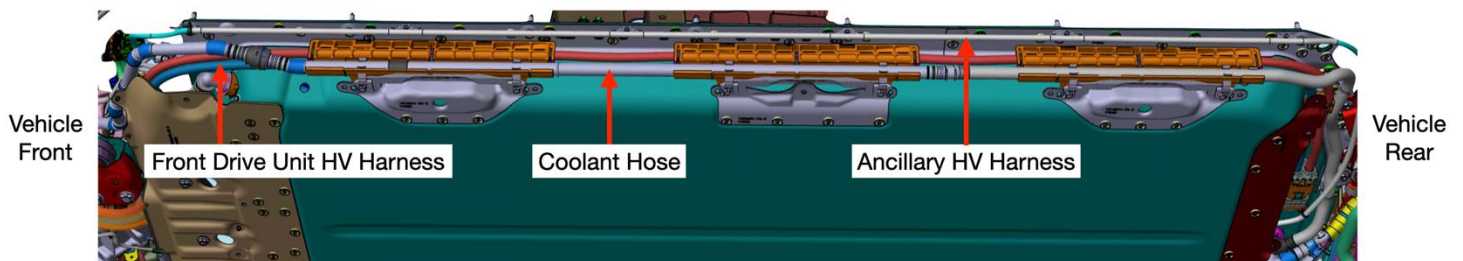
Figure 13 – Left side of HV battery

2. Remove the rocker cover(s) and inspect the HV cables and/or coolant hoses thoroughly (Figures 13 and 14).

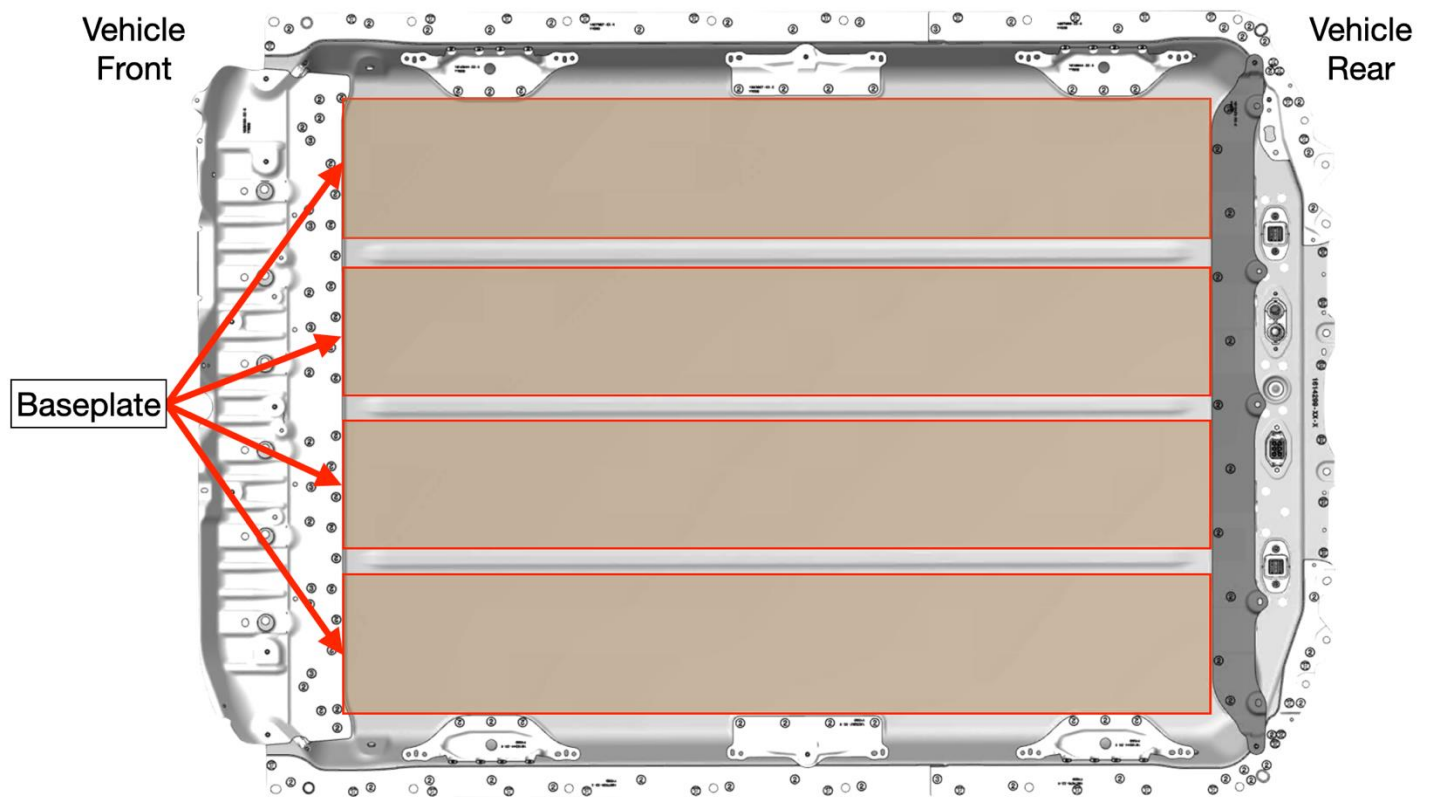
Figure 16 – Array baseplate

The array baseplate zones covers most of the underside of the HV battery and serves as a base for the battery arrays (Figure 16). The array baseplate zones start at rear of the front skid plate and extends to the front edge of the rear aero shield bracket.

When the baseplate is damaged, follow the steps below:
