Article #33186 - ABS_0x4090

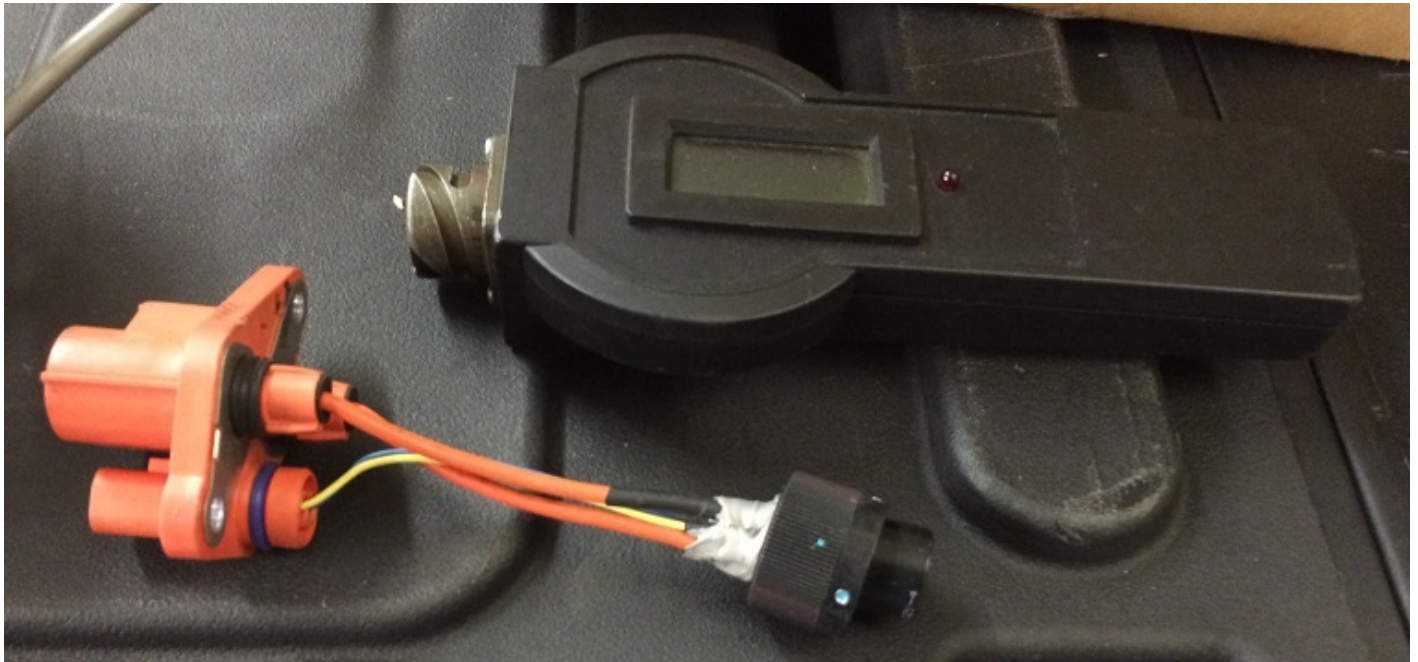
- Connect Heating, Ventilation, Air-Conditioning (HVAC) Simulator and check for cleared fault.
- Replace the 400V controller with a known functioning controller and check for cleared fault.
- Check J3 connection at battery (ESS).
- Install HVAC adapter harness and connect HVAC Simulator and check for cleared fault.

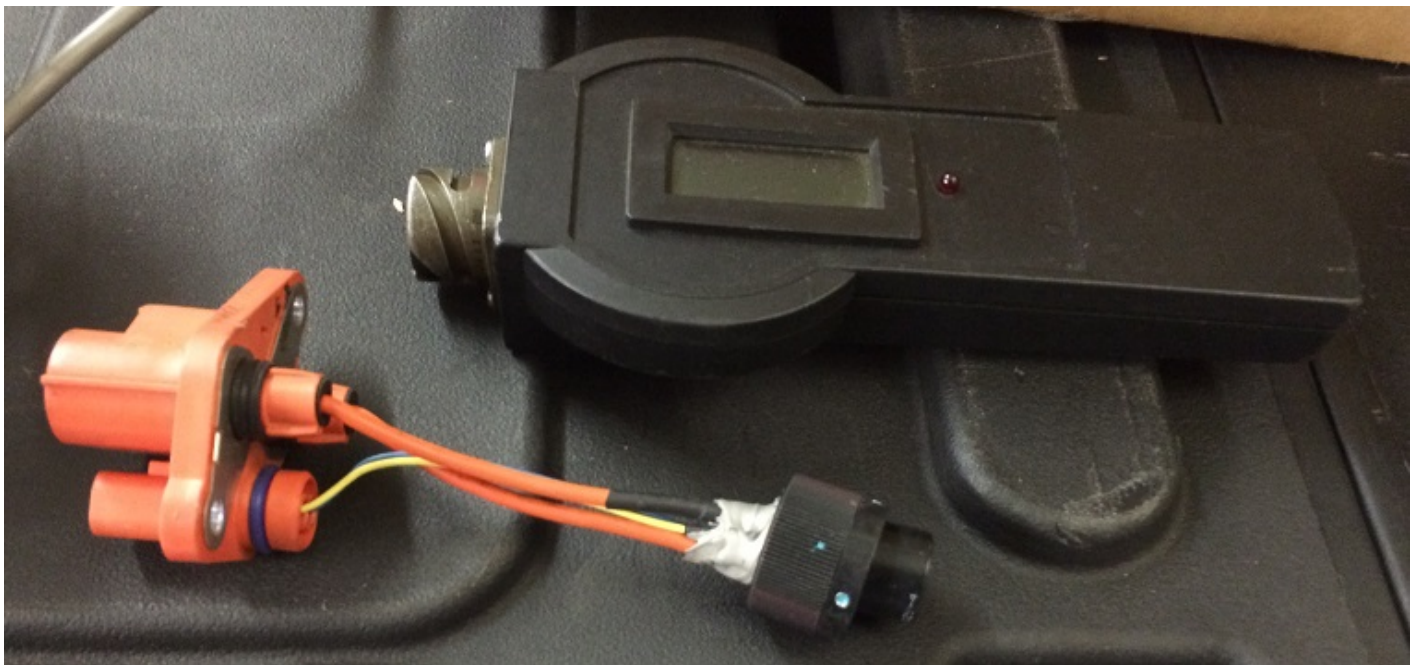
simulator in place of the 400V HVAC controller. Attempt to close contactors.

- The fault likely lies in the 400V HVAC controller, Positive Temperature Coefficient (PTC) heater, or A/C compressor. Inspect each component for physical damage or damaged wiring. Check for contactor closure.

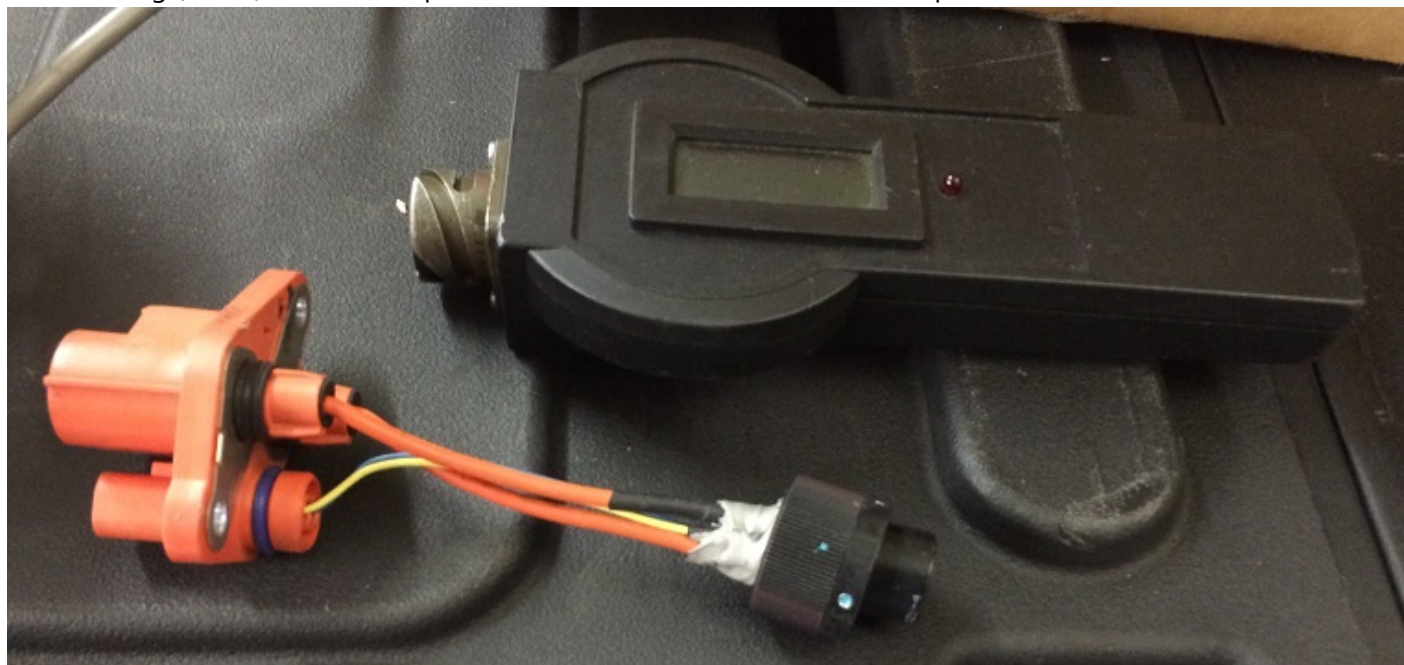
Pull the vehicle logs and review the fault occurrence, often the data text information that accompanies the fault will include valuable information regarding the battery precharge voltage. If the data text indicates that the battery (ESS) voltage was 0V, this may indicate a failure internal to the pack. This fault is often intermittent, if this is the case attempt to duplicate the fault. When the fault is present connect the Heating, Ventilation, Air-Conditioning (HVAC) simulator in place of the 400V HVAC controller. Attempt to close the contactors.

- If the contactors close, the fault likely lies in the 400V controller, PTC heater, or A/C compressor. Inspect each component for physical damage or damaged wiring.
- If the contactors do not close, connect the HVAC simulator directly to the battery in order to eliminate the possibility of damaged wiring between the 400V HVAC controller and the battery. Attempt to close the contactors.
 - If the contactors close, inspect the HVAC wiring between the battery and the 400V HVAC controller.

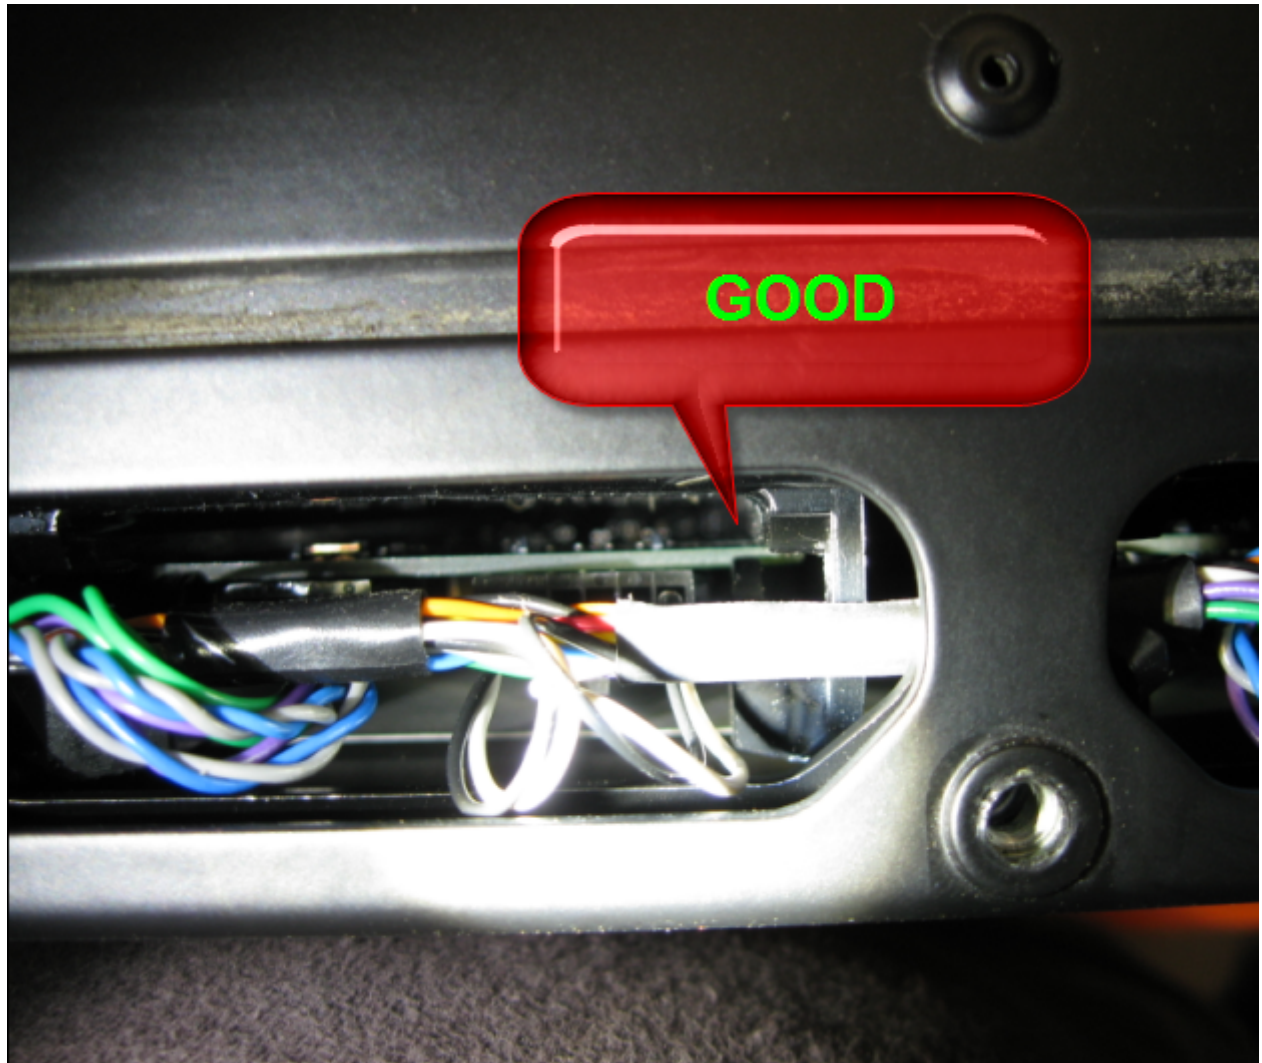
- Remove BMB cover.
- Inspect securing tabs for all BMBs.
- If any securing tabs are not properly engaged, take picture (noting BMB position) and proceed to fully insert BMB until securing tabs are all in proper position.
- When all securing tabs are properly engaged, open BMBUI in diagnostic tools using the 4 way CAN breakout connection point.

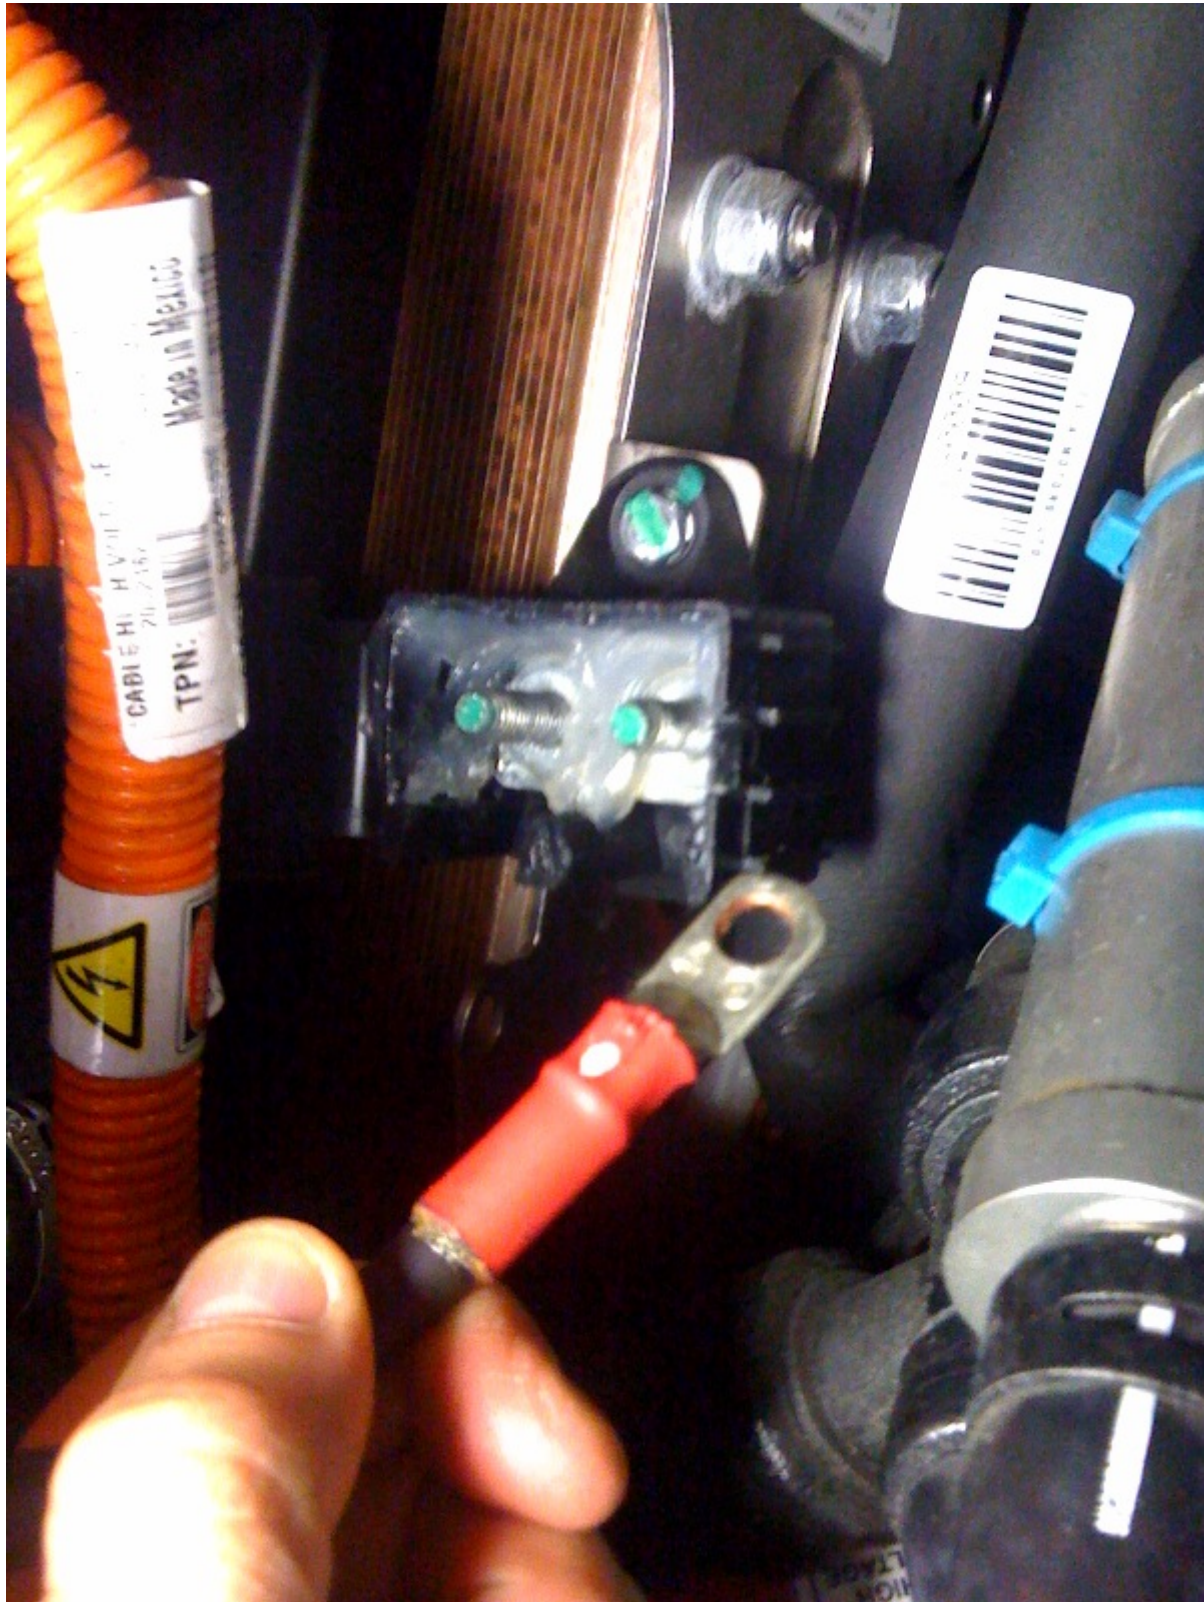
2. Next, disconnect the main output from the dual binding post as shown below.

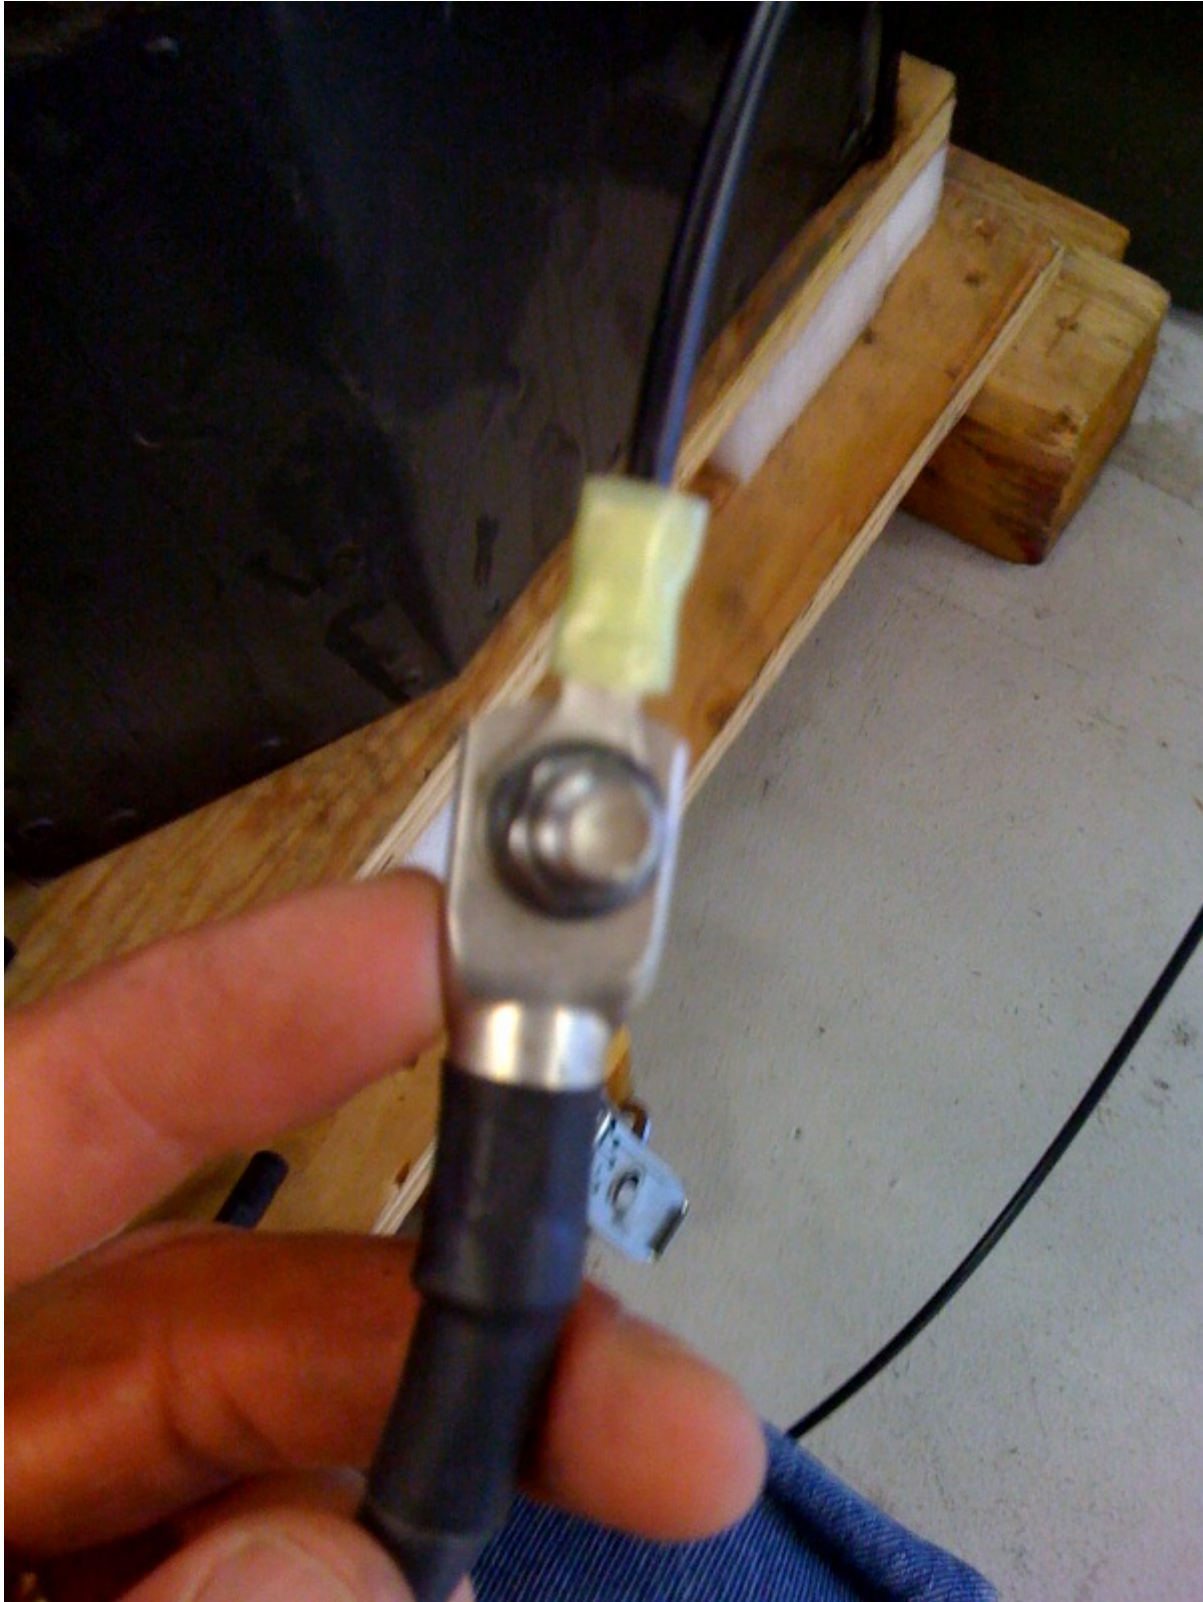
3. Then connect the RED heater wire to the APS Main output and wrap it with an insulating tape to avoid any shorts. (Note the image shows the black wire for clarity, but the RED wire goes to APS main.)

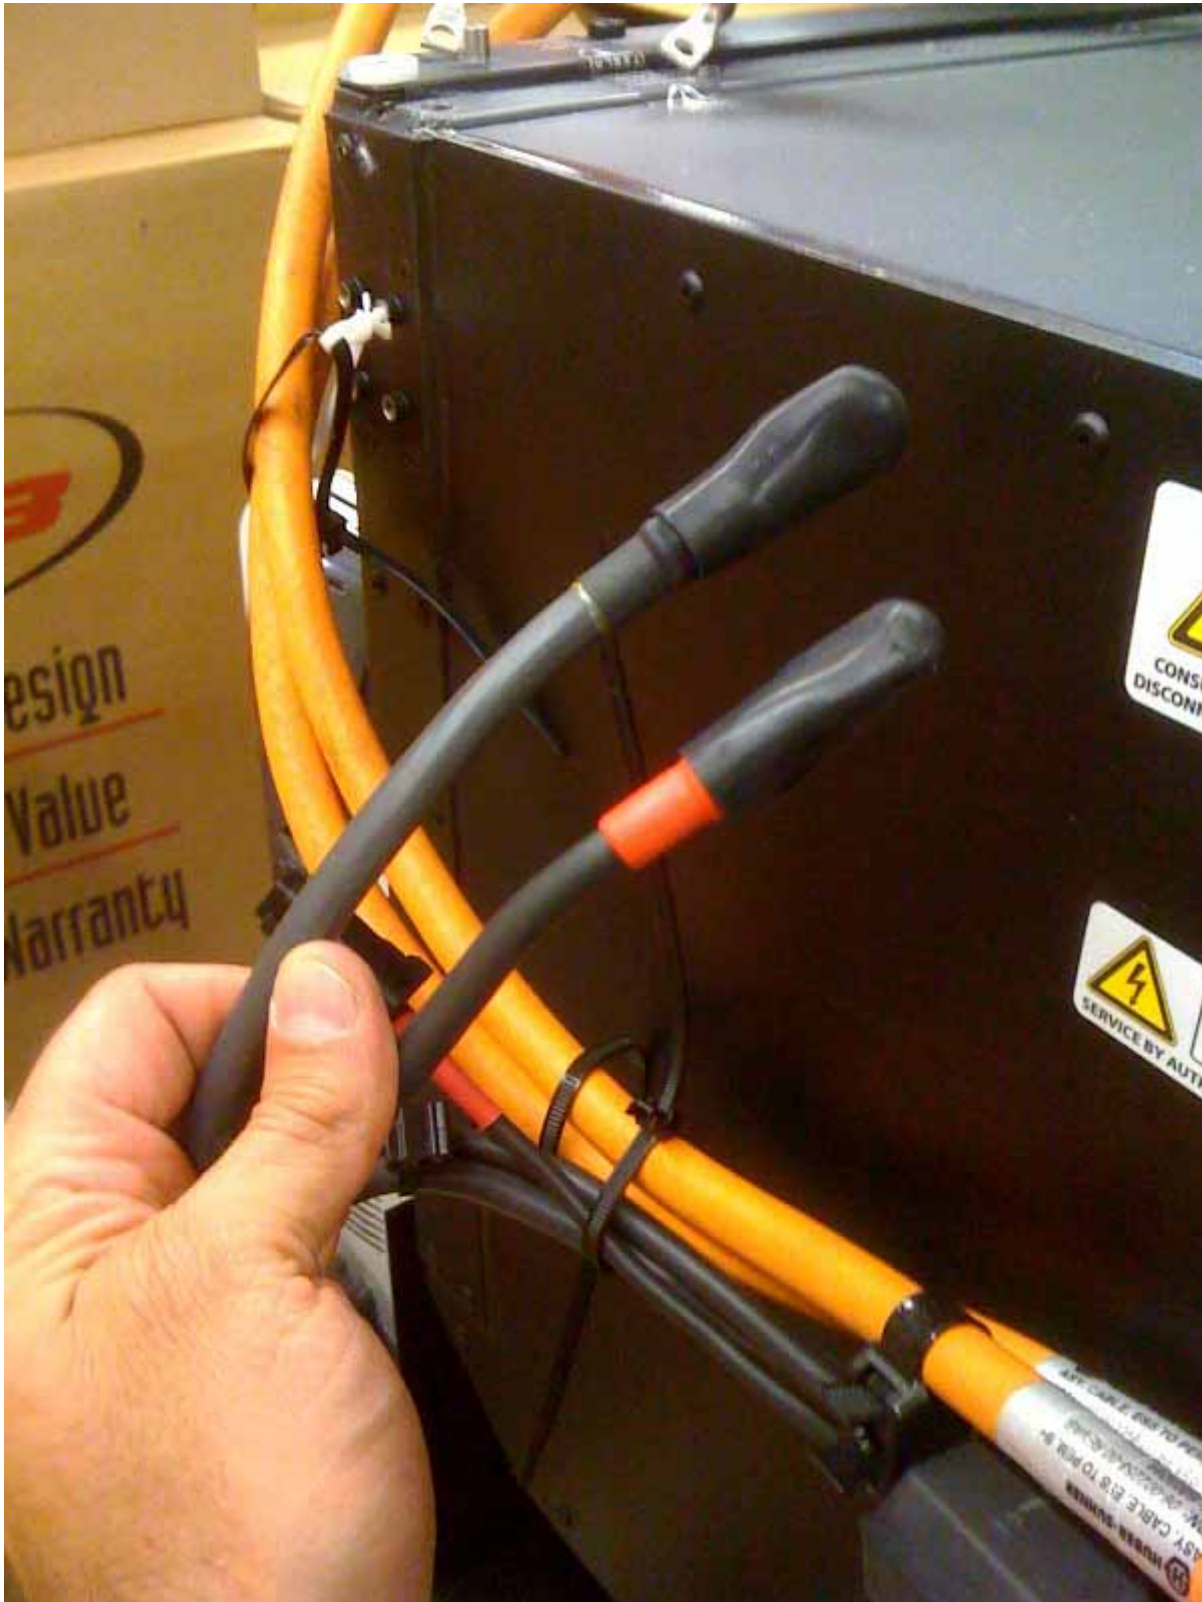
The out of car set-up is fairly simple, and safe. The following images show the APS main outputs. These cables shall be connected to the INPUT of the 12 volt heater.

1. Connect these lugs to the 12V heater inlet:

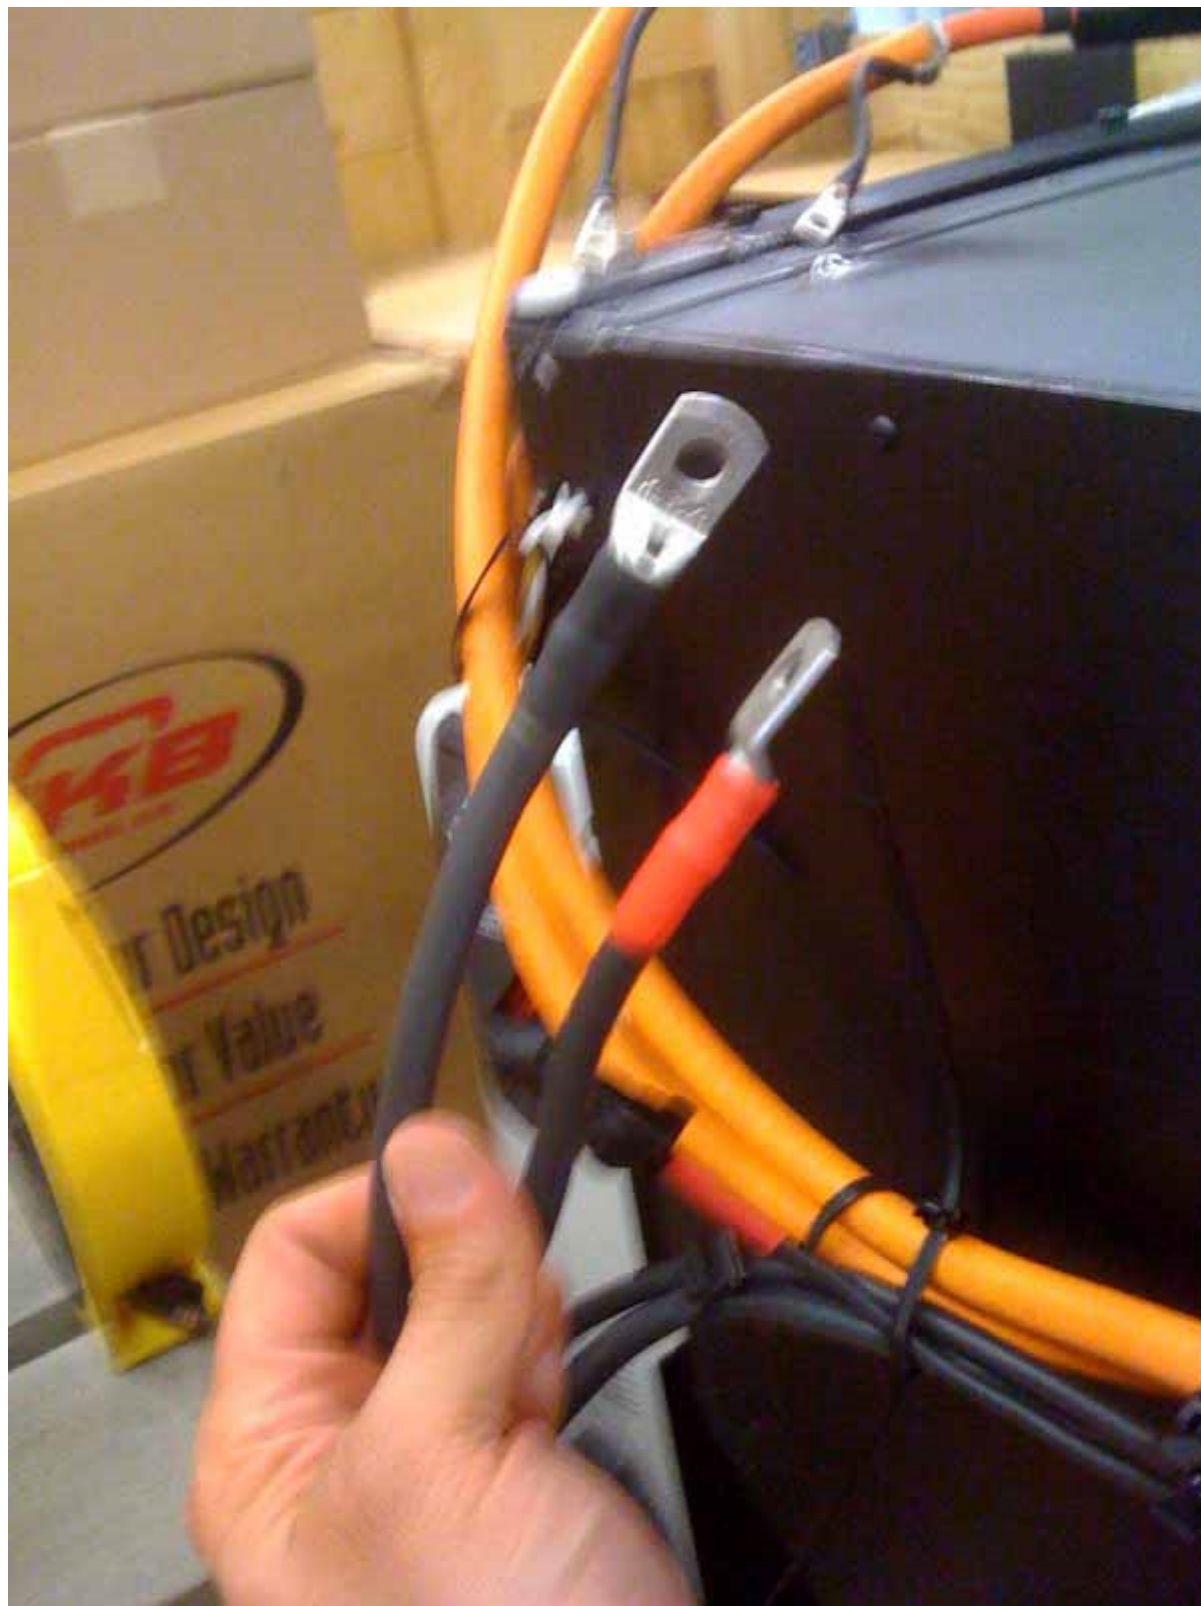
2. Pull off the rubber covers on the APS output, one at a time and connect to the heater inputs. Even though the APS outputs only 12 volts, it is capable of driving HUGE current loads, so after making any electrical connections, be sure to cover them with an insulating tape, such as electrician's vinyl tape.

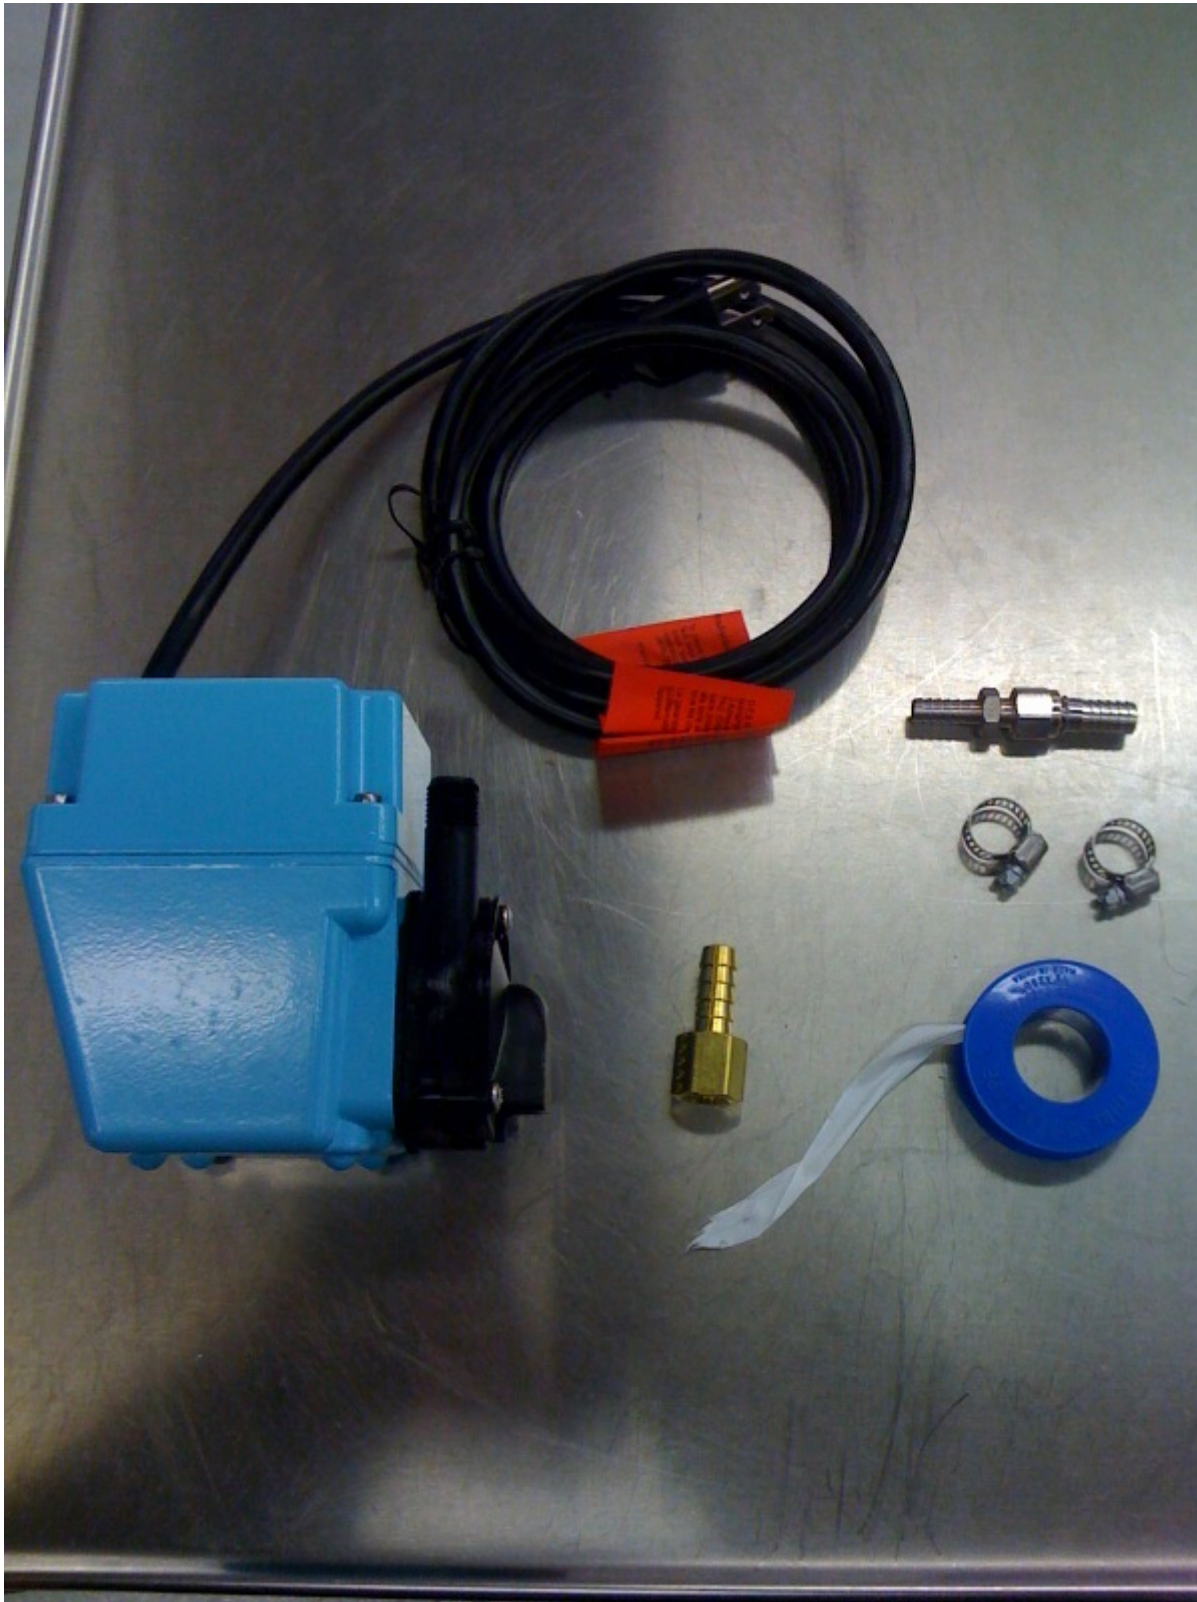
barb fittings and clamps

Pump kit with

- You will need to obtain about 2-3 feet (1 meter) of 3/8 ID tubing (8mm tubing). This tubing will go between the pump and the APS coolant inlet.

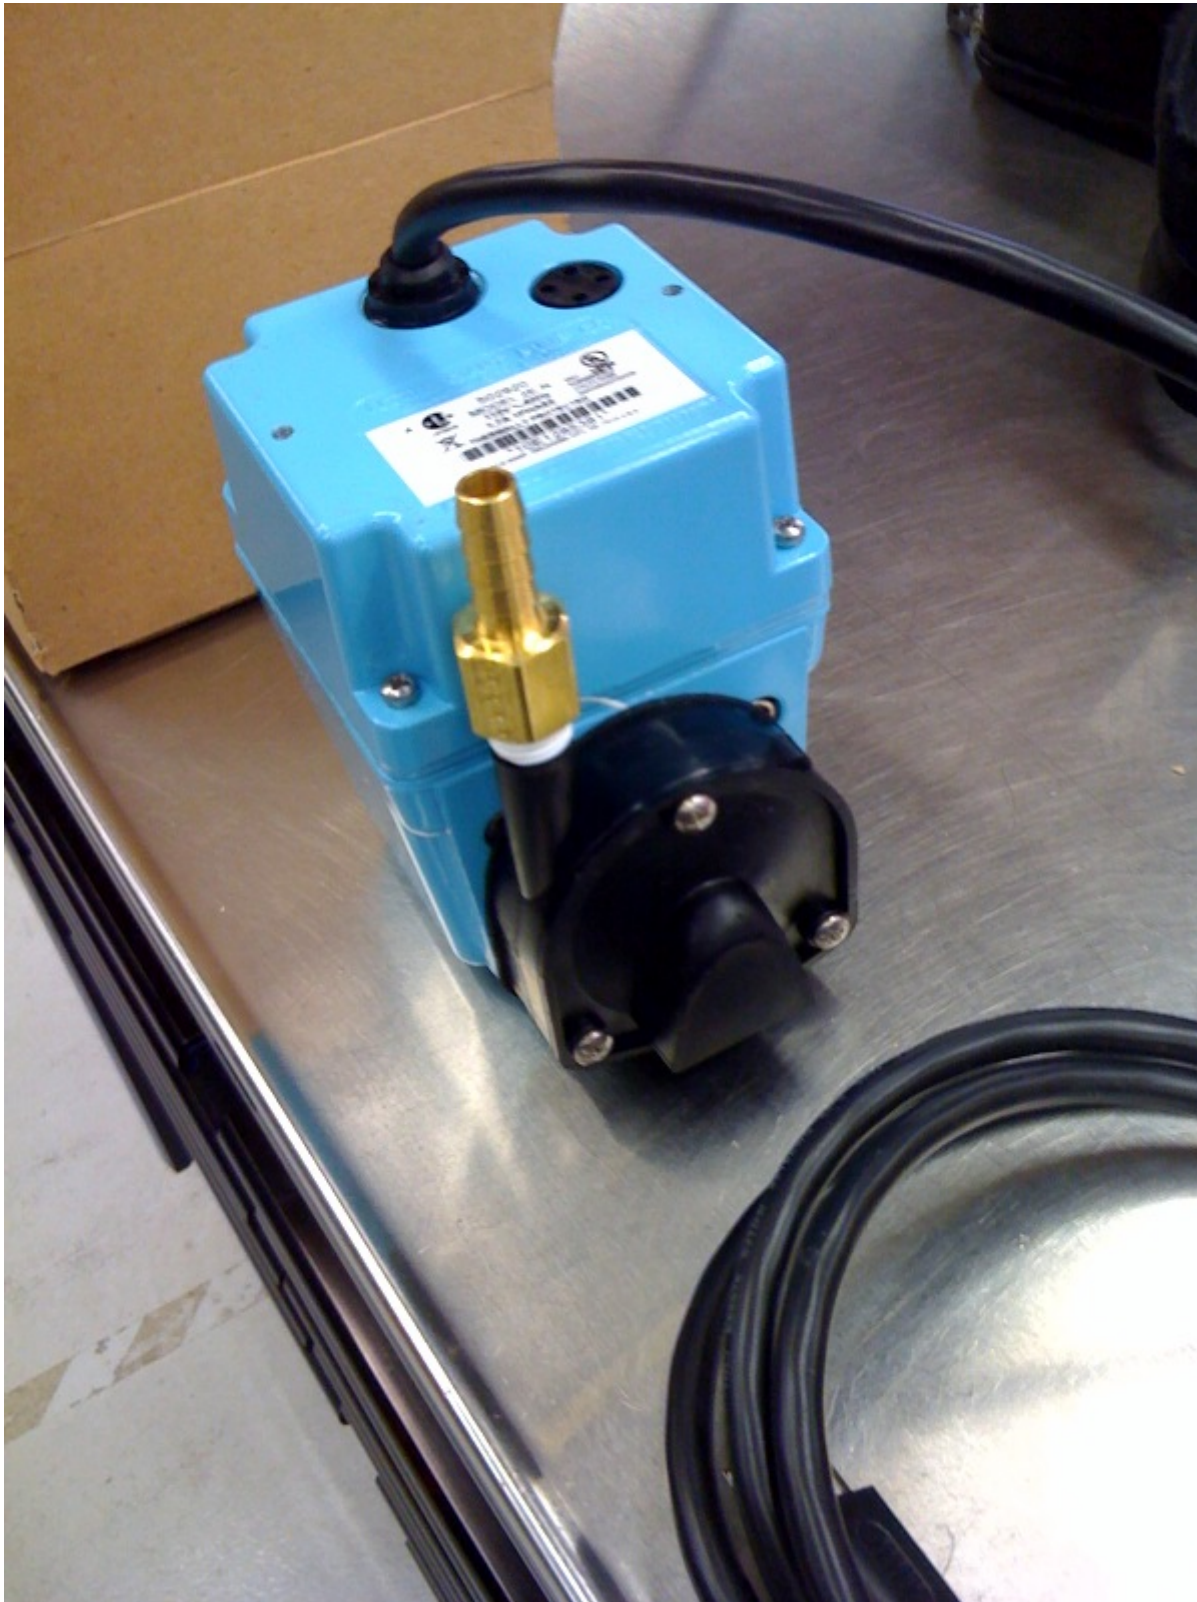
Barb fitting on
the pump.

- Next, push the tubing onto the barb fitting and secure with one of the included hose clamps.
- Then put the 3/8 to 1/4 adapter onto the other end and secure with the other hose clamp. The pump outlet hose with the adapter on it will be connected to the shorter of the two APS coolant tubes. The other tube will serve as the outlet for the coolant.

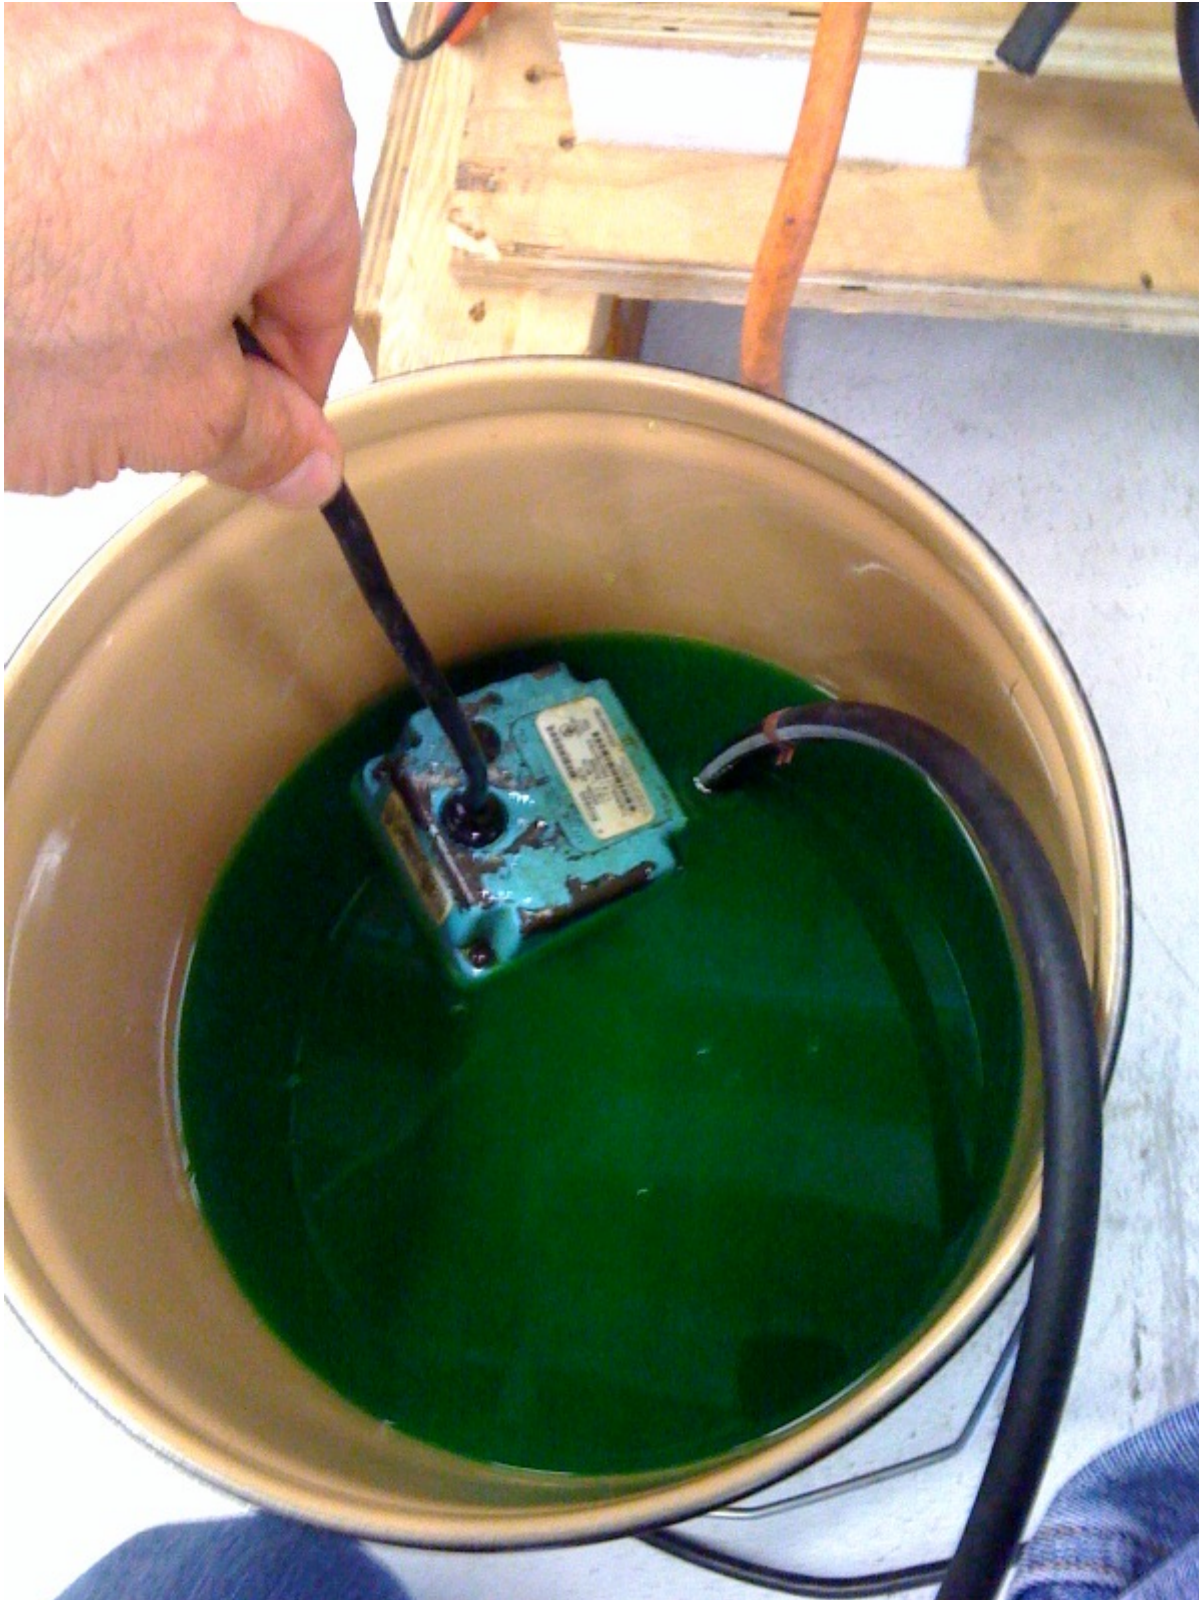
- Next, you will need to fill a 5 to 10 gallon bucket with coolant, coolant and distilled water mixed to 50:50 or just distilled water. This bucket will serve as the reservoir for cooling the APS as you discharge the pack through the heater.
- Lower the pump into the reservoir, and be sure that the power cord and the outlet tube are coming straight up, out of the tank. Let the longer APS coolant tube hang back into the tank, as shown below.

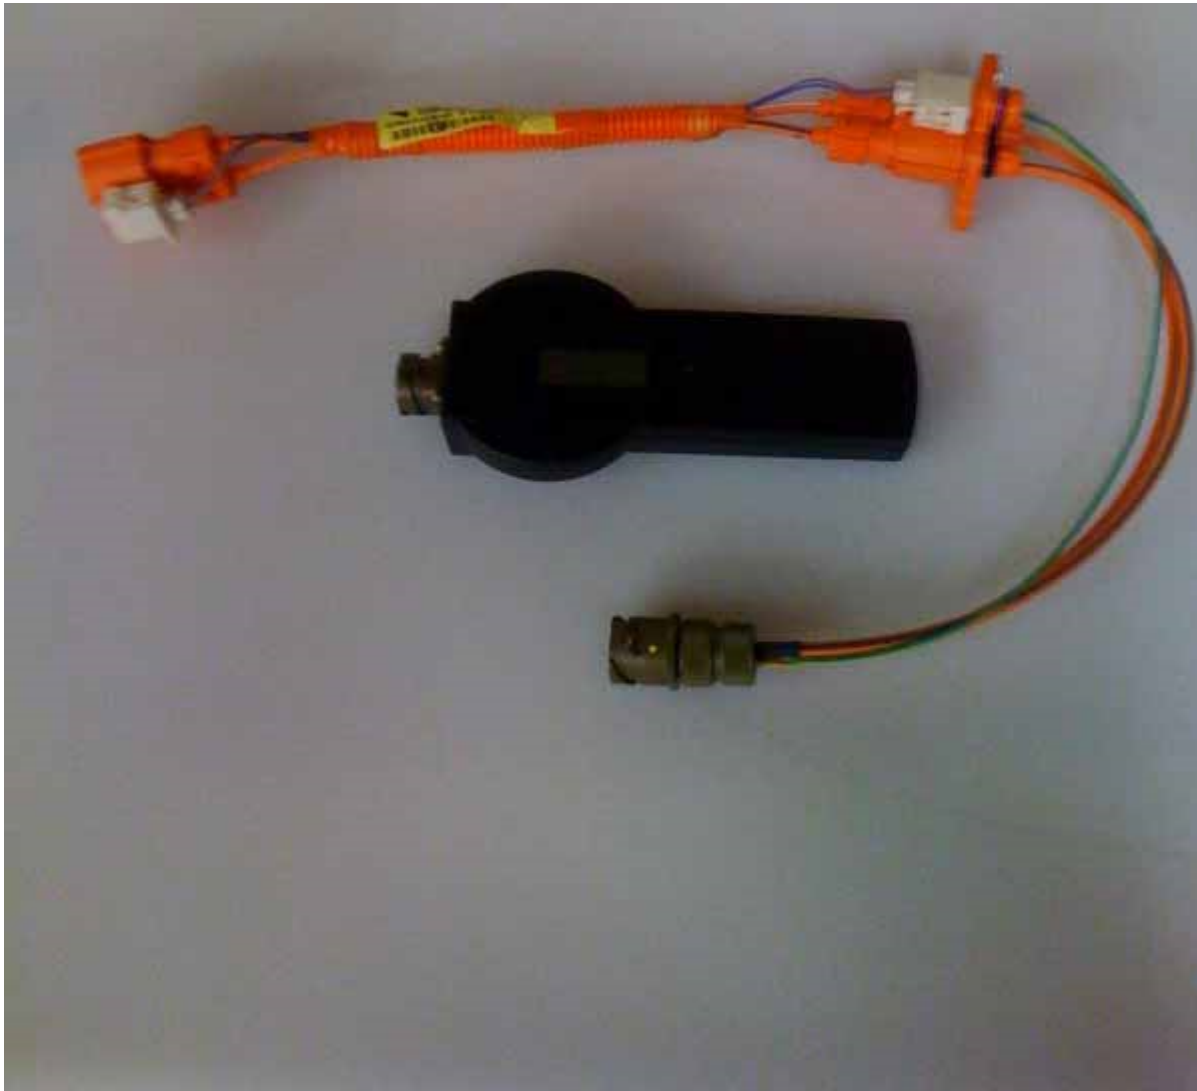
HVAC simulator

This device goes onto the HVAC outlet of the pack and contains the 65 Ohm End-Of-Line resistor that is needed in order to turn on the APS. Connect as shown above.

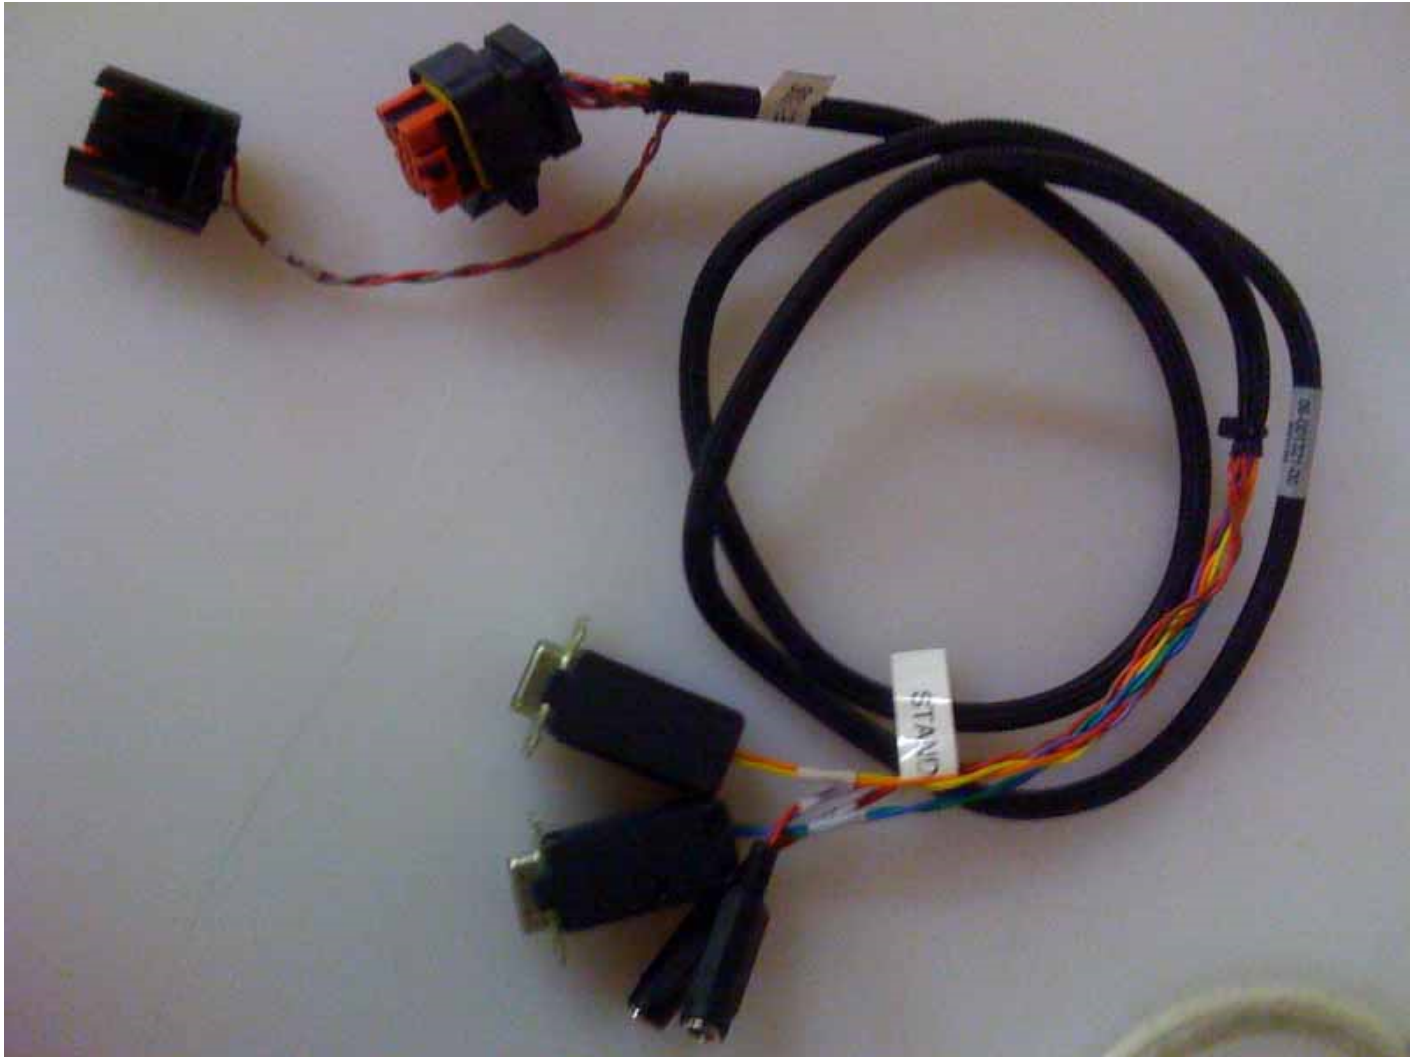
ESS logic connect cable

- Then connect your laptop PC running LINUX and the PERL diagnostic suite via the ESS logic connector, the USB-CAN adapter and the ESS Logic connect cable.
