<b>Tesla, Inc.</b> Service Bulletin		<h2 style="text-align: center;">Replace Instrument Panel Air Vent(s) due to Rattling Noise</h2>		
<b>SB-24-14-001</b> October 11, 2024	<b>R1</b>			
<b>Classification</b>		<b>Section/Group</b>	<b>Mobile Service</b>	<b>Configuration</b>
Repair Bulletin		14 - Instrument Panel	Cannot Perform	All
<b>Model</b>	<b>Model Year</b>	<b>Country/Region</b>	<b>Build Location</b>	
Model 3	2024	North America, Taiwan	Fremont	
<small>The model(s) and model year(s) listed are a general approximation of the affected VIN list. Refer to the VIN/Bulletin Tracker or Customer/Vehicle profile to determine applicability of this bulletin for a particular vehicle.</small>

On some 2024+ Model 3 vehicles built at Fremont, a rattling noise may be noticed from the driver and/or front passenger instrument panel air vent while the face-level air vents are directed to straight ahead air flow.

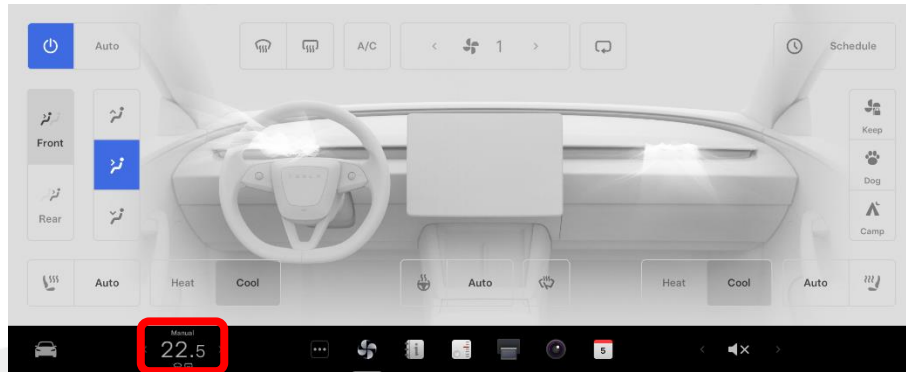
Figure 1

1. Touch the temperature button on the bottom of the touchscreen to display the main climate controls screen (Figure 1).

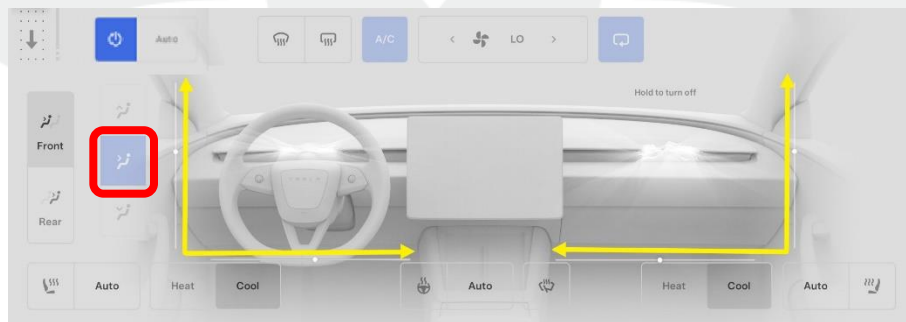
Figure 2

2. Set the air to flow from the face-level air vents only, and touch and drag the radiating air waves from the vents on the touchscreen to adjust the direction of the air flow to centered and straight ahead (Figure 2).

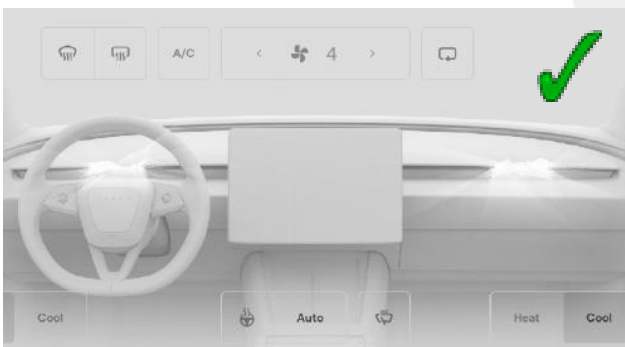
**NOTE:** The air flows in a merged single stream when centered or splits into mirrored air streams when air is directed outward or inward from the center of the vent. Make sure both air flows are set to “Merged” (Figure 3) and not to “Split” (figure 4).

Figure 3 – Both air flows set to “Merged”

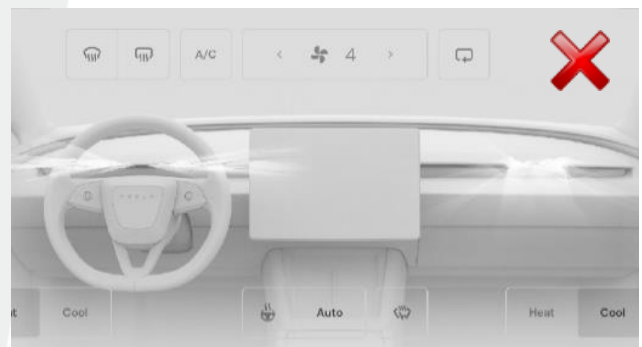
Figure 4 – Driver air flow set to “Split”, passenger air flow set to “Merged”

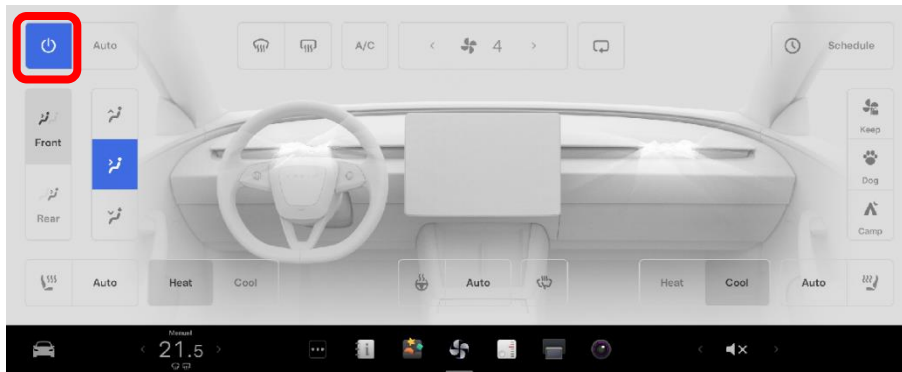
**Figure 5**

3. Turn off the climate system (Figure 5).

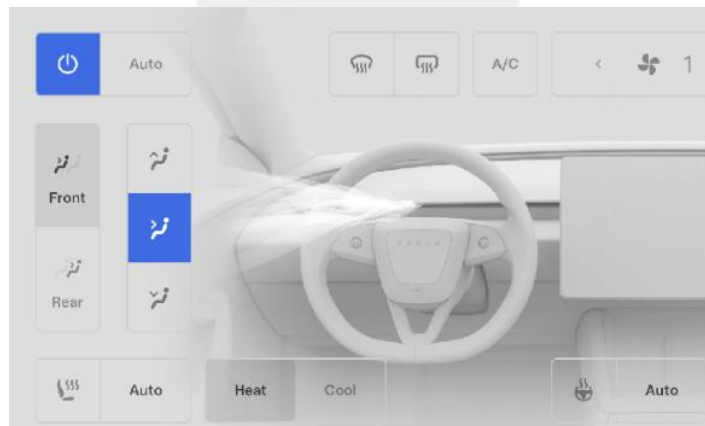
4. Take the vehicle for a test drive and perform the following sub-steps while driving to check for a rattling noise coming from the driver and/or front passenger air vent:
  - a. If a rattling noise is noticed from one or both air vents, turn on Climate Control, adjust the direction of the air flow through the air vents towards the outboard sides of the vehicle (Figure 6), and then turn off Climate Control again.

**Figure 6 – Merged air flows directed to the side of the vehicle**
