Tesla, Inc.
Service Bulletin

Inspect Accelerator Pedal

SB-24-33-003
April 18, 2024

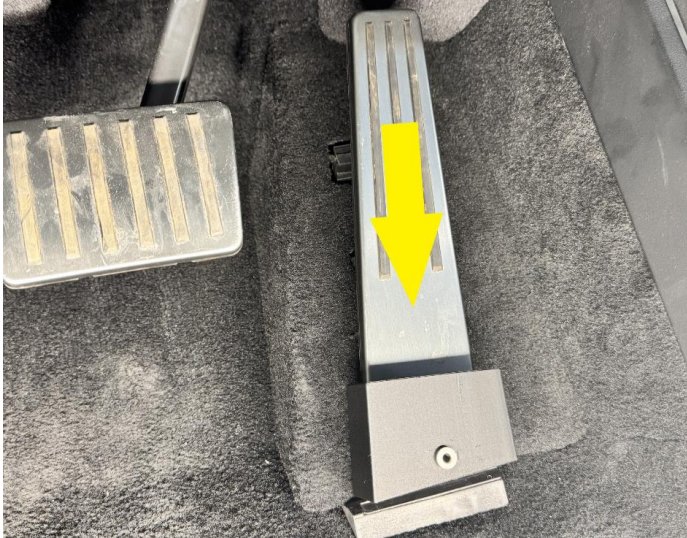
Figure 3

5. Position the drilling jig (provided in the pedal rework kit) on the accelerator pedal assembly, making sure the bottom of the jig aligns with the bottom of the pedal (Figure 3).

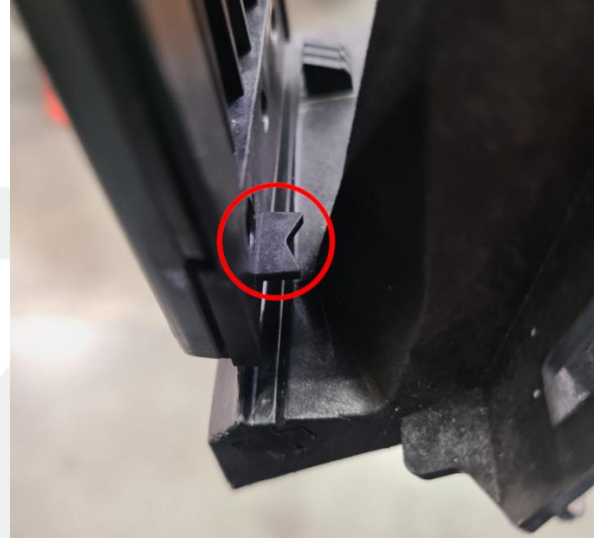
Figure 4

⚠ CAUTION: The drilling jig is designed to contact a reinforcement tab (circled, Figure 4) on the back of the pedal assembly, at which point, the jig will no longer slide downwards. Do not force the jig past this point, as doing so could damage the pedal assembly.

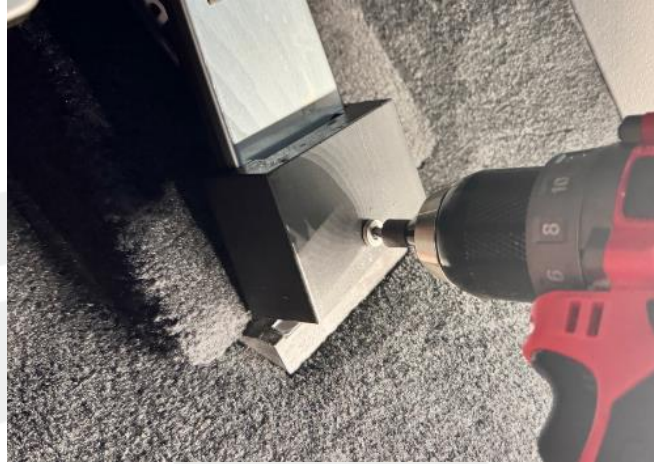
Figure 6

- Position the drill bit in the hole of the drilling jig (Figure 6), and then drill through the pedal, making sure the back side of the pedal is drilled through.

ℹ TIP: Use an inspection mirror to confirm that the back side of the pedal has been drilled through.

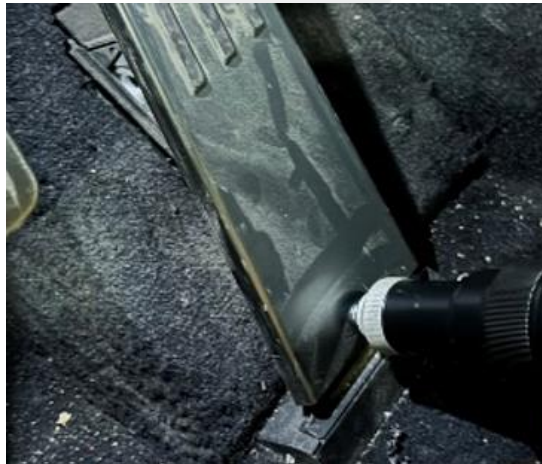
Figure 7

- Remove the drilling jig, and then vacuum up any drilling debris around the base of the pedal.
- Install a 4 mm rivet bit in the rivet gun, and then position the rivet (1064496-00-A) on the rivet bit.
- Install the rivet that attaches the pedal pad to the pedal backing (Figure 7).
