<b>Tesla, Inc.</b> Service Bulletin		<b><i>Inspect and Replace Rear Tires due to NVH Issue</i></b>	
<b>SB-24-34-003</b>					
October 11, 2024					
<b>Classification</b>		<b>Section/Group</b>	<b>Mobile Service</b>	<b>Configuration</b>	
Campaign Bulletin		34 - Wheels & Tires	Cannot Perform	All	
<b>Model</b>	<b>Model Year</b>	<b>Country/Region</b>	<b>Build Location</b>		
Model 3	All	Europe	All		
Model Y	All				
The model(s) and model year(s) listed are a general approximation of the affected VIN list. Refer to the VIN/Bulletin Tracker or Customer/Vehicle profile to determine applicability of this bulletin for a particular vehicle.

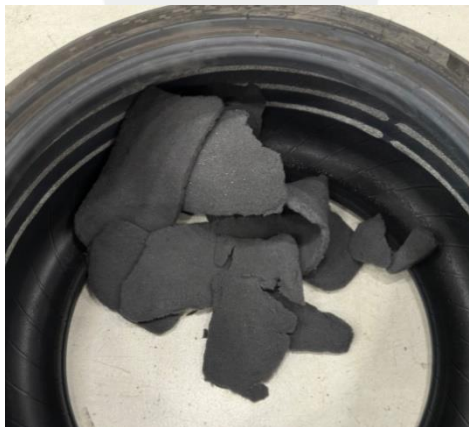
**Figure 1 – Loose NVH foam inside tire**

On some Model 3 and Model Y vehicles, there may be noise from the factory installed left hand rear and/or right-hand rear Michelin tire(s) due to the foam insert detaching from the tire which may cause imbalance and vibration.

1. Dismount the tire from the wheel (refer to Service Manual procedure [34021002](#)).
2. Inspect the inside of the tire to see if the NVH foam is loose (Figure 1).

Inspect the vehicle for symptoms related to the condition. If symptoms are present, replace both tires on the axle.

- If the NVH foam is properly attached, the imbalance was not caused by foam separation. Go to section [Reinstall Tire](#).
- If the NVH foam is loose, replace both tires on the rear axle. Go to section [Replace Tires](#).
